BaseVan Initial Inspection

Vehicle registration	LB67AOR
Vehicle chassis no.	WFOXXXTTGXHD14563
Miles (if in km, multiply by 0.62)	084072
Make	FORD
Model	Transit
Transmission	Manual, 6 speed
Factory immobiliser installed	Yes
Speed limiter installed	No
Drive configuration	AWD
Gross vehicle weight	3500kg
Towing capacity	2500
Tow bar installed	Yes

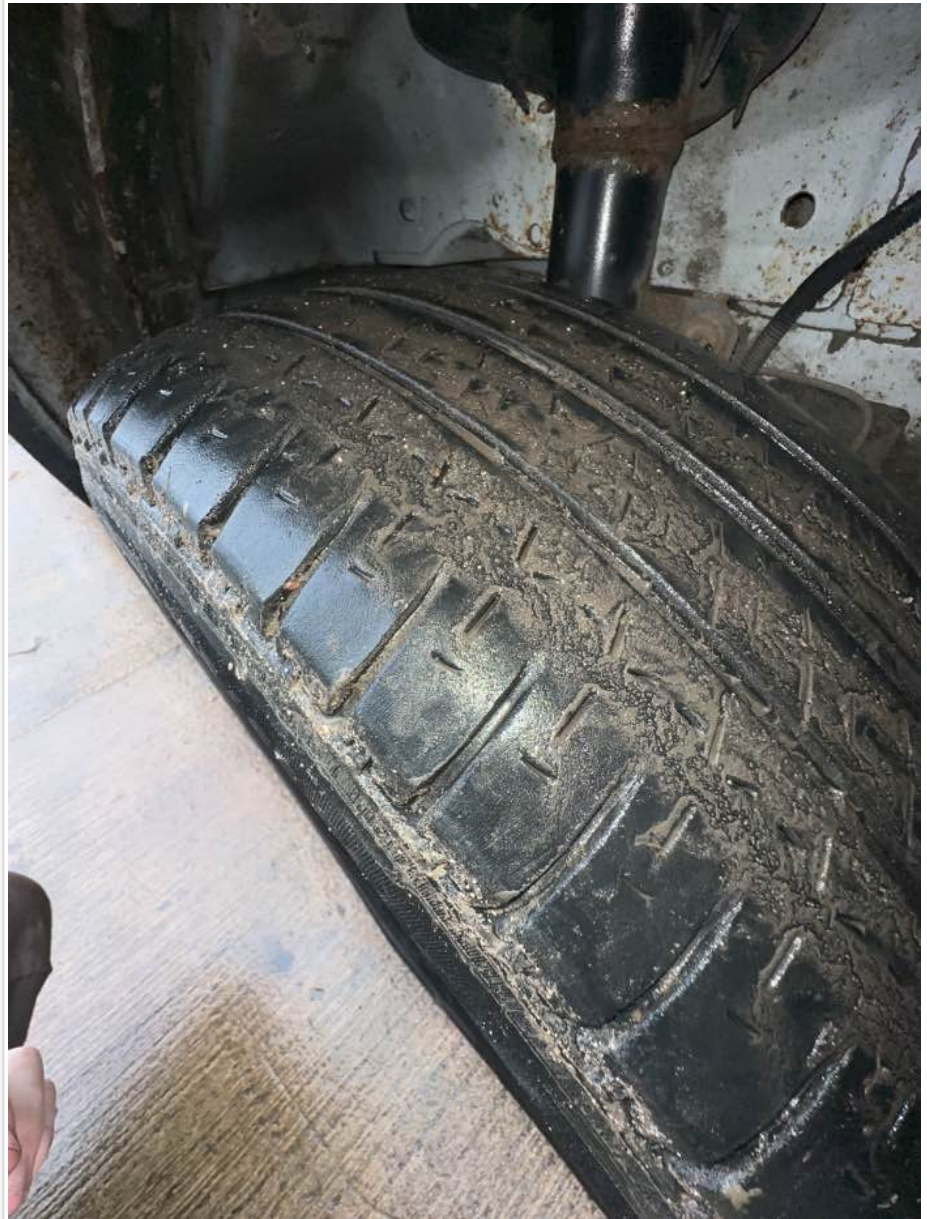
Off side front

Age (month/year) Manufactured	21/17
Make, brand.	Michelin
Tyre size	235/65/R16
Pressure 1	
Pressure 2	
Wearing / Perishing (inner)	none
Wearing / Perishing (outer)	None
tread depth (mm)	4
General comments	tyres are good but some wear

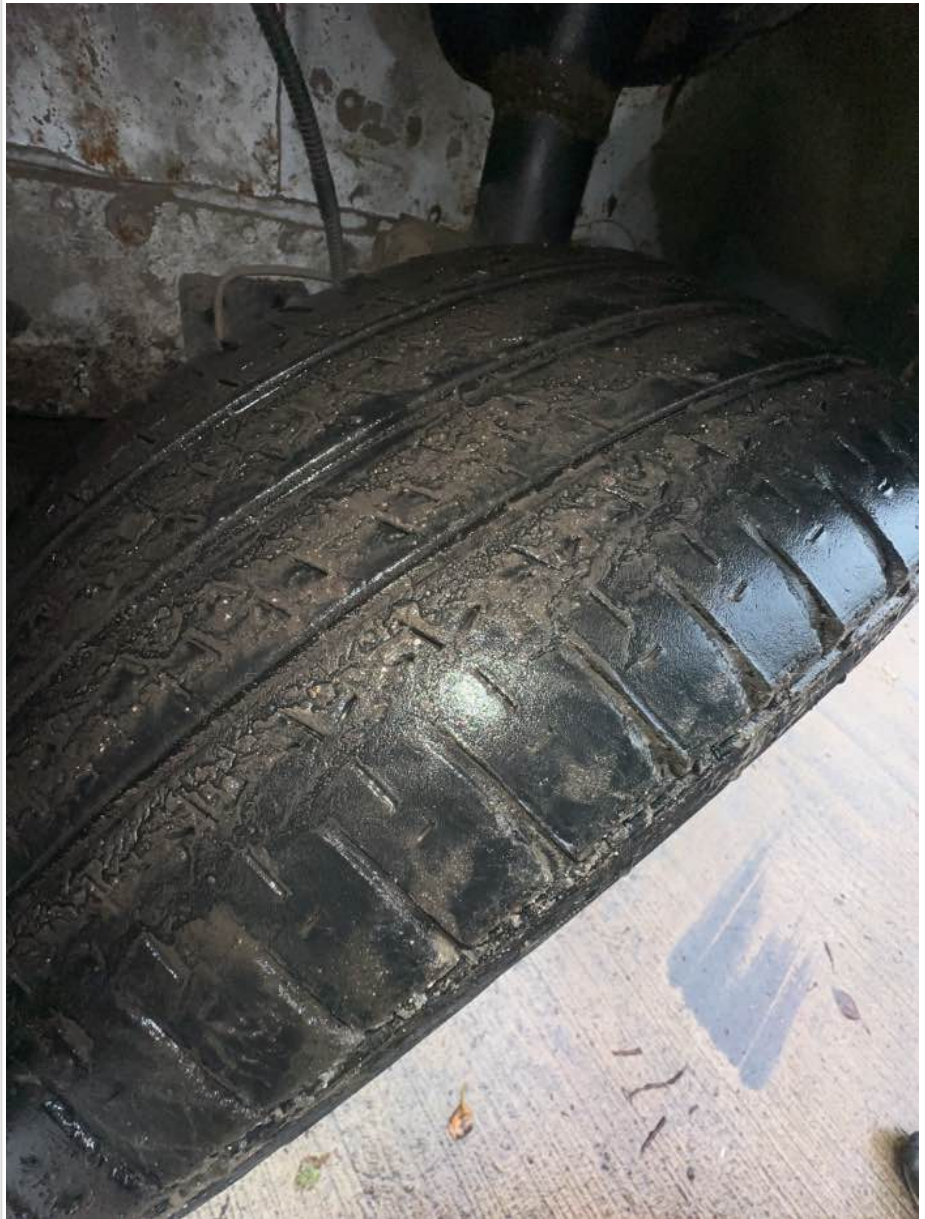
Near side front

Age (month/year) Manufactured	21/17
Make, brand.	Michelin
Tyre size	235/65/R16
Pressure 1	
Pressure 2	
Wearing / Perishing (inner)	none
Wearing / Perishing (outer)	None
tread depth (mm)	4
General comments	tyres good but some wear

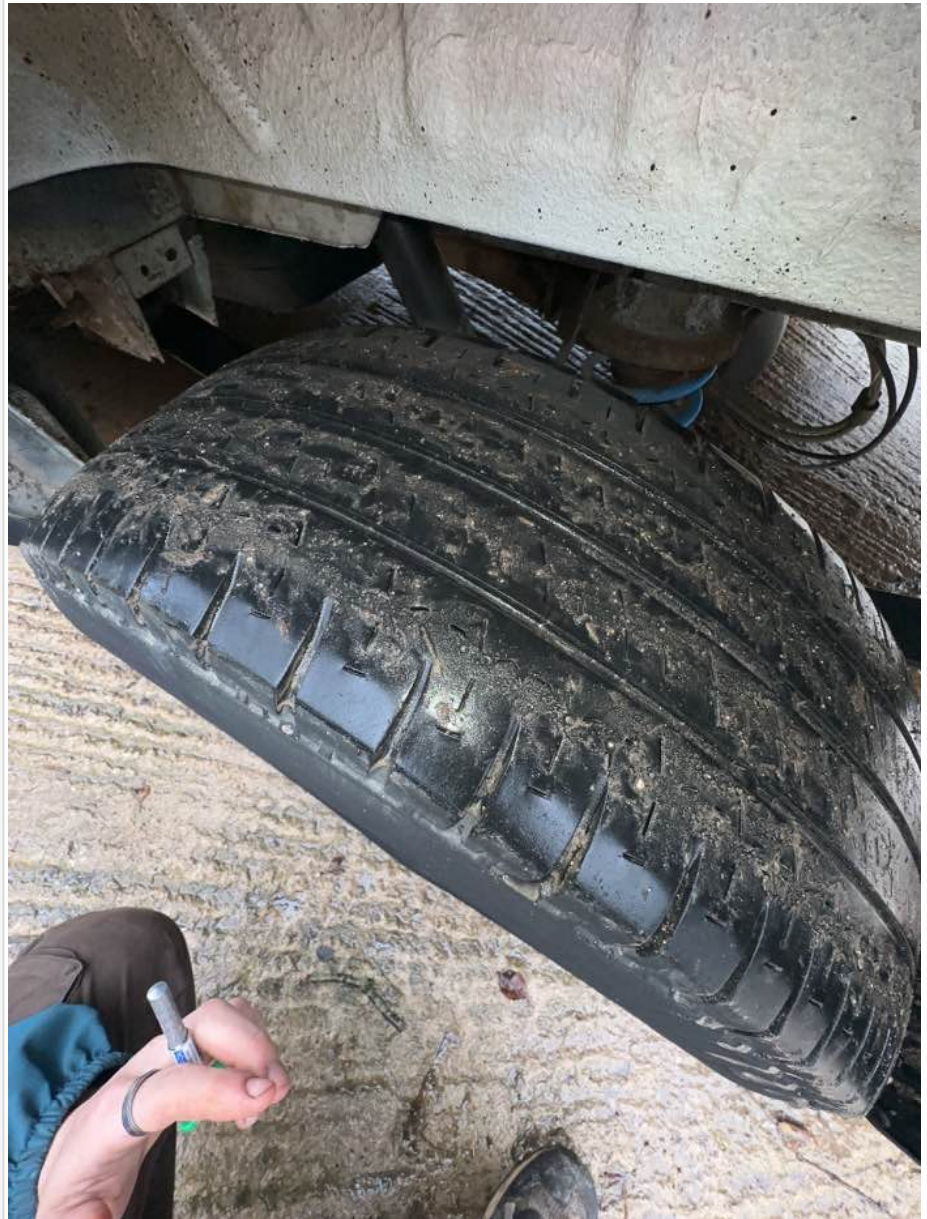
near side rear

Age (month/year) Manufactured	46/20
Make, brand.	Michelin
Tyre size	235/65/R16
Pressure 1	
Pressure 2	
Wearing / Perishing (inner)	none
Wearing / Perishing (outer)	None
tread depth (mm)	4
General comments	tyre is good but some wear

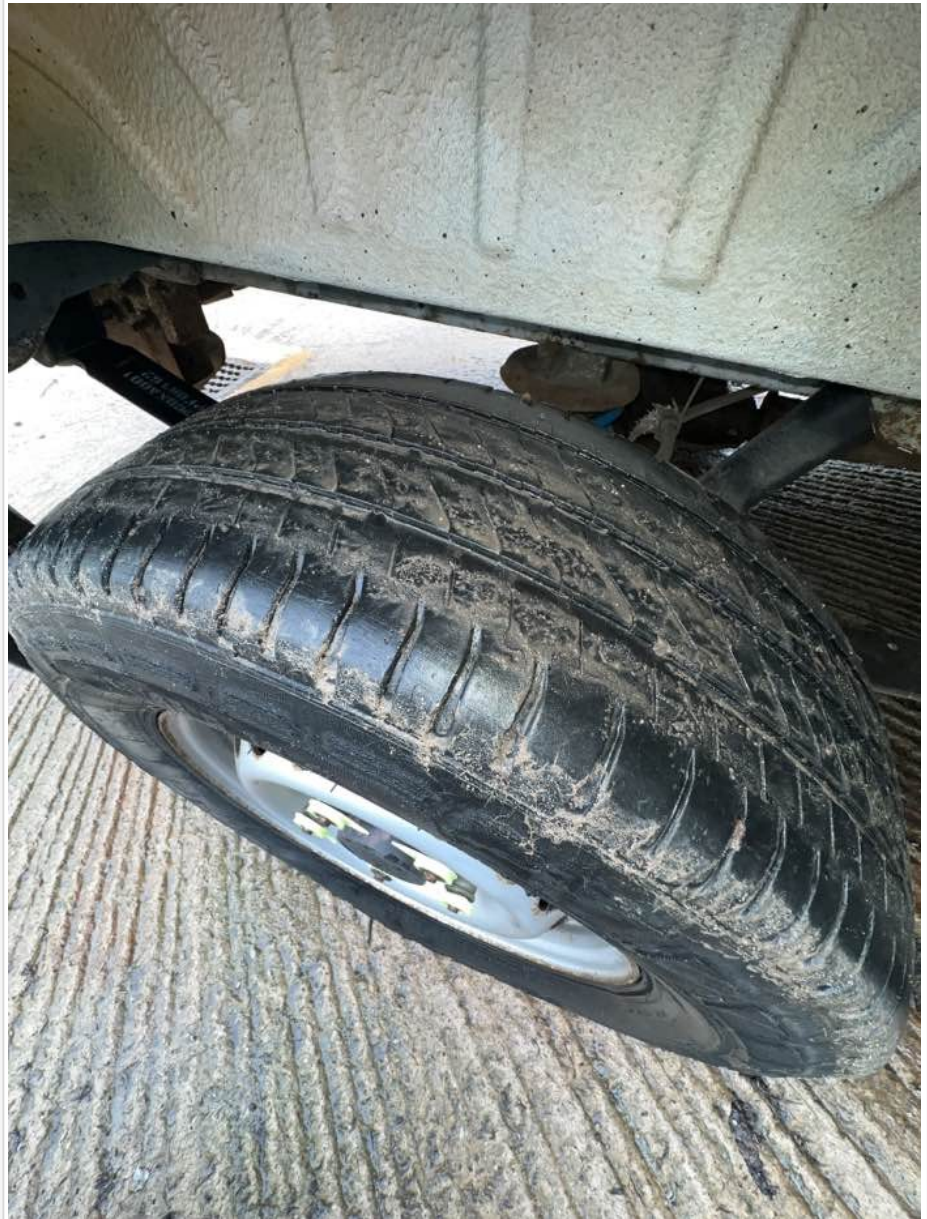
Off side rear

Age (month/year) Manufactured	46/20
Make, brand.	Michelin
Tyre size	235/65/R16
Pressure 1	
Pressure 2	
Wearing / Perishing (inner)	none
Wearing / Perishing (outer)	None
tread depth (mm)	4
General comments	tyre is good but some wear

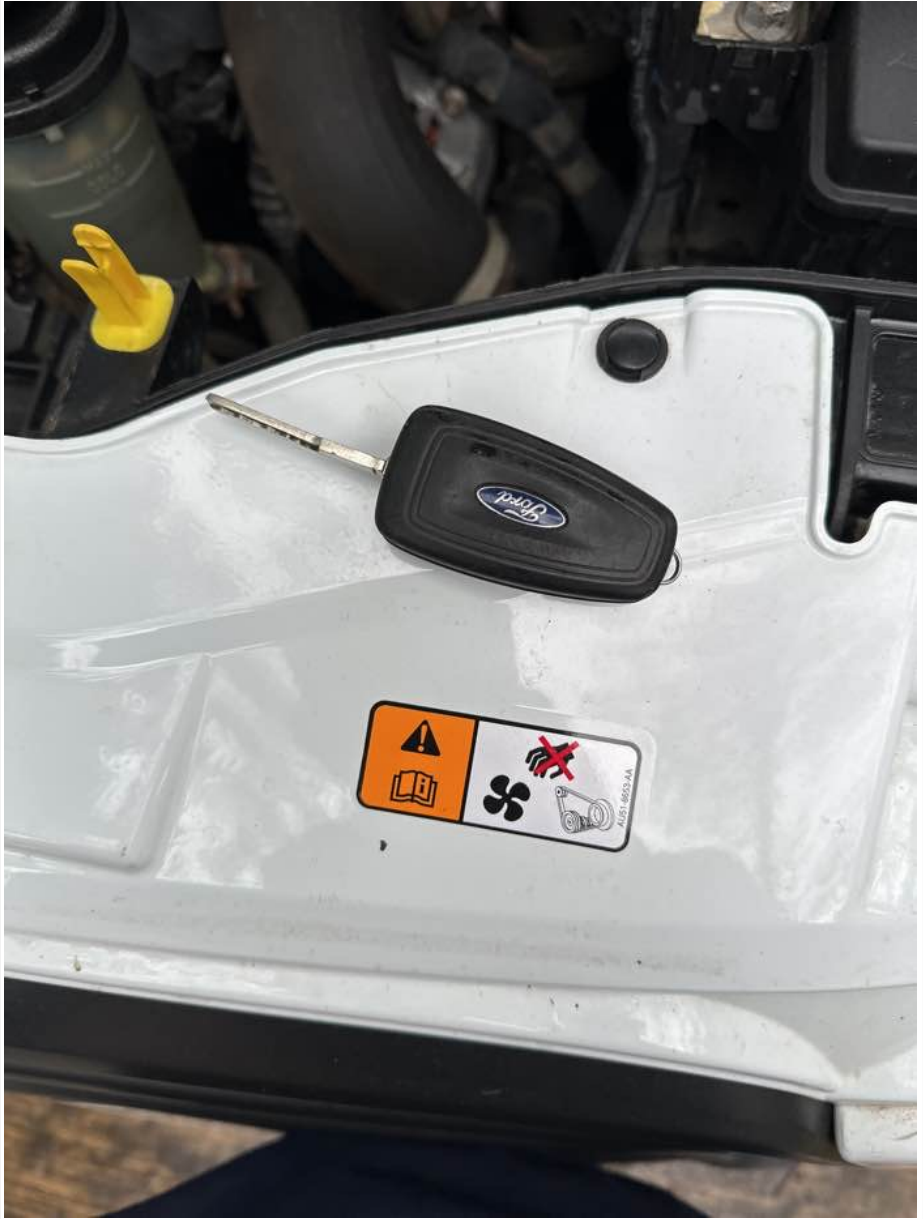
Comment	all works

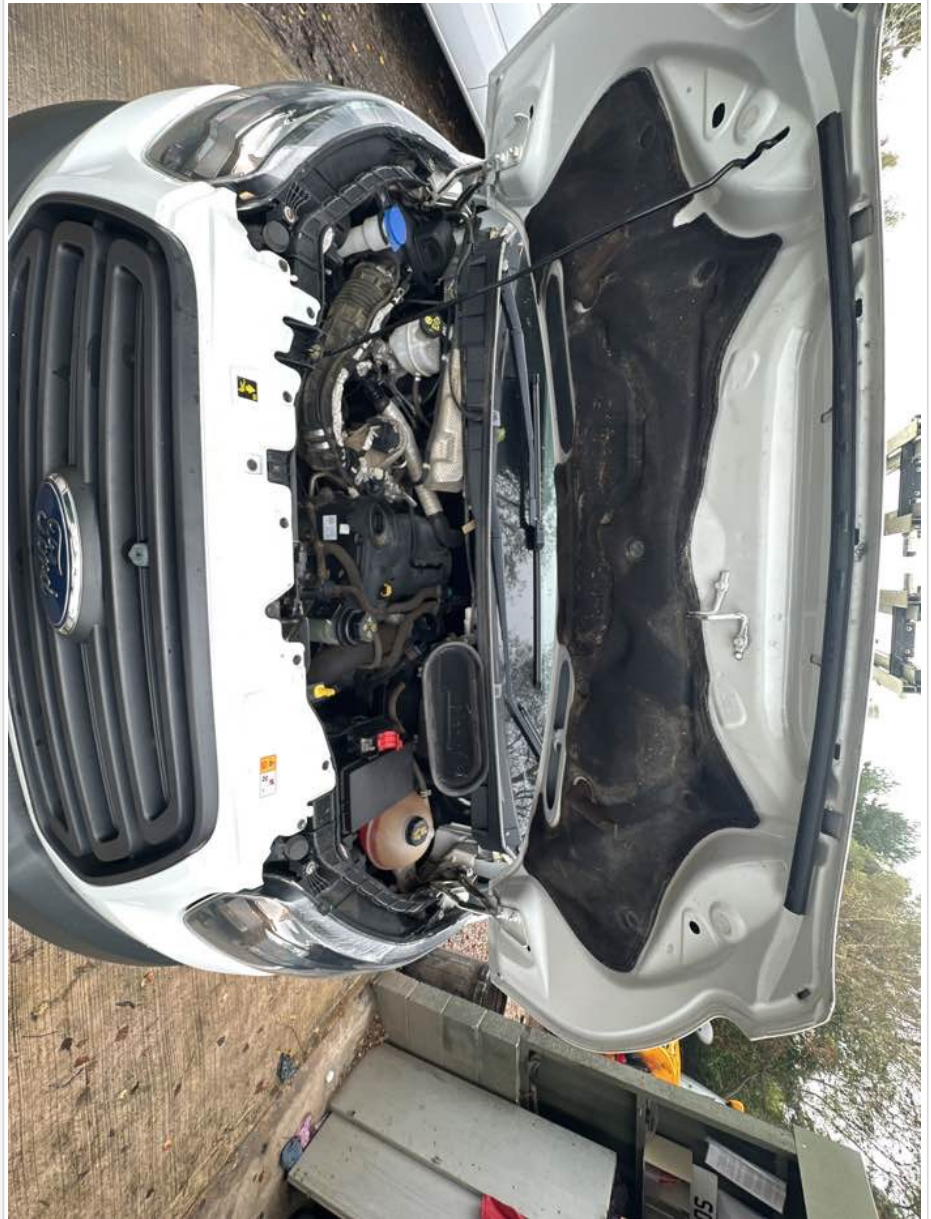
Engine bay photo

Fuel level	1/2 Full
Oil level	Full
Oil conditon	Clean
Start up, chassis battery check	Started without jump pack
Start-up from cold	2 seconds
Exhaust smoke from cold	Normal
Output Voltage of Alternator test	14.5
Chain or Belt driven engine?	Chain
If belt any proof of change?	-
Coolant condition	Clean
Coolant level	Full
Anti-freeze temperature check	-20
Washer fluid	Full
Brake fluid	Full
Power steering fluid	Maximum
Dashboard warning light	No warning lights
OBD Scan results
