BaseVan Initial Inspection

| Vehicle registration | GN11KKE |
| Make | FIAT |
| Model | DUCATO |

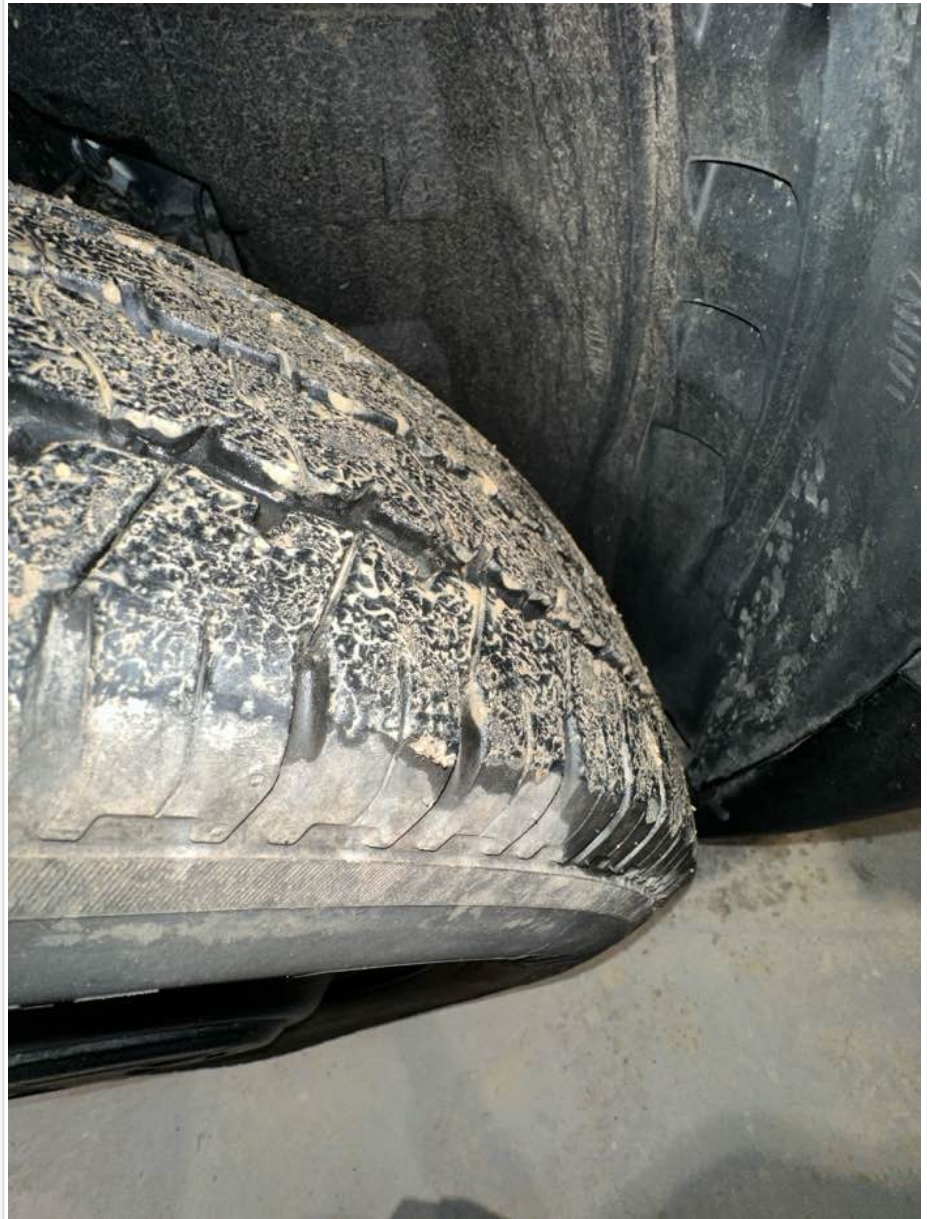
Off side front

| Wearing / Perishing (inner) | none |
| Wearing / Perishing (outer) | None |
| tread depth (mm) | 7 |
| General comments | straight tyre, minimal wear and tear |

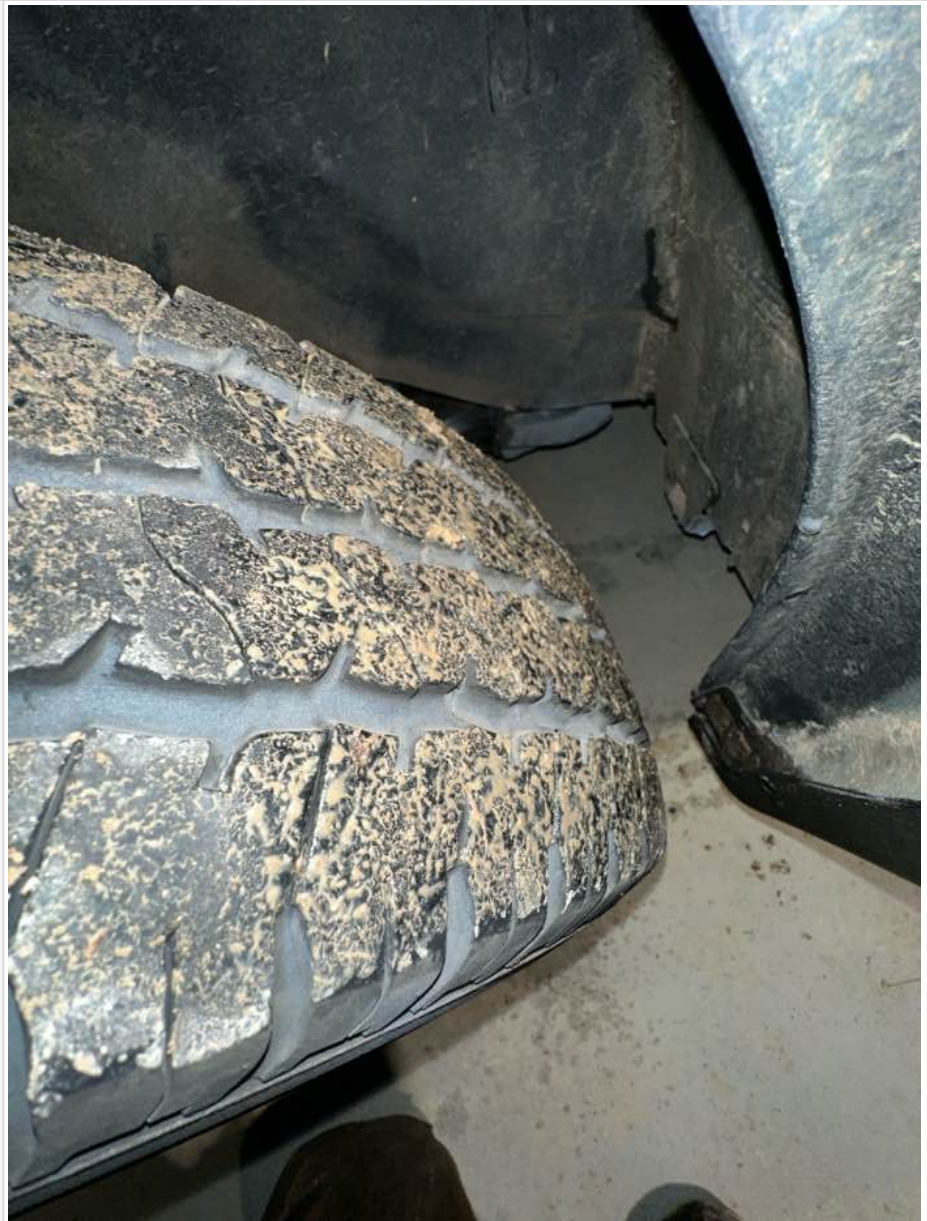
Near side front

| tread depth (mm) | 7 |
| General comments | straight tyre, minimal wear and tyre same as other side |

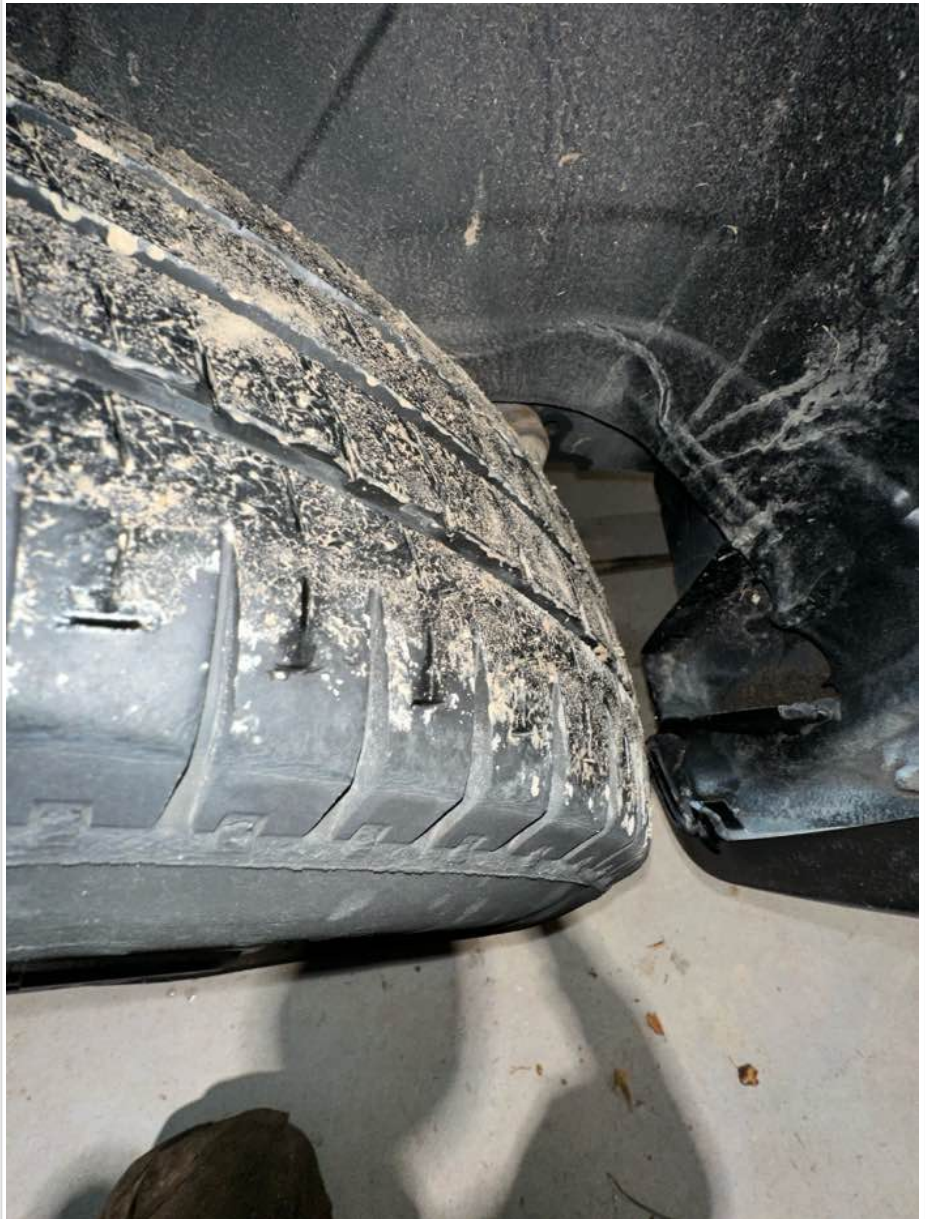
near side rear

| tread depth (mm) | 8 |
| General comments | very good tyre, some kerb rashing but causing no problems |

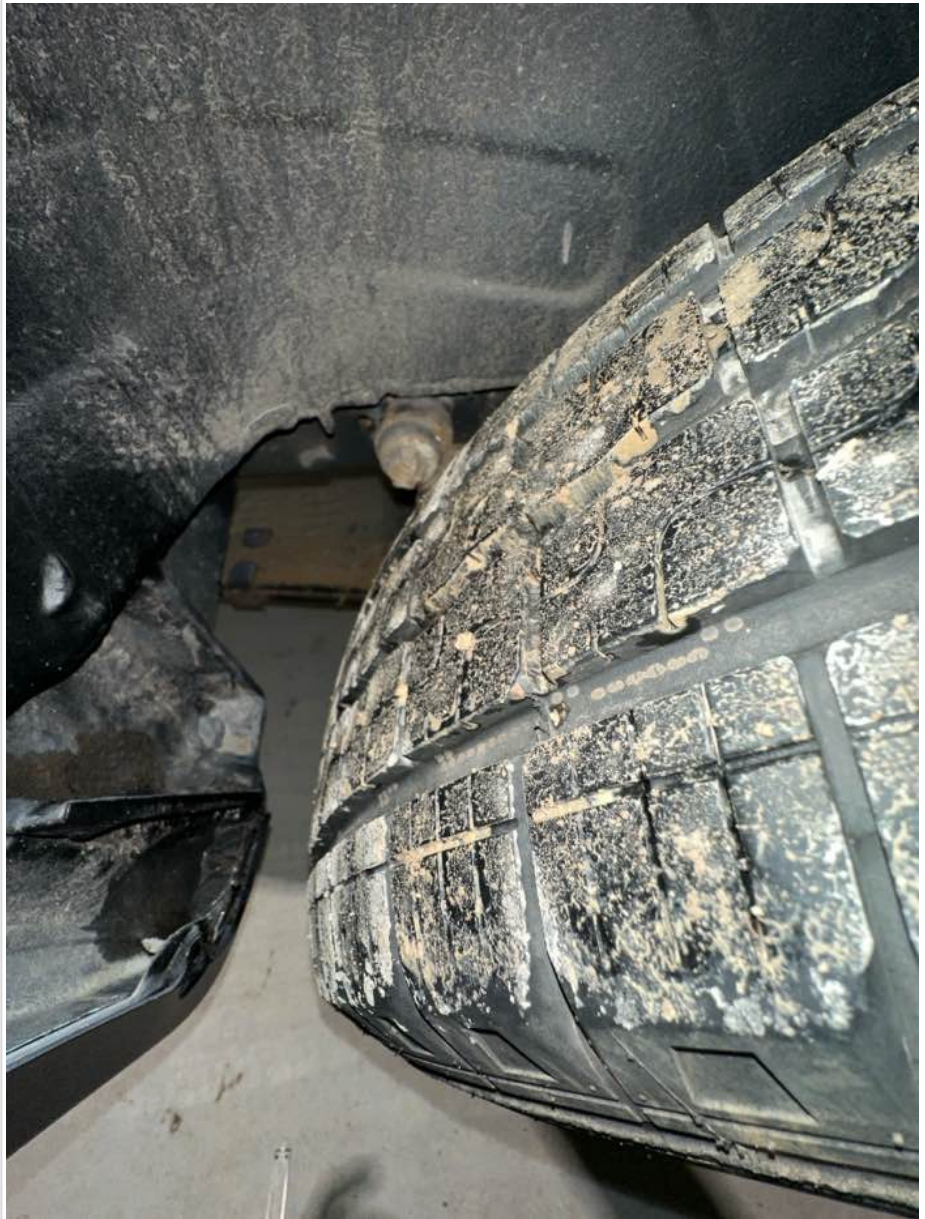
Off side rear

| tread depth (mm) | 8 |
| General comments | great tyre, no wear or tear |
