## BaseVan Initial Inspection

Vehicle registration	KR16CFP
Vehicle chassis no.	WOLVV34UEEB064783
Miles (if in km, multiply by 0.62)	tacho
Make	Renault
Model	Master
Transmission	Manual, 6 speed
Factory immobiliser installed	Yes
Speed limiter installed	N/A
Drive configuration	FWD
Gross vehicle weight	
Towing capacity	3890 gross. 6000 train
Tow bar installed	No

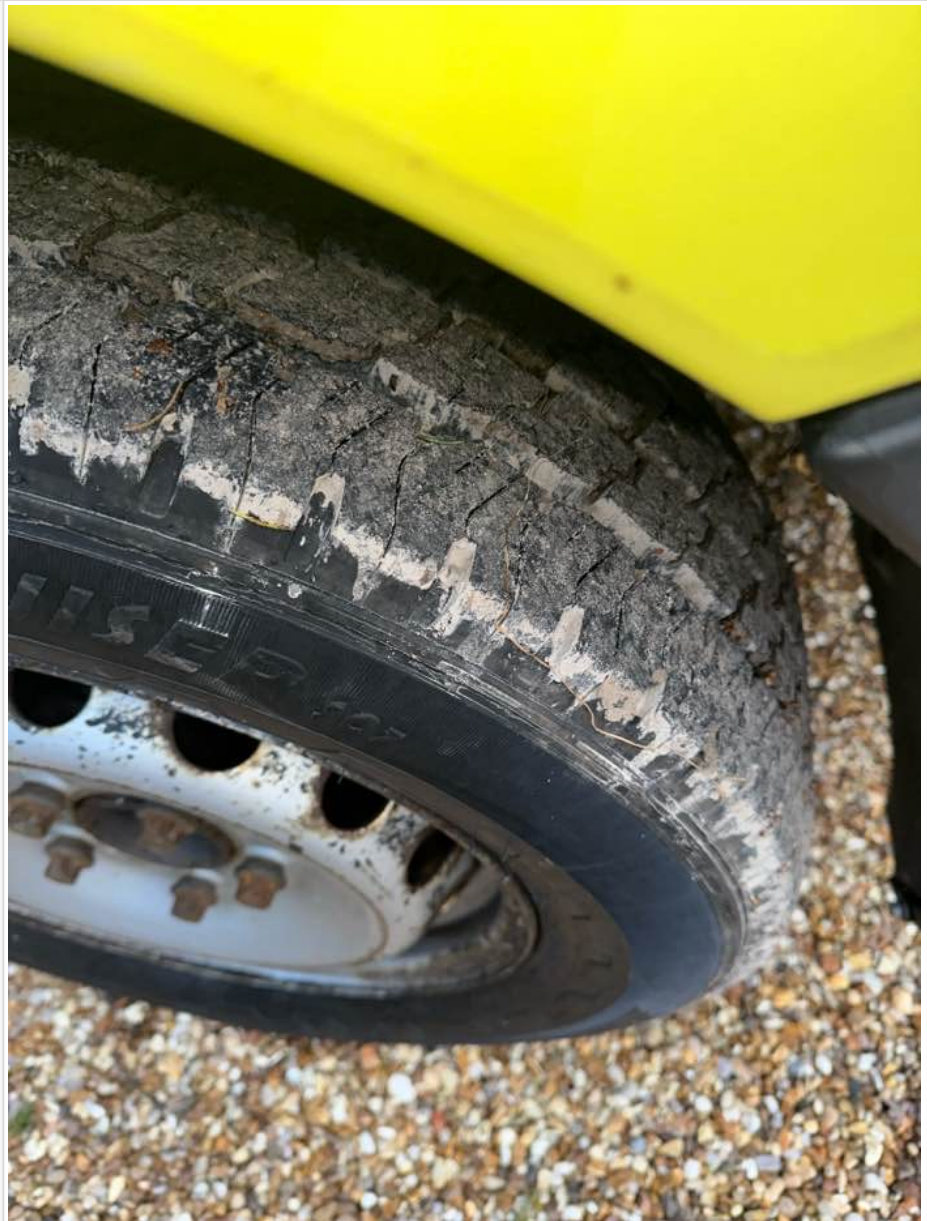
### Off side front

Age (month/year) Manufactured	10/23
Make, brand.	Budget
Tyre size	225/65/R16
Pressure 1	
Pressure 2	
Wearing / Perishing (inner)	none
Wearing / Perishing (outer)	None
tread depth (mm)	9
General comments	brand new tyre fitted by us

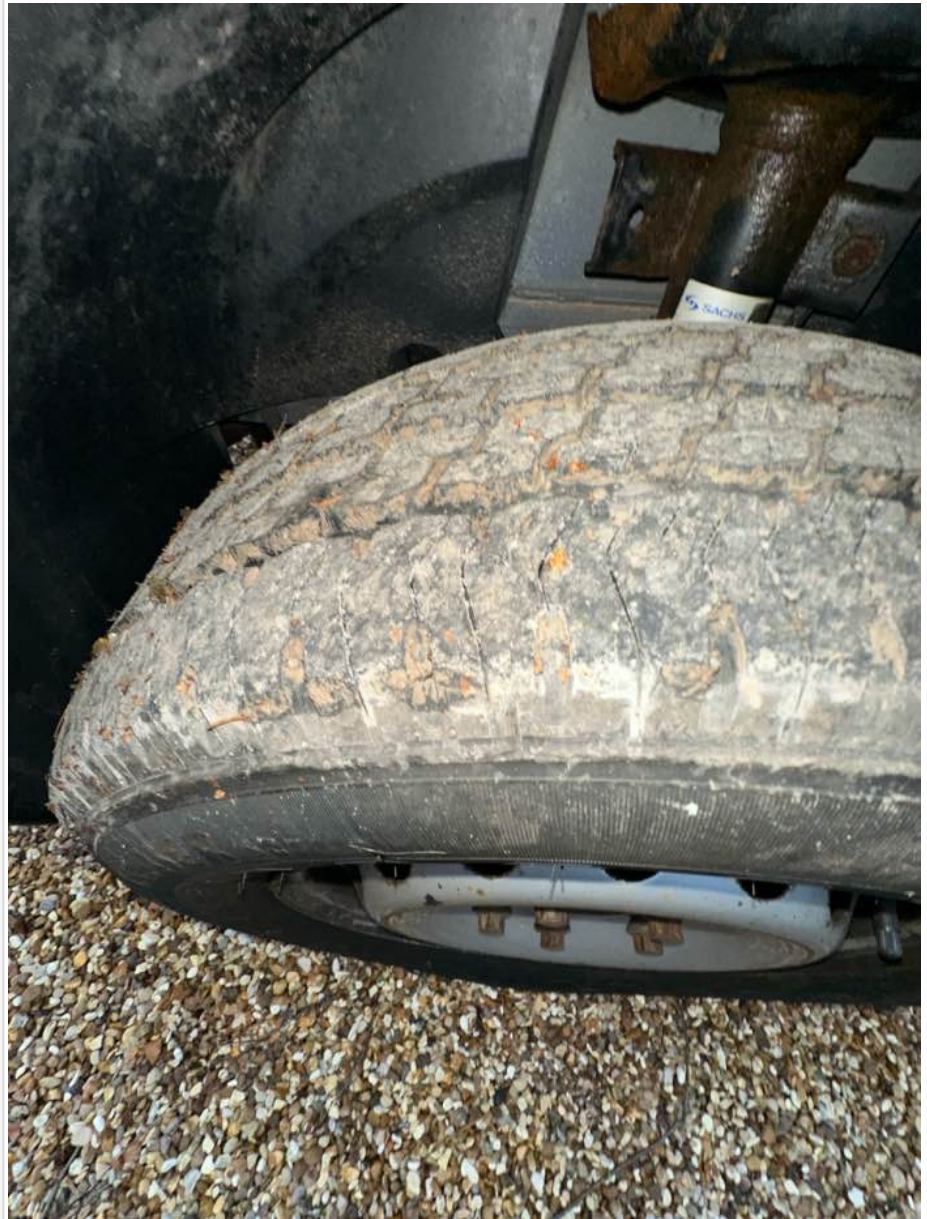
### Near side front

Age (month/year) Manufactured	10/23
Make, brand.	Budget
Tyre size	225/65/R16
Pressure 1	
Pressure 2	
Wearing / Perishing (inner)	none
Wearing / Perishing (outer)	None
tread depth (mm)	9
General comments	brand new tyre fitted by us

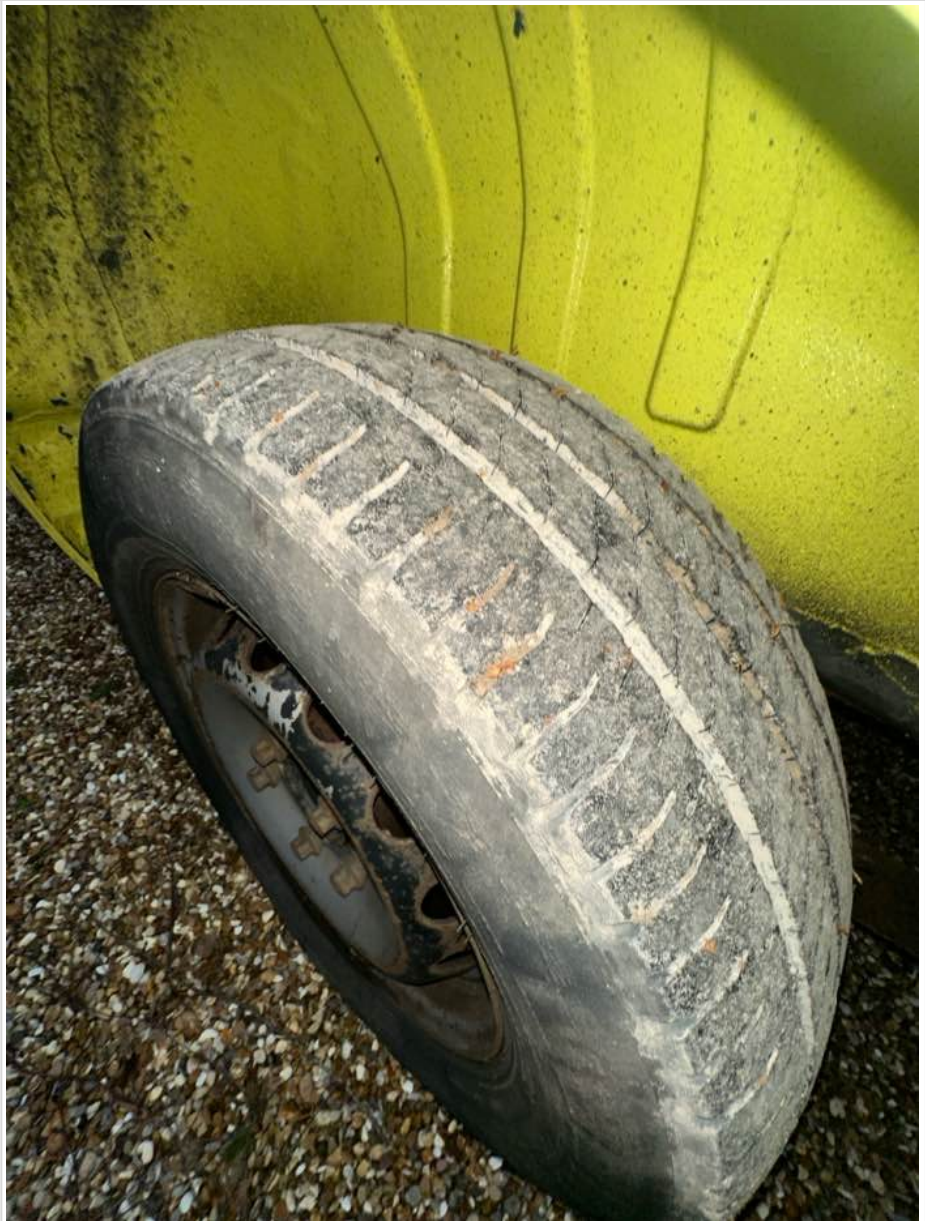
### near side rear

Age (month/year) Manufactured	52/20
Make, brand.	Michelin
Tyre size	225/65/R16
Pressure 1	
Pressure 2	
Wearing / Perishing (inner)	none
Wearing / Perishing (outer)	None
tread depth (mm)	6
General comments	good tyre

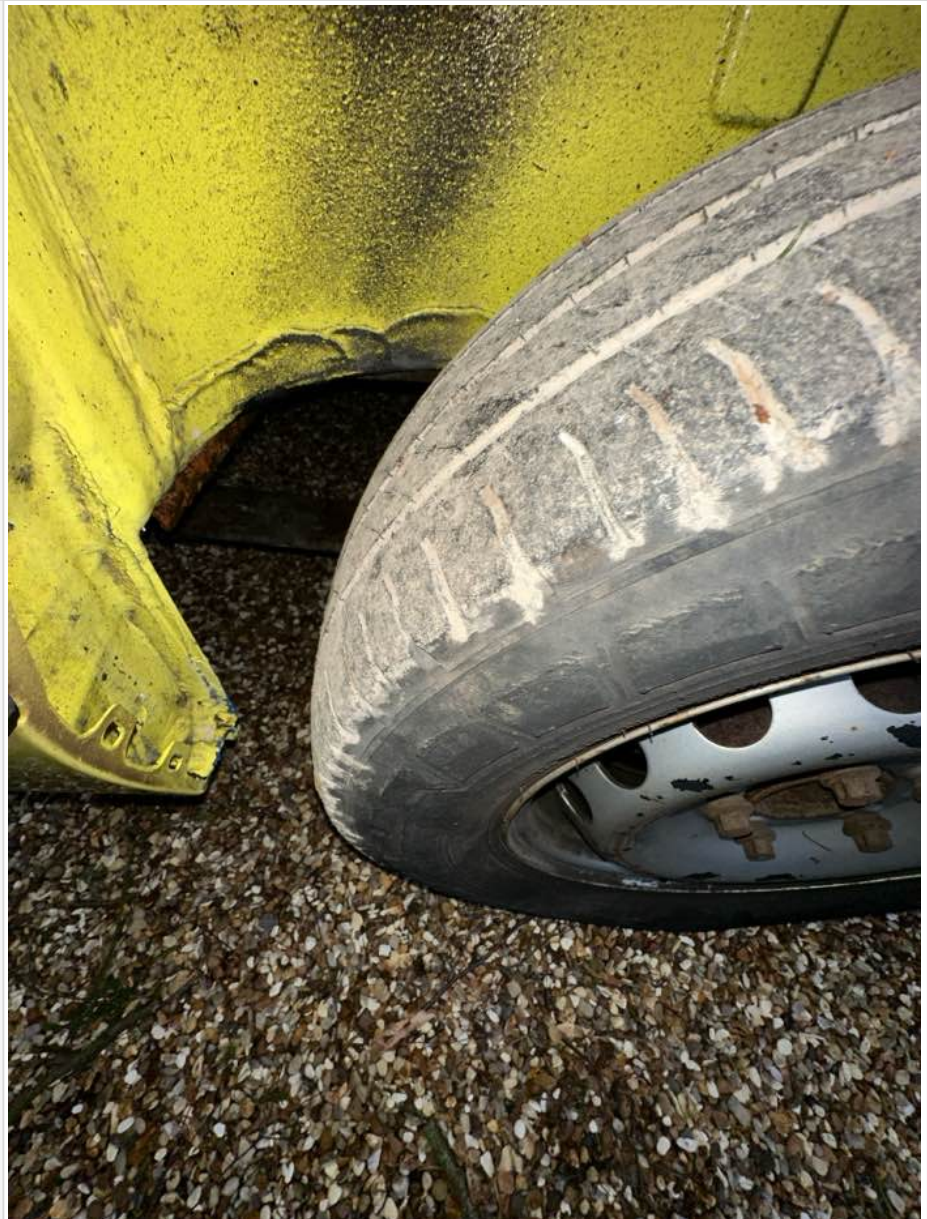
### Off side rear

Age (month/year) Manufactured	52/20
Make, brand.	Michelin
Tyre size	225/65/R16
Pressure 1	
Pressure 2	
Wearing / Perishing (inner)	none
Wearing / Perishing (outer)	None
tread depth (mm)	4
General comments	moderate wear, but very much legal
