BaseVan Initial Inspection

Vehicle registration	LJ18EXU
Vehicle chassis no.	WV1ZZZ2KZJX049110
Miles (if in km, multiply by 0.62)	92926
Make	Volkswagen
Model	Caddy Maxi
Transmission	Manual, 6 speed
Factory immobiliser installed	Yes
Speed limiter installed	No
Drive configuration	FWD
Gross vehicle weight	<3500kg
Towing capacity	
Tow bar installed

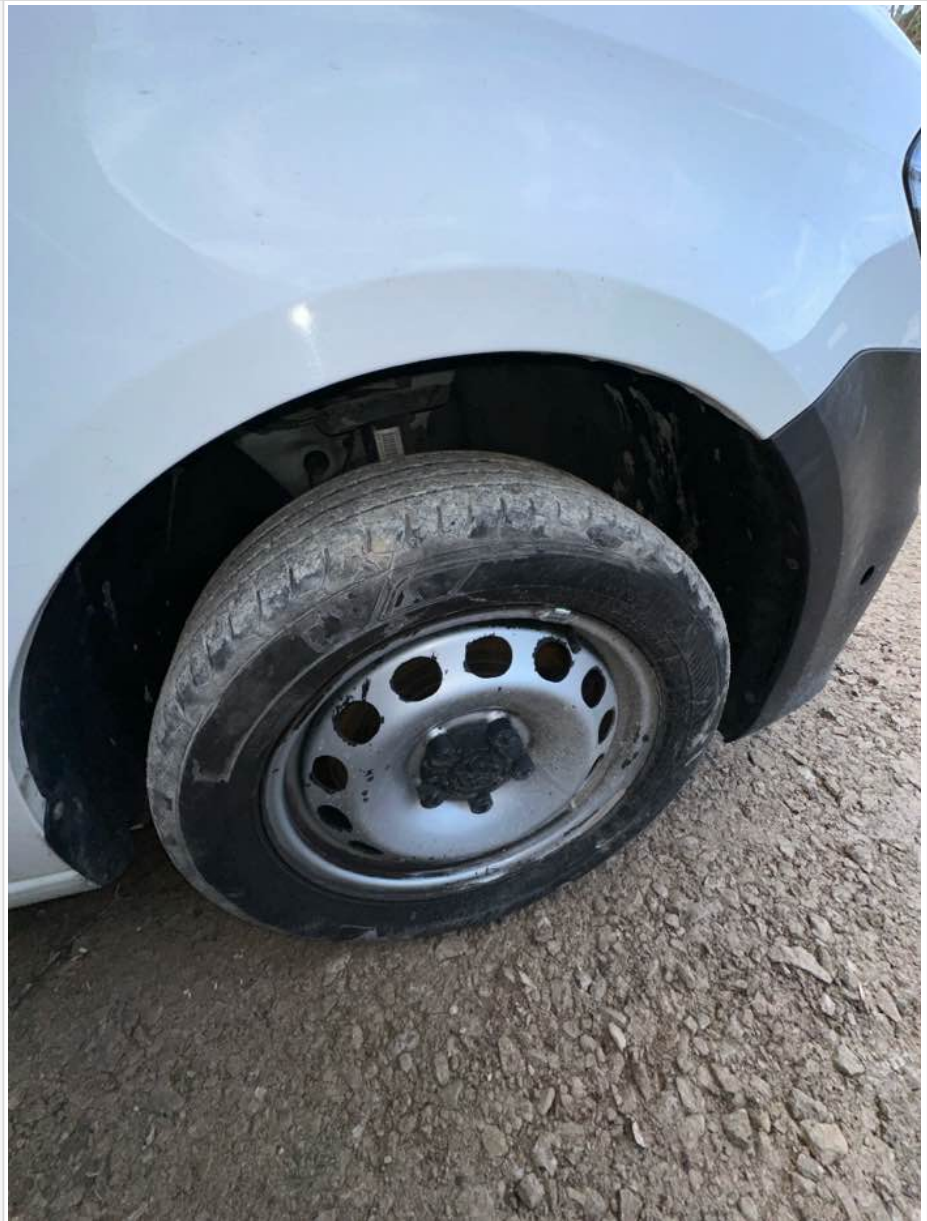
Off side front

Age (month/year) Manufactured	48/22
Make, brand.	Good Year
Tyre size	Not here (see comment)
Pressure 1	
Pressure 2	
Wearing / Perishing (inner)	none
Wearing / Perishing (outer)	None
tread depth (mm)	7
General comments	205/55r16

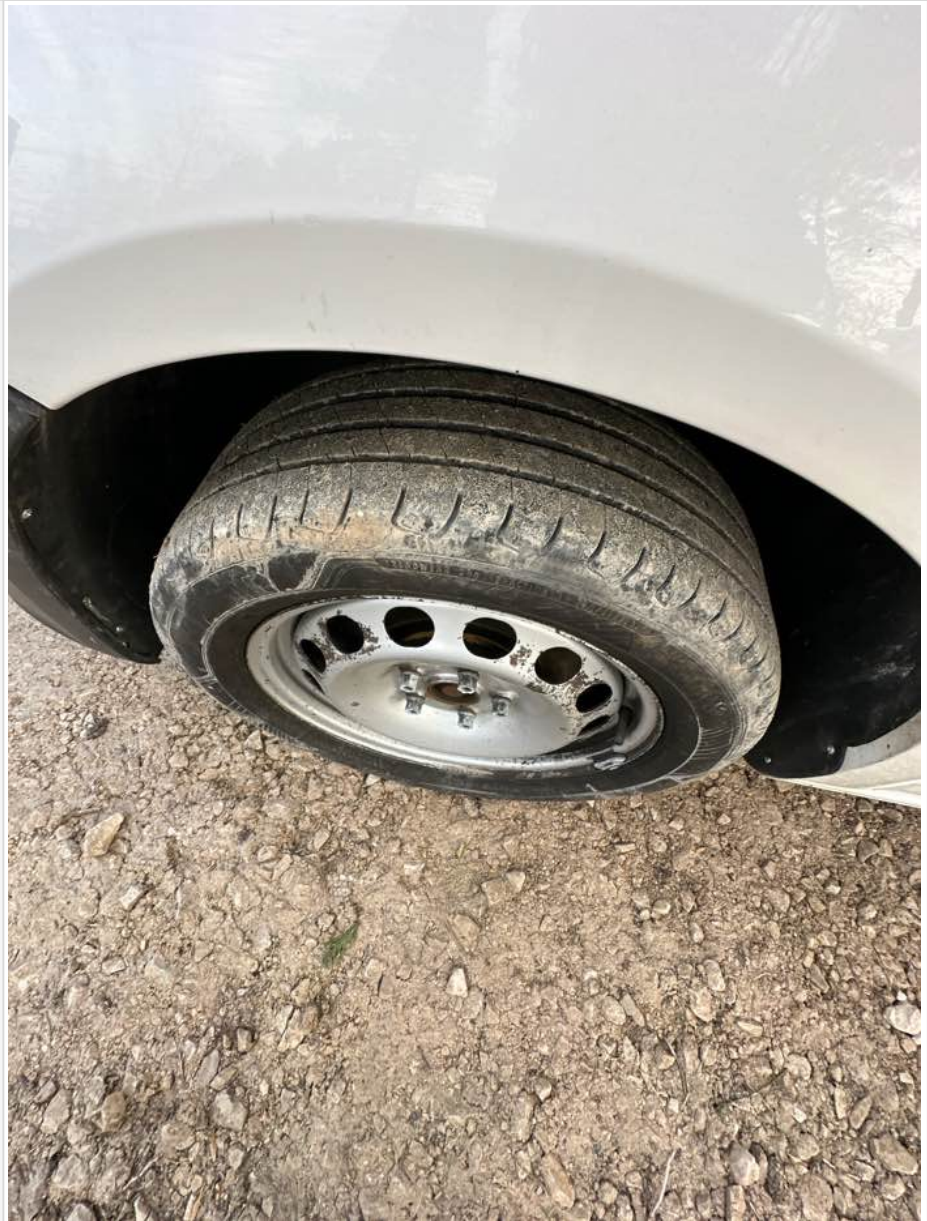
Near side front

Age (month/year) Manufactured	48/22
Make, brand.	Good Year
Tyre size	Not here (see comment)
Pressure 1	
Pressure 2	
Wearing / Perishing (inner)	none
Wearing / Perishing (outer)	None
tread depth (mm)	6
General comments	size 225:55/16

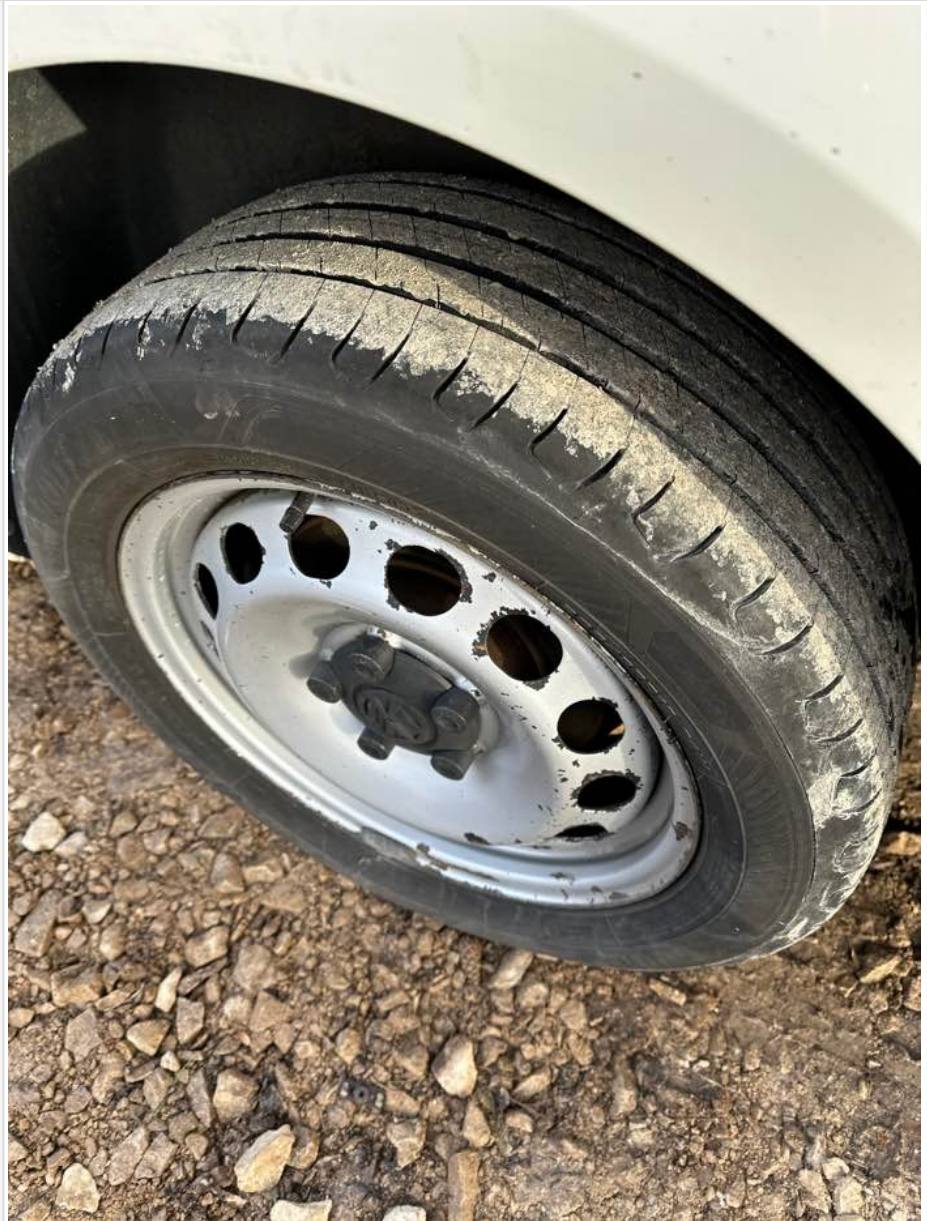
near side rear

Age (month/year) Manufactured	50/21
Make, brand.	Good Year
Tyre size	Not here (see comment)
Pressure 1	
Pressure 2	
Wearing / Perishing (inner)	none
Wearing / Perishing (outer)	None
tread depth (mm)	7
General comments	205/55/16

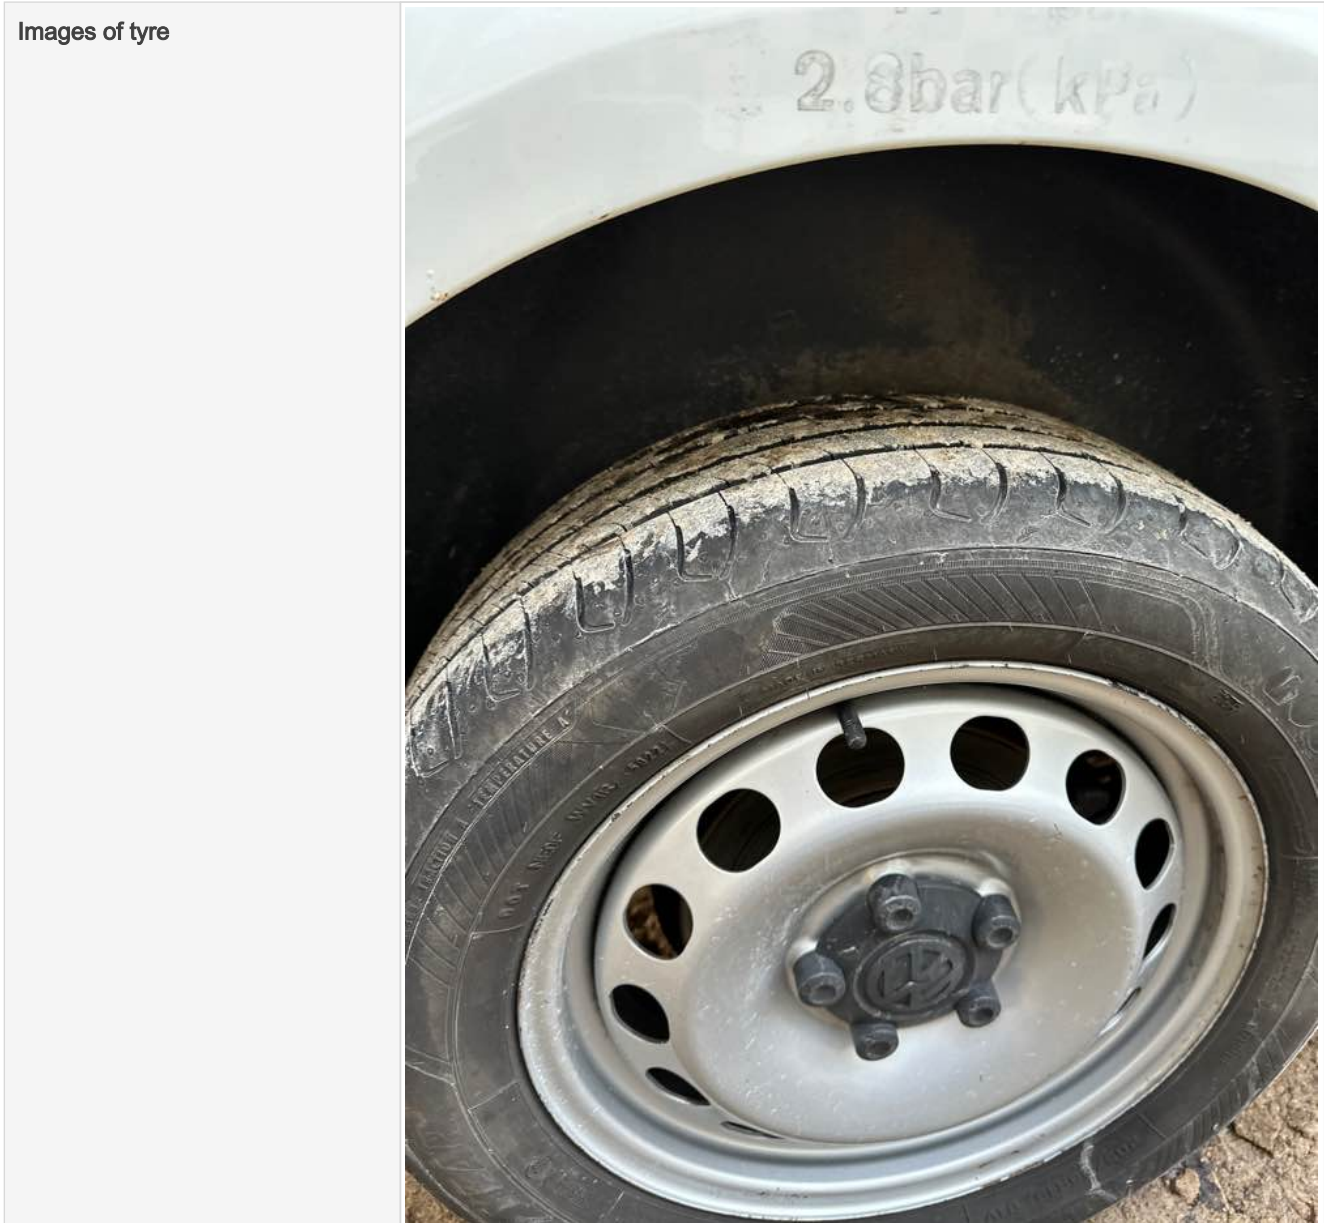
Off side rear

Age (month/year) Manufactured	50/22
Make, brand.	Good Year
Tyre size	Not here (see comment)
Pressure 1	
Pressure 2	
Wearing / Perishing (inner)	none
Wearing / Perishing (outer)	None
tread depth (mm)	8
General comments	205/55/16

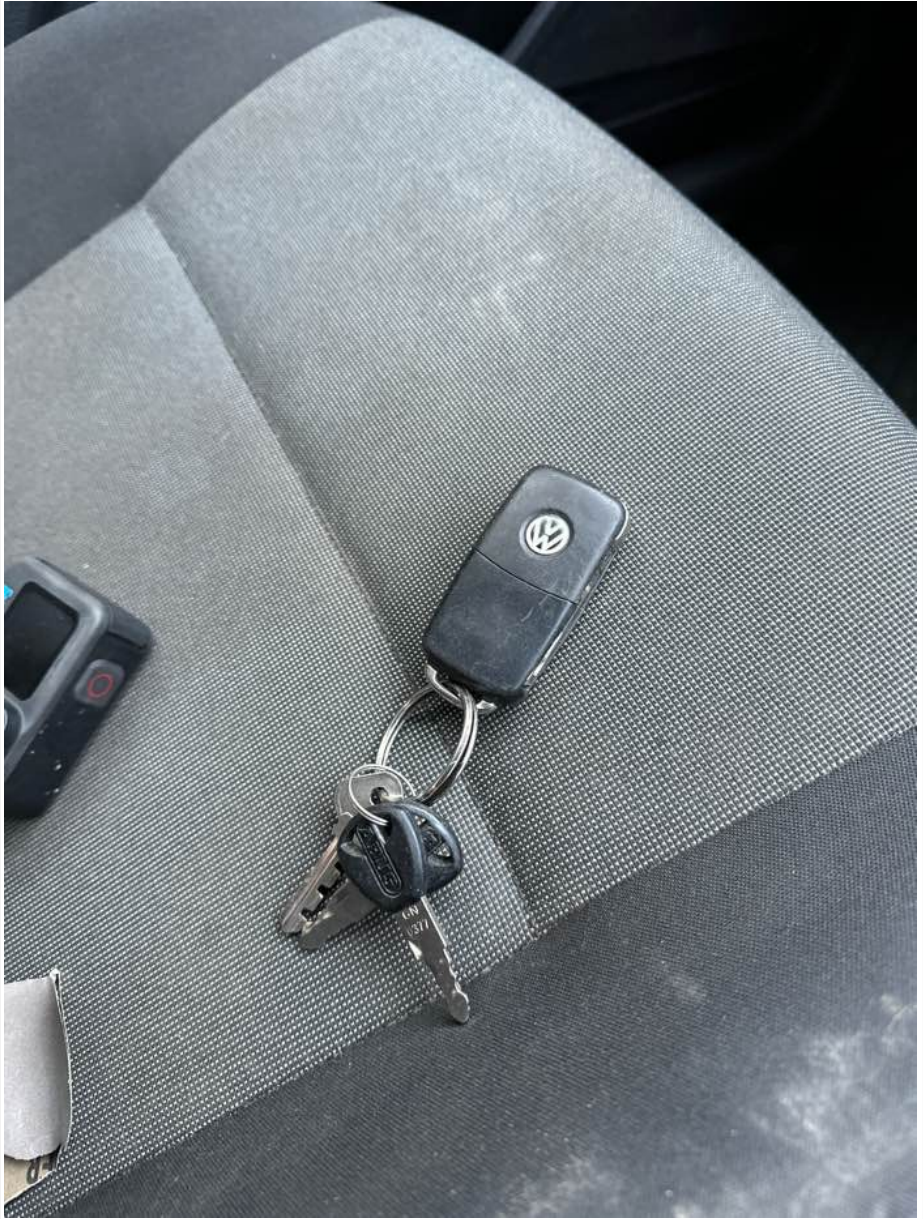
Select the following doors that lock.	N/S Front, O/S Front, O/S SL, N/S Rear, O/S Rear
Method of locking	Fob
In conclusion can all the doors be locked in some way and thus the vehicle can be left unattended at night safely?	No
How many keys present at time of inspection?

Comment	near side loading door lock inoperative
