BaseVan Initial Inspection

V CI II OIC GCIAIIS	
Vehicle registration	GN53ORV
Vehicle chassis no.	ZCFC509000D222228
Miles (if in km, multiply by 0.62)	63149
Make	Iveco
Model	Daily
Transmission	Manual, 6 speed
Factory immobiliser installed	Yes
Speed limiter installed	Yes
Drive configuration	RWD
Gross vehicle weight	5200kg
Towing capacity	3500kg
Tow bar installed	No

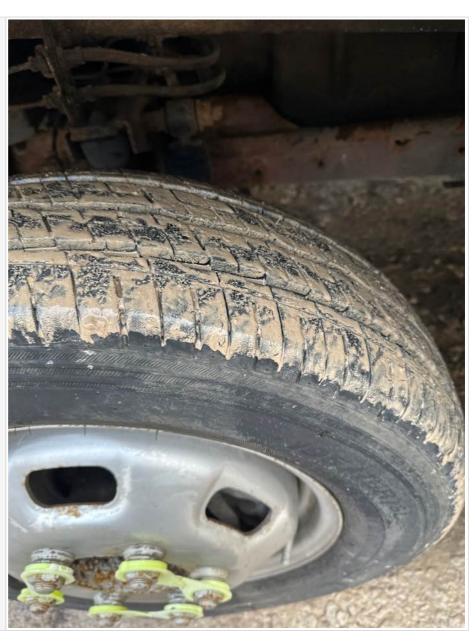
Off side front

Age (month/year) Manufactured	33/20
Make, brand.	Cooper
Tyre size	195/75/R16
Pressure 1	
Pressure 2	
Wearing / Perishing (inner)	none
Wearing / Perishing (outer)	None
tread depth (mm)	8
General comments	mint tyre

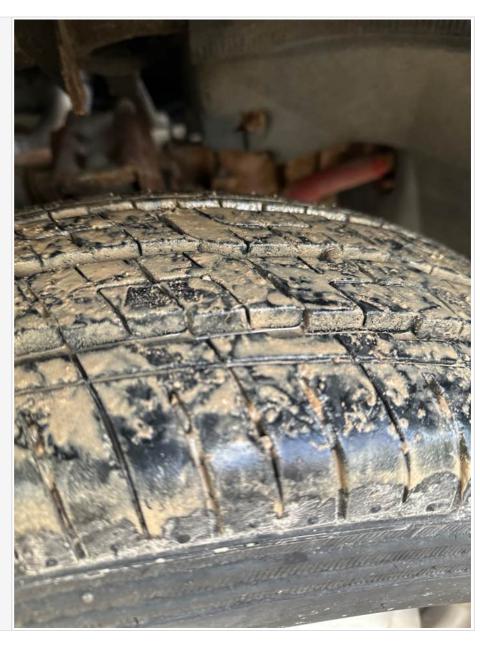
Near side front

Age (month/year) Manufactured	33/20
Make, brand.	Cooper
Tyre size	195/75/R16
Pressure 1	
Pressure 2	
Wearing / Perishing (inner)	none
Wearing / Perishing (outer)	None
tread depth (mm)	8
General comments	great tyre

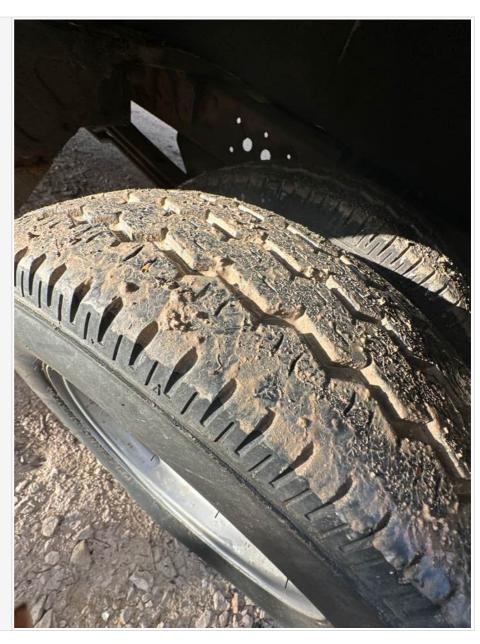
near side rear

Age (month/year) Manufactured	47/17
Make, brand.	Budget
Tyre size	195/75/R16
Pressure 1	
Pressure 2	
Wearing / Perishing (inner)	none
Wearing / Perishing (outer)	None
tread depth (mm)	7
General comments	great tyre

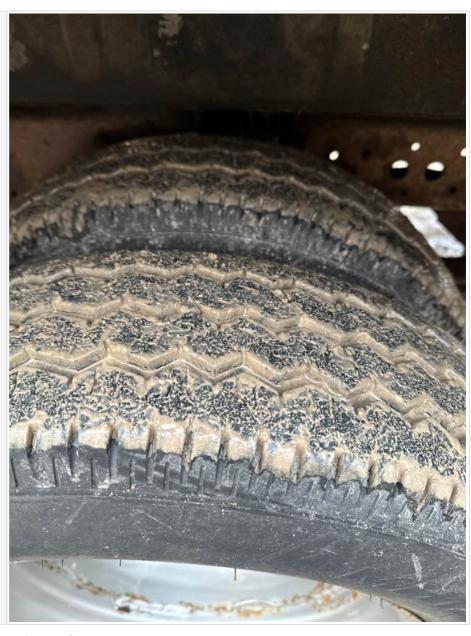
Off side rear

Age (month/year) Manufactured	48/20
Make, brand.	Budget
Tyre size	195/75/R16
Pressure 1	
Pressure 2	
Wearing / Perishing (inner)	none
Wearing / Perishing (outer)	None
tread depth (mm)	8
General comments	great tyre

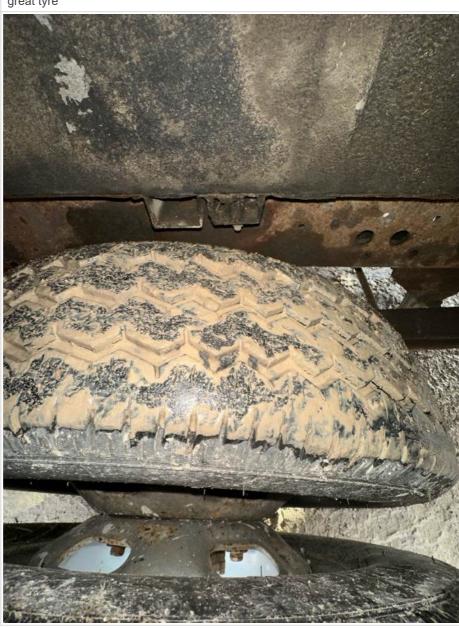
off side Inner (for twin wheel vans)

Is the vehicle a twin wheel axle? (if no don't fill out)	Yes
Age (month/year) Manufactured	48/20
Make, brand.	Budget
Tyre size	195/75/R16
Pressure 1	
Pressure 2	
Wearing / Perishing (inner)	none
Wearing / Perishing (outer)	None

tread depth (mm) 8

General comments great tyre

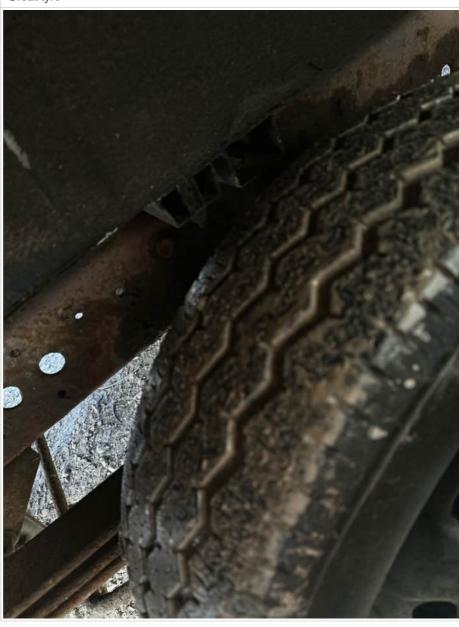
near side Inner (for twin wheel vans)

Is the vehicle a twin wheel axle? (if no don't fill out)	Yes
Age (month/year) Manufactured	48/20
Make, brand.	Budget
Tyre size	195/75/R16
Pressure 1	
Pressure 2

tread depth (mm) General comments	8 Great tyre
Wearing / Perishing (outer)	None
Wearing / Perishing (inner)	none

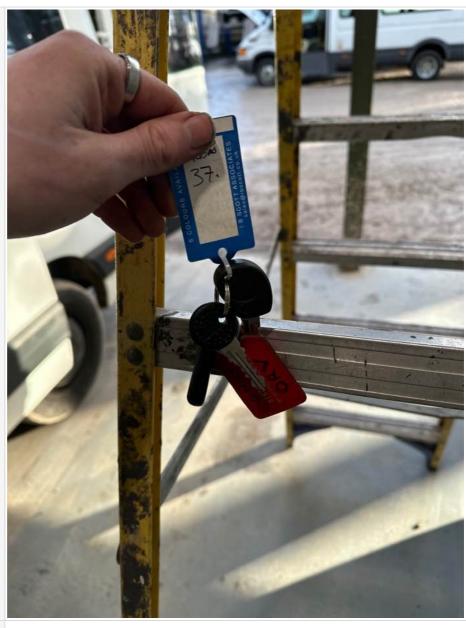
Factory central locking fitted?	No
Response from key fob?	N/A
Response from in-cab locking button?	N/A
Do all the doors lock from central locking function?	None
Select the following doors that lock.	O/S Front, N/S Rear, O/S Rear
Method of locking	Key
In conclusion can all the doors be locked in some way and thus the vehicle can be left unattended at night safely?	No

no way of locking electric side door

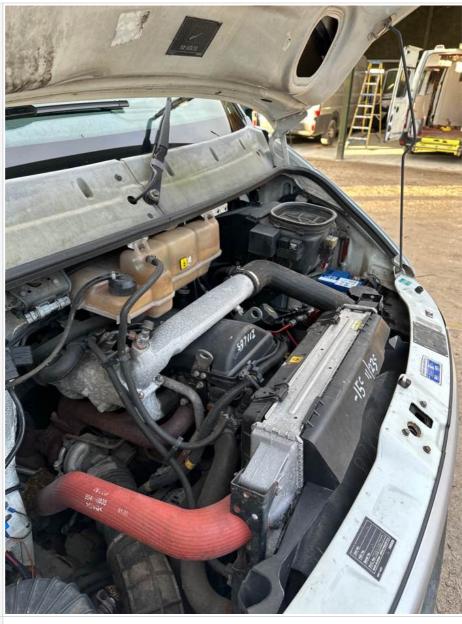
Engine bay photo

Fuel level	1/2 Full
Oil level	Full
Oil conditon	Clean
Start up, chassis battery check	Started without jump pack
Start-up from cold	Instant
Exhaust smoke from cold	Normal
Output Voltage of Alternator test	14.0
Chain or Belt driven engine?	Chain
If belt any proof of change?	-
Coolant condition	Clean
Coolant level	Full
Anti-freeze temperature check	-15
Washer fluid	Full
Brake fluid	Full
Power steering fluid	Maximum
Dashboard warning light	SRS / Airbag
OBD Scan results

mechanically very well
