Inspection details

Vehicle details

Vehicle registration	CN13BZY
Vehicle chassis no.	WOLMTFBFHCB035826
Miles (if in km, multiply by 0.62)	79917
Make	Vauxhall
Model	Movano
Transmission	Manual, 6 speed
Factory immobiliser installed	Yes
Speed limiter installed	No
Drive configuration	RWD
Gross vehicle weight	4600kg
Towing capacity	3000kg
Tow bar installed	Yes

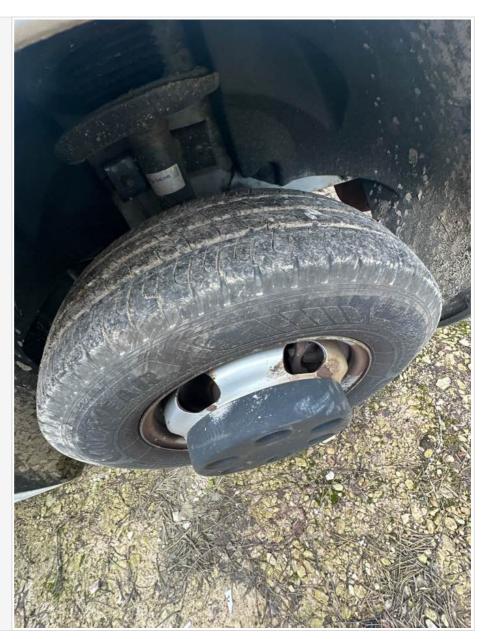
Off side front

Age (month/year) Manufactured	23/21
Make, brand.	Good Year
Tyre size	195/75/R16
Pressure 1	
Pressure 2	
Wearing / Perishing (inner)	none
Wearing / Perishing (outer)	None
tread depth (mm)	8
General comments	barely used

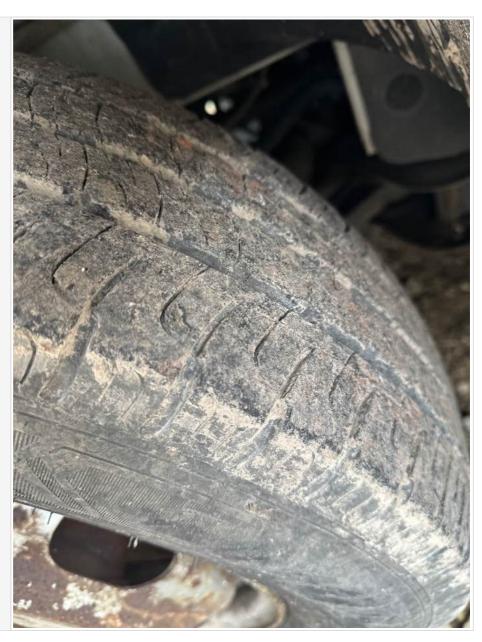
Near side front

Age (month/year) Manufactured	01/21
Make, brand.	Good Year
Tyre size	195/75/R16
Pressure 1	
Pressure 2	
Wearing / Perishing (inner)	none
Wearing / Perishing (outer)	None
tread depth (mm)	8
General comments	barely used

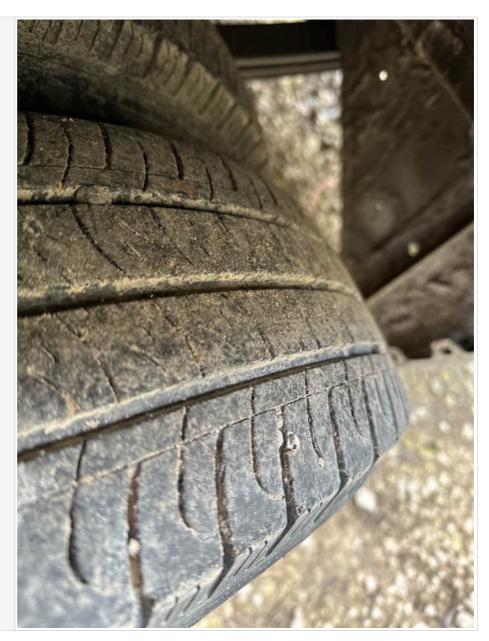
near side rear

Age (month/year) Manufactured	01/21
Make, brand.	Good Year
Tyre size	195/75/R16
Pressure 1	
Pressure 2	
Wearing / Perishing (inner)	none
Wearing / Perishing (outer)	None
tread depth (mm)	7
General comments	barely used

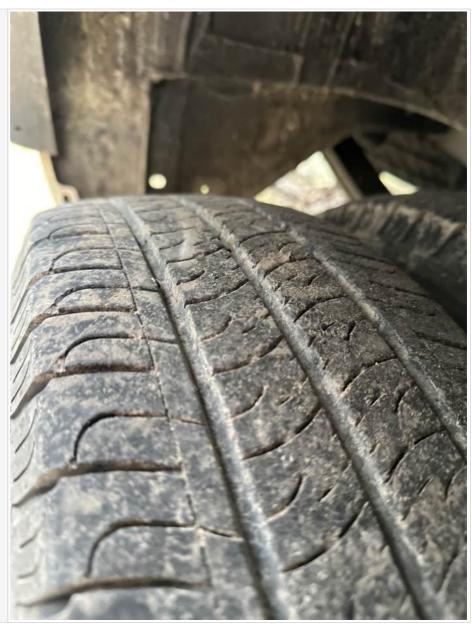
Off side rear

Age (month/year) Manufactured	51/20
Make, brand.	Good Year
Tyre size	195/75/R16
Pressure 1	
Pressure 2	
Wearing / Perishing (inner)	none
Wearing / Perishing (outer)	None
tread depth (mm)	6
General comments	barely used
