## BaseVan Initial Inspection

Vehicle registration	DX08ATN
Vehicle chassis no.	VF1EDC1K638340727
Miles (if in km, multiply by 0.62)	10,382
Make	Renault
Model	Master
Transmission	Manual, 6 speed
Factory immobiliser installed	Yes
Speed limiter installed	No
Drive configuration	FWD
Gross vehicle weight	3500kg
Towing capacity	2000kg
Tow bar installed	No

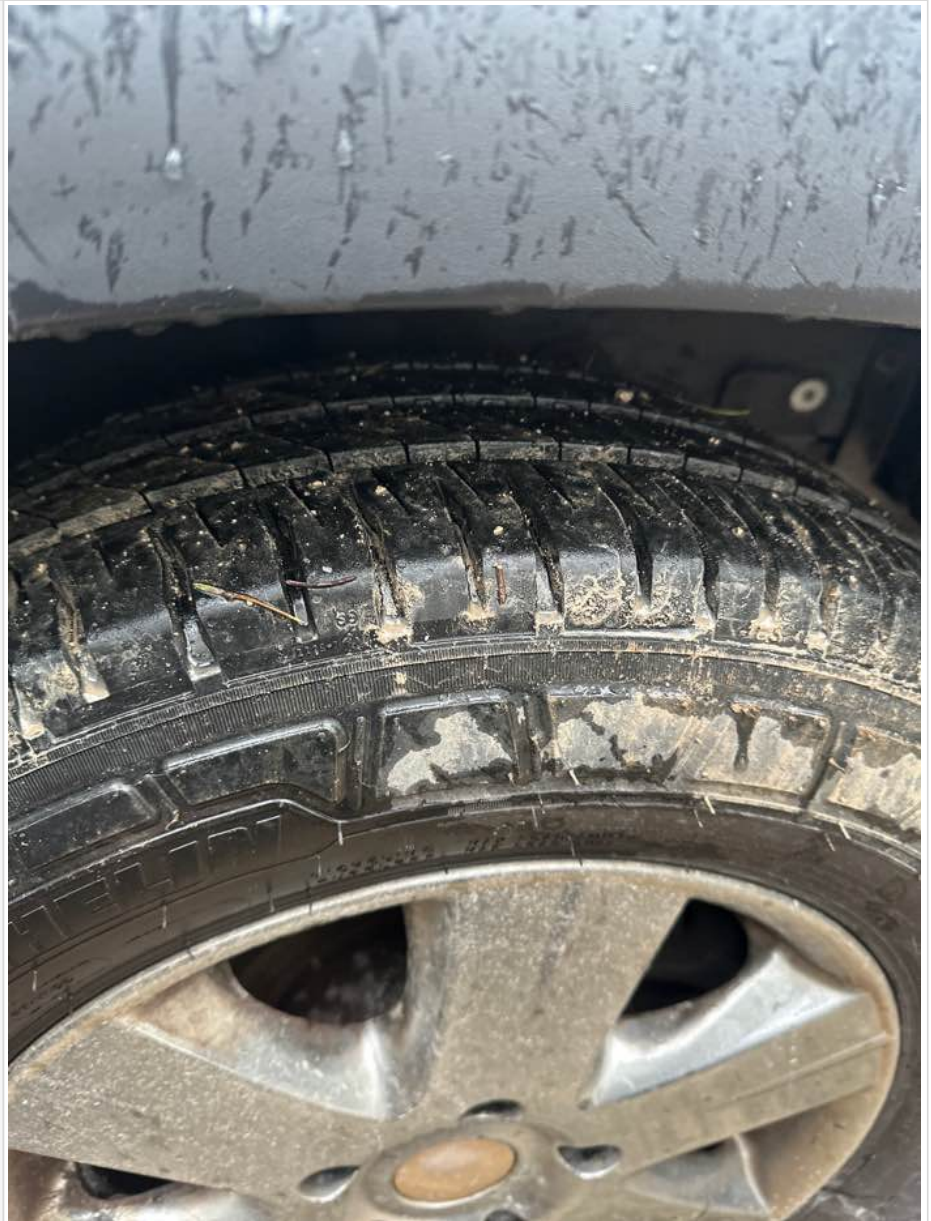
### Off side front

Age (month/year) Manufactured	52/20
Make, brand.	Michelin
Tyre size	225/65/R16
Pressure 1	
Pressure 2	
Wearing / Perishing (inner)	none
Wearing / Perishing (outer)	None
tread depth (mm)	6
General comments	good tyre

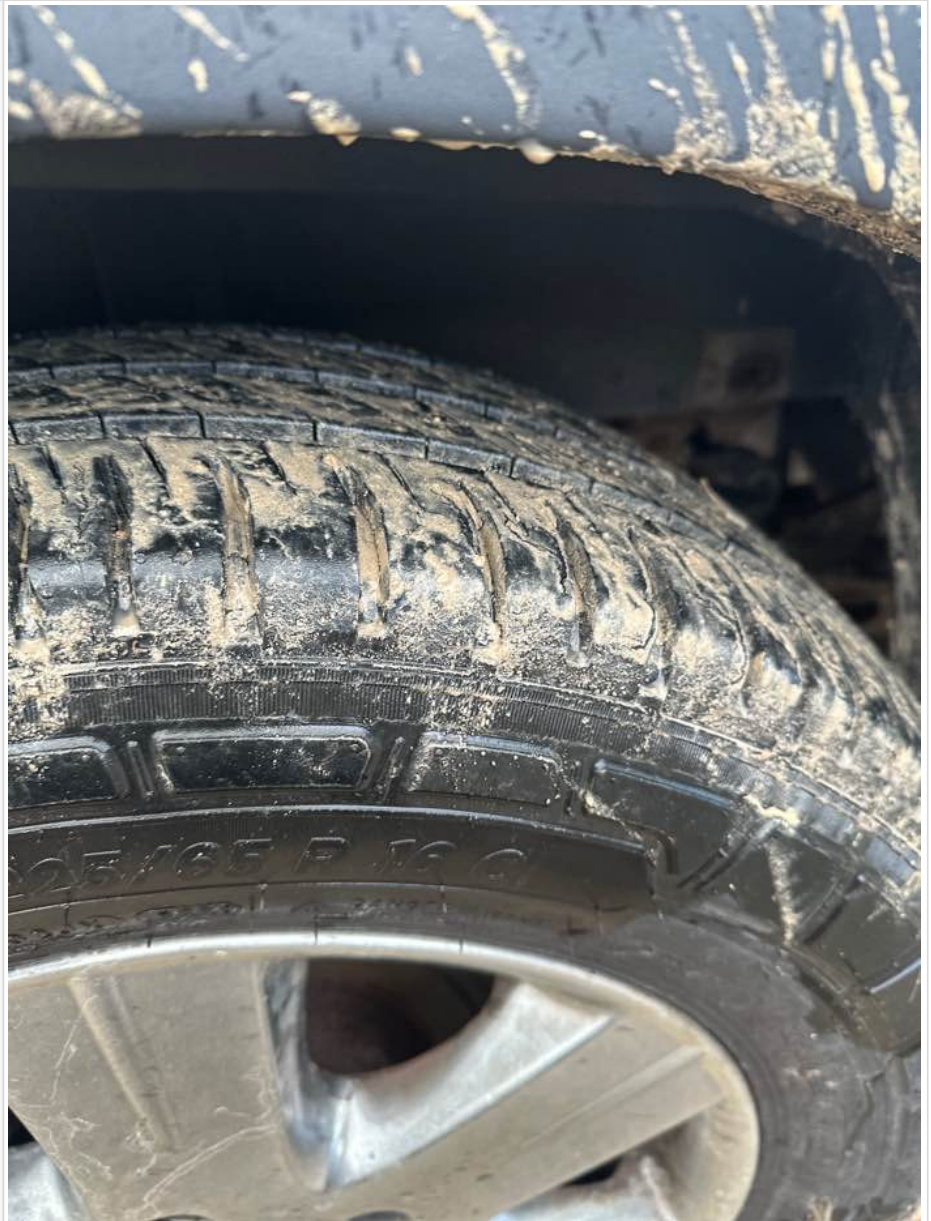
### Near side front

Age (month/year) Manufactured	52/20
Make, brand.	Michelin
Tyre size	225/65/R16
Pressure 1	
Pressure 2	
Wearing / Perishing (inner)	none
Wearing / Perishing (outer)	None
tread depth (mm)	6
General comments	good tyre

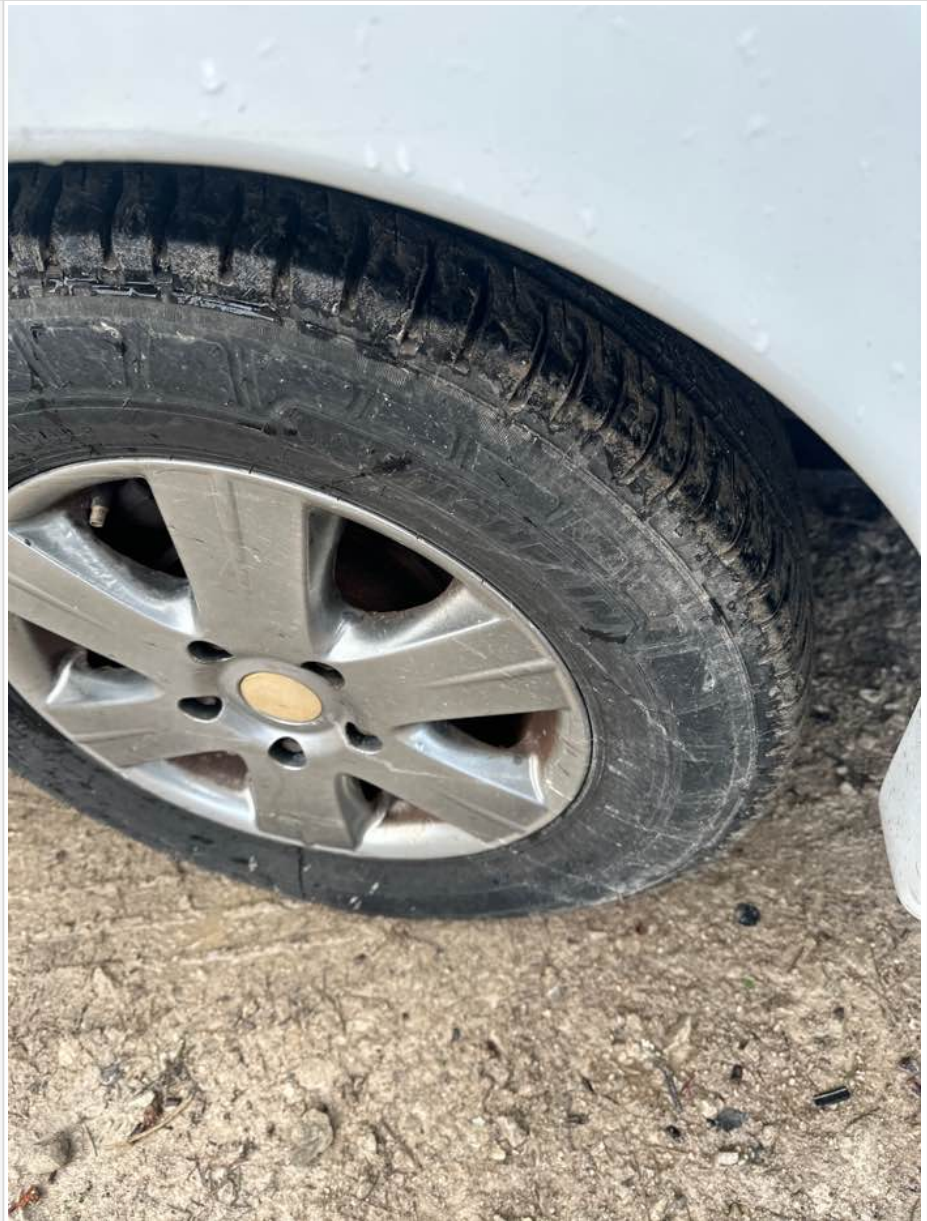
### near side rear

Age (month/year) Manufactured	52/20
Make, brand.	Michelin
Tyre size	225/65/R16
Pressure 1	
Pressure 2	
Wearing / Perishing (inner)	none
Wearing / Perishing (outer)	None
tread depth (mm)	7
General comments	good tyre

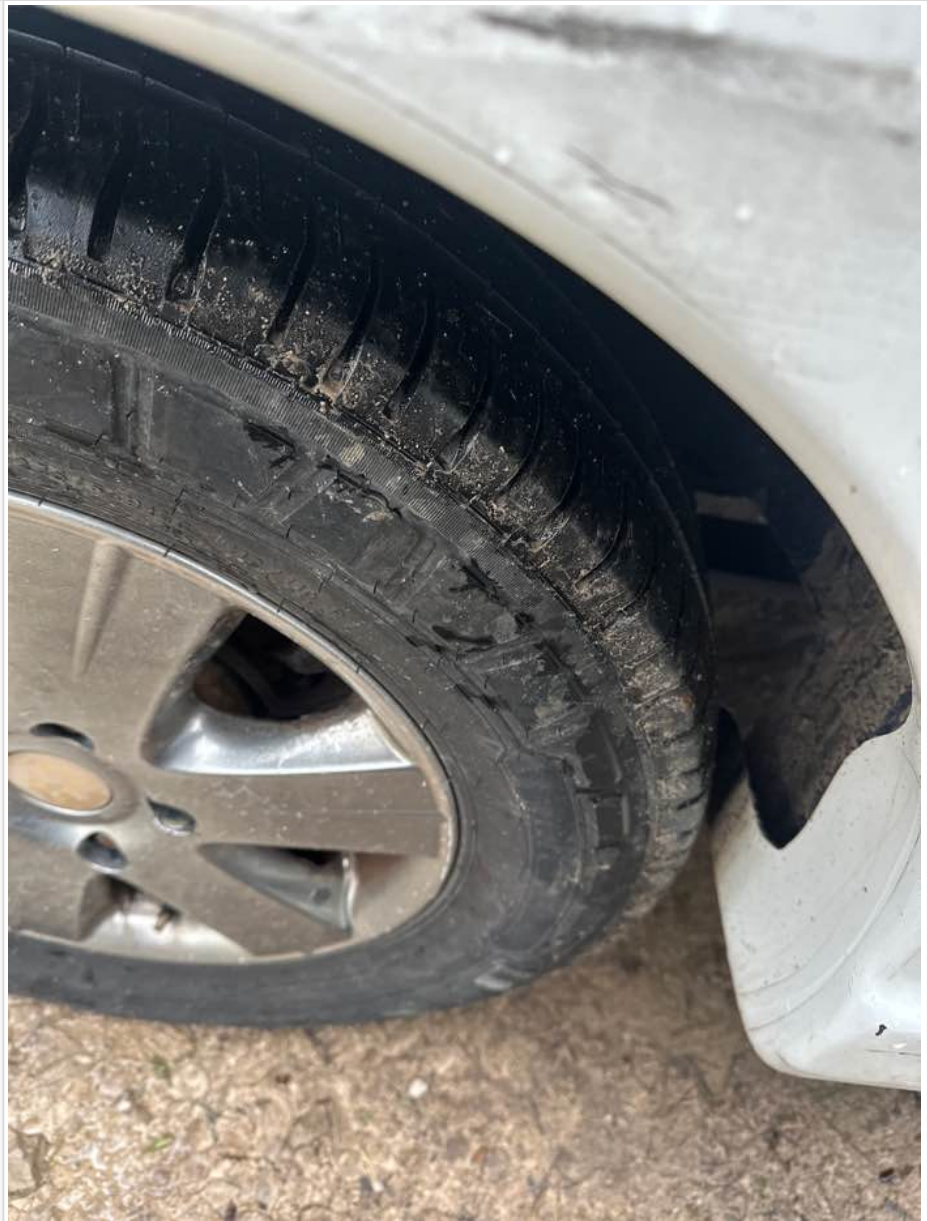
### Off side rear

Age (month/year) Manufactured	52/20
Make, brand.	Michelin
Tyre size	225/65/R16
Pressure 1	
Pressure 2	
Wearing / Perishing (inner)	none
Wearing / Perishing (outer)	None
tread depth (mm)	7
General comments	good tyre

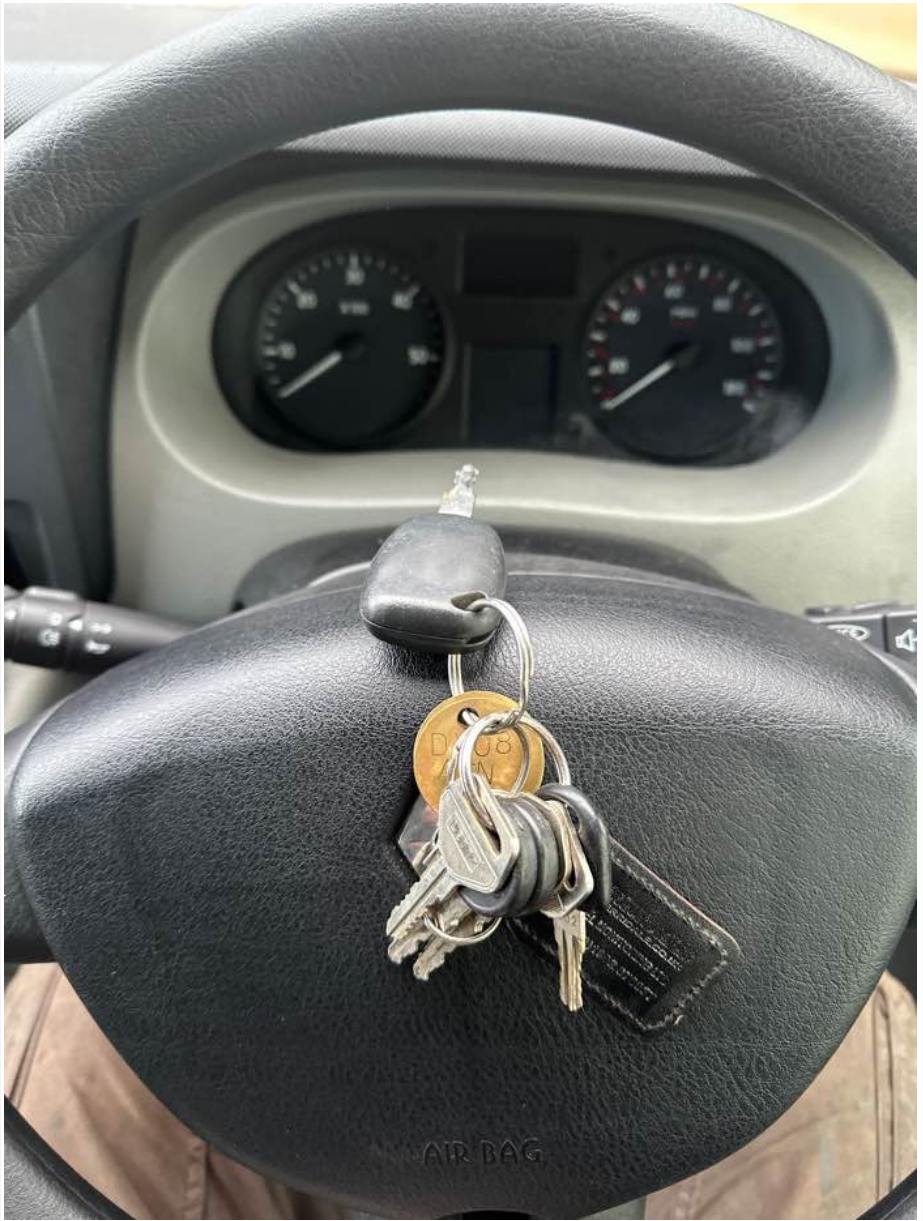
Select the following doors that lock.	N/S Front, O/S Front
Method of locking	Fob
In conclusion can all the doors be locked in some way and thus the vehicle can be left unattended at night safely?	No
How many keys present at time of inspection?

Comment	rear door barrel needs inspecting, worn, doesn't lock

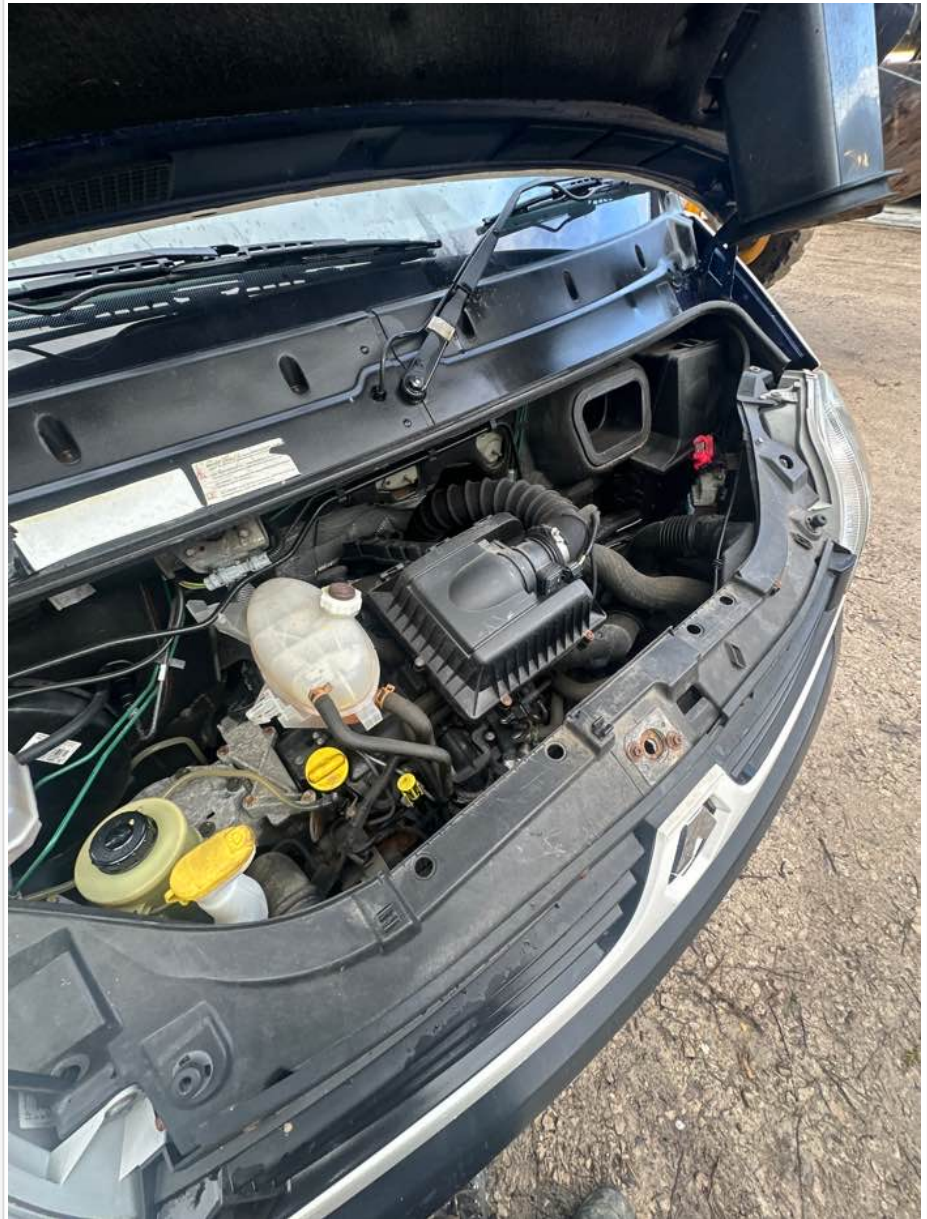
Engine bay photo

mechanically well
