BaseVan Initial Inspection

Vehicle registration	LN64ZXH
Vehicle chassis no.	VF3YDTMFC12615285
Miles (if in km, multiply by 0.62)	-
Make	Peugeot
Model	Boxer
Transmission	Manual, 6 speed
Factory immobiliser installed	Yes
Speed limiter installed	No
Drive configuration	FWD
Gross vehicle weight	3500kg
Towing capacity	3 tonne
Tow bar installed	No

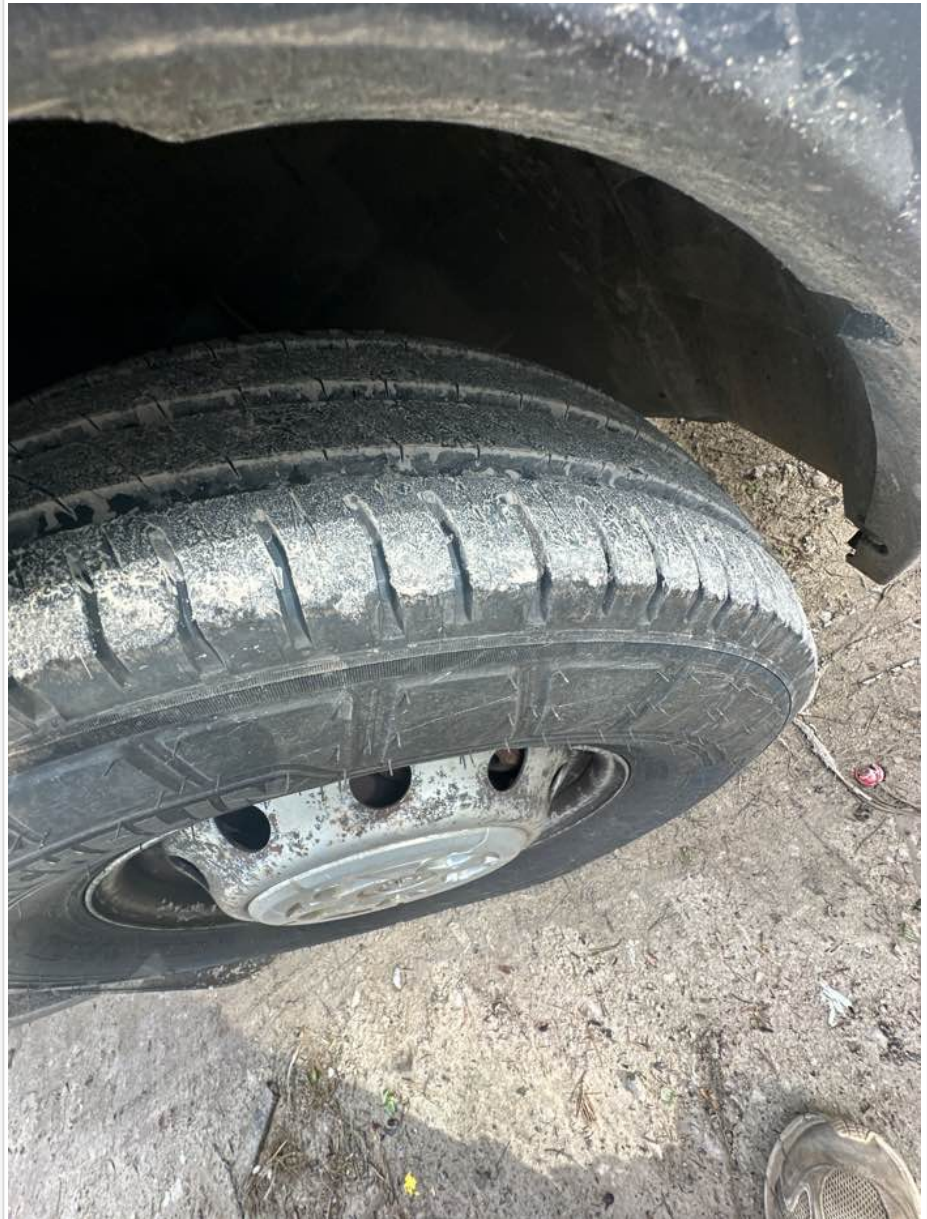
Off side front

Age (month/year) Manufactured	08/23
Make, brand.	Michelin
Tyre size	225/75/R16
Pressure 1	
Pressure 2	
Wearing / Perishing (inner)	none
Wearing / Perishing (outer)	None
tread depth (mm)	8
General comments	virtually brand new

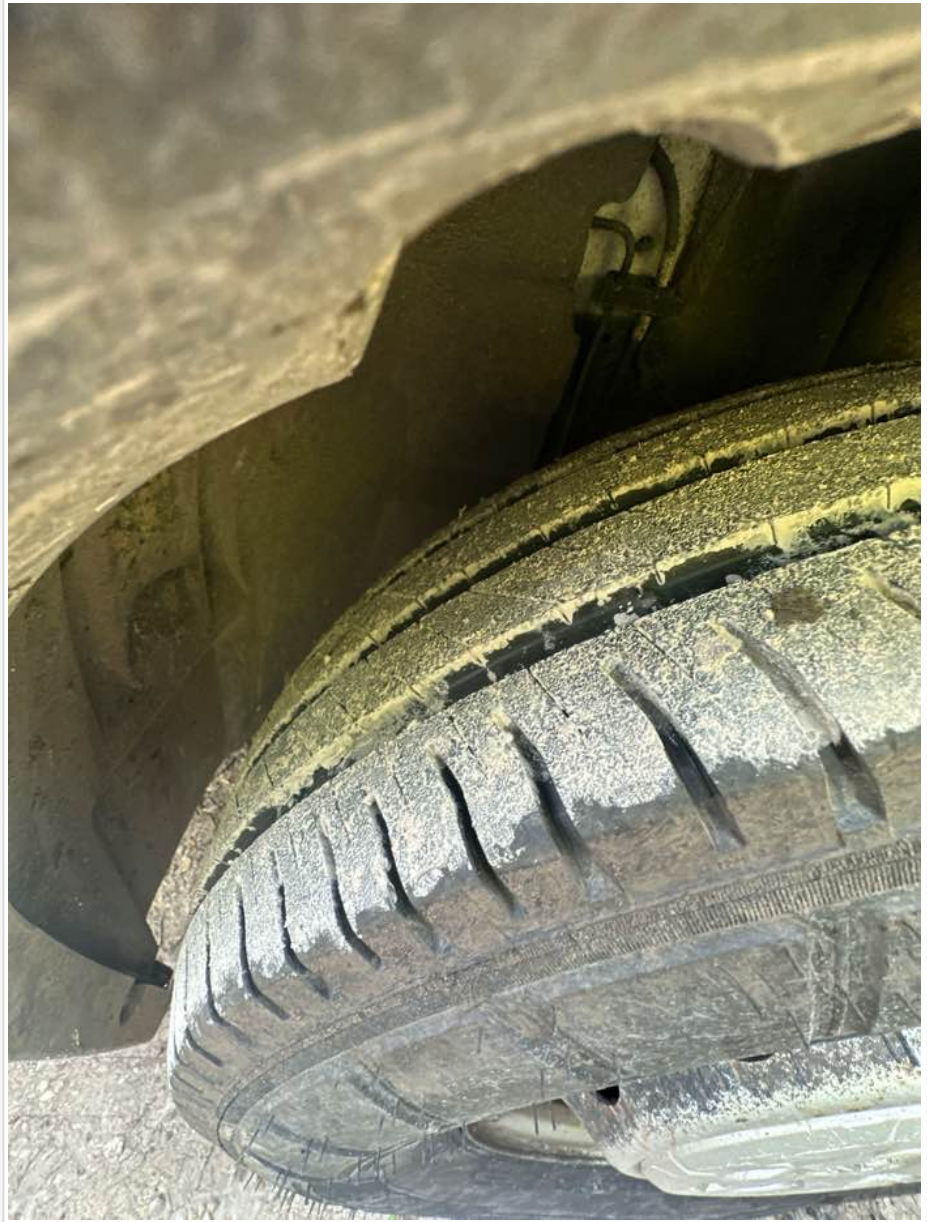
Near side front

Age (month/year) Manufactured	34/22
Make, brand.	Michelin
Tyre size	225/75/R16
Pressure 1	
Pressure 2	
Wearing / Perishing (inner)	none
Wearing / Perishing (outer)	None
tread depth (mm)	8
General comments	virtually brand new

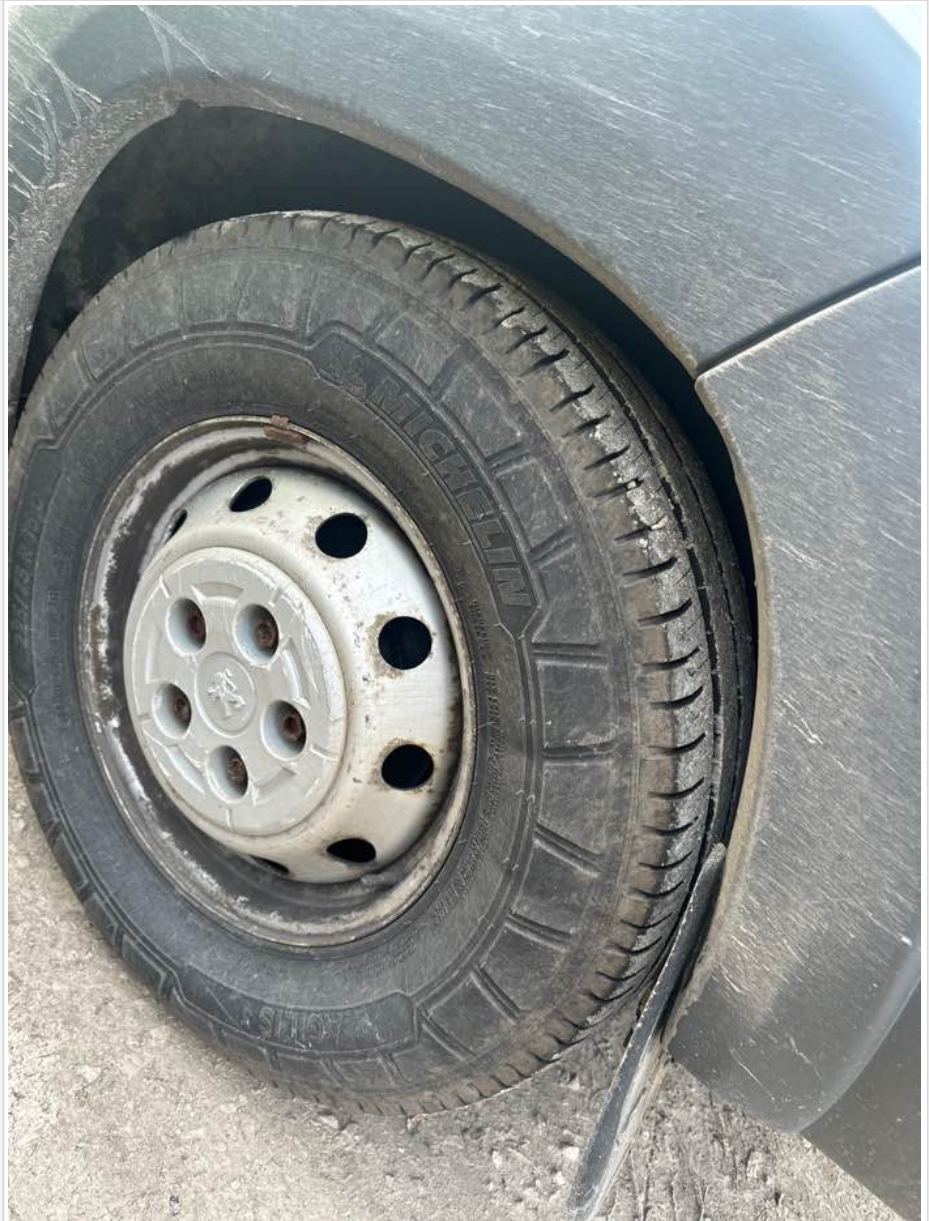
near side rear

Age (month/year) Manufactured	34/22
Make, brand.	Michelin
Tyre size	225/75/R16
Pressure 1	
Pressure 2	
Wearing / Perishing (inner)	none
Wearing / Perishing (outer)	None
tread depth (mm)	7
General comments	virtually brand new

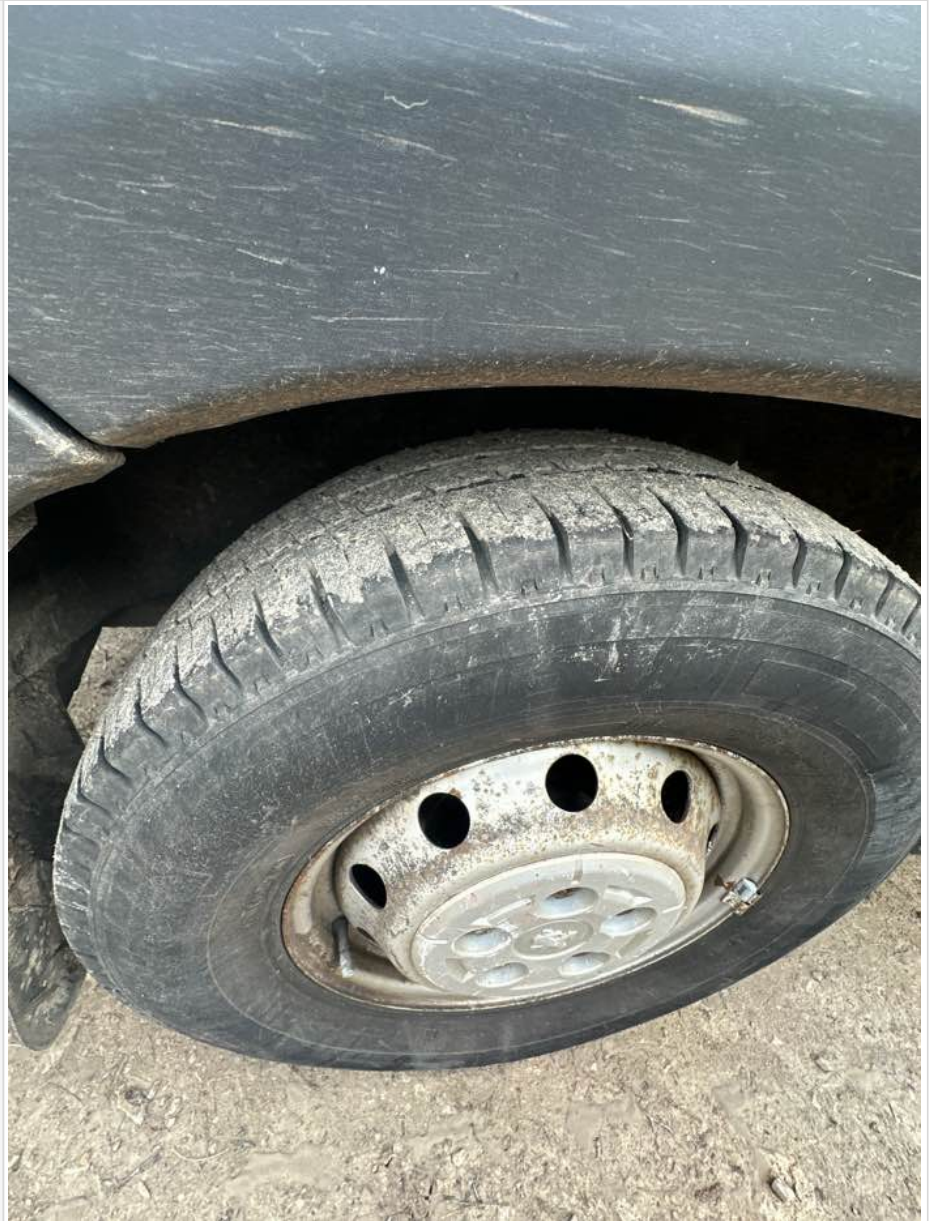
Off side rear

Age (month/year) Manufactured	30/19
Make, brand.	Michelin
Tyre size	225/75/R16
Pressure 1	
Pressure 2	
Wearing / Perishing (inner)	none
Wearing / Perishing (outer)	None
tread depth (mm)	6
General comments	great condition

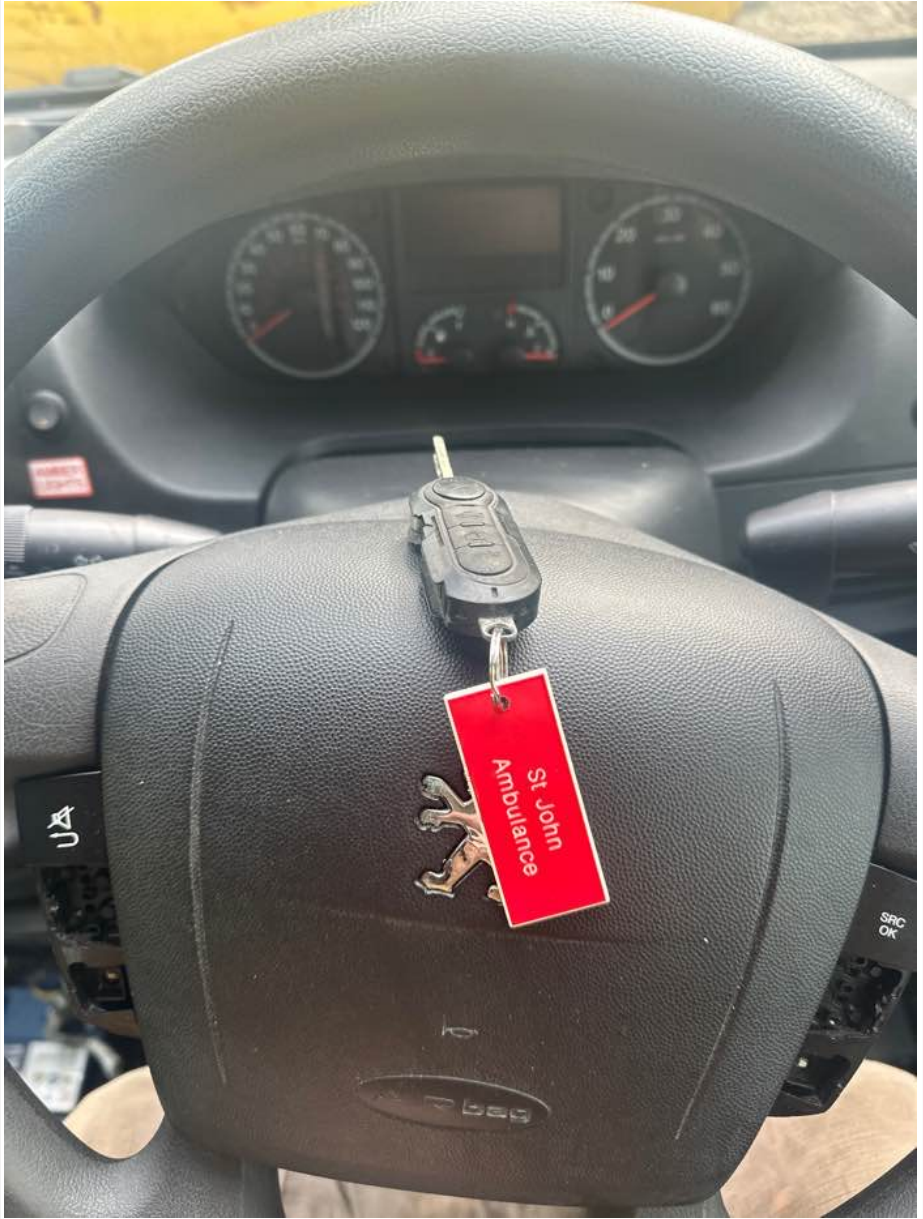
Comment	functions as should

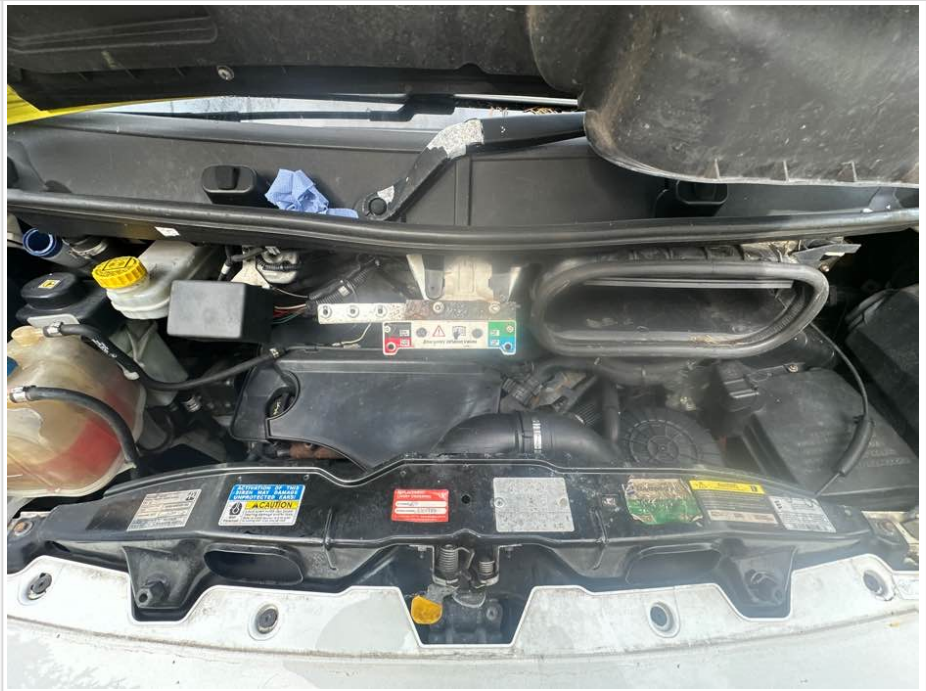
<p>Engine bay photo</p>

<p>Comment</p>	<p>MFD not functional</p>
