BaseVan Initial Inspection

Vehicle registration	KE12BBN
Vehicle chassis no.	VF3YCTMFC12200950
Miles (if in km, multiply by 0.62)	127566
Make	Peugeot
Model	BOXER
Transmission	Manual, 6 speed
Factory immobiliser installed	Yes
Speed limiter installed	No
Drive configuration	FWD
Gross vehicle weight	3500kg
Towing capacity	2500kg
Tow bar installed	No

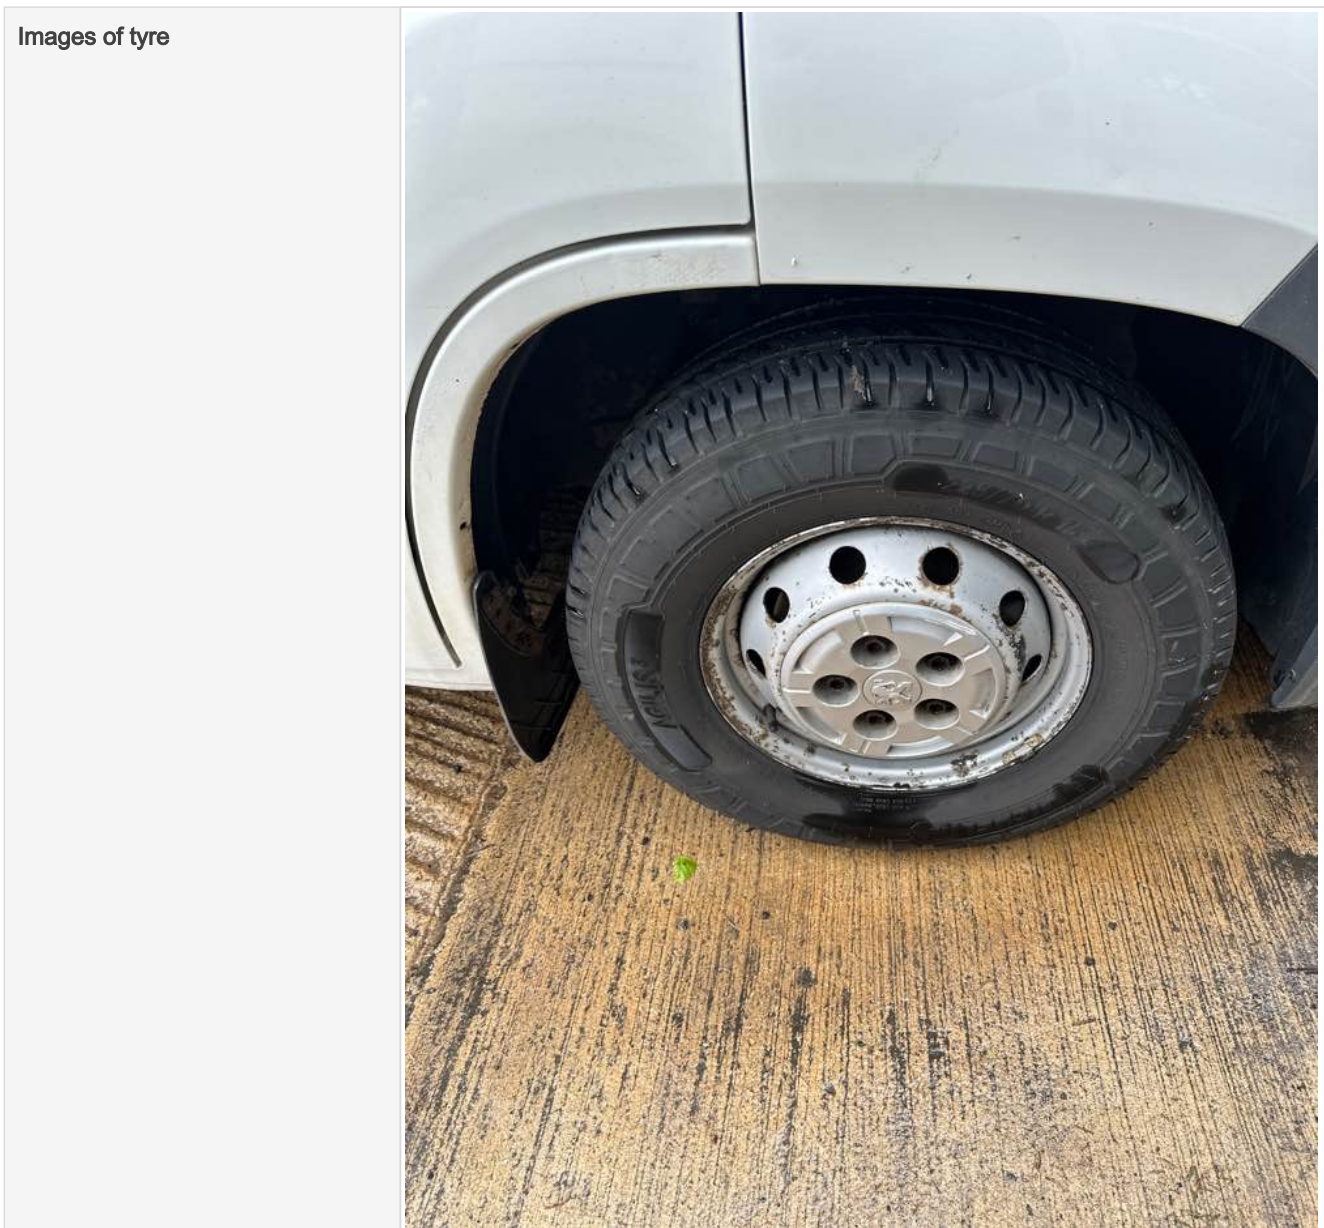
Near side front

Age (month/year) Manufactured	01/20
Make, brand.	GT Radial
Tyre size	Not here (see comment)
Pressure 1	
Pressure 2	
Wearing / Perishing (inner)	none
Wearing / Perishing (outer)	None
tread depth (mm)	5
General comments	worn, but still got life, 225/70/15

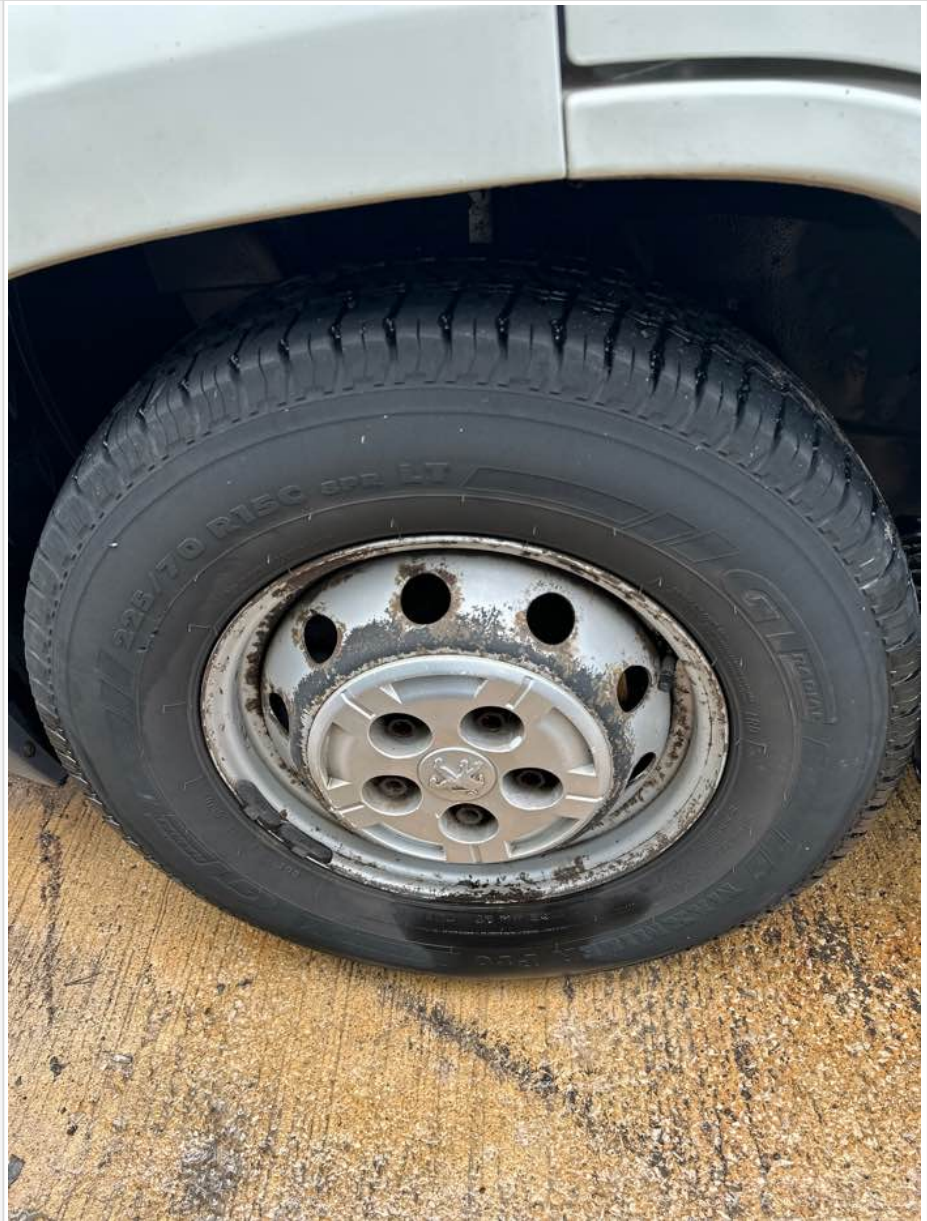
near side rear

Age (month/year) Manufactured	12/22
Make, brand.	Michelin
Tyre size	Not here (see comment)
Pressure 1	
Pressure 2	
Wearing / Perishing (inner)	none
Wearing / Perishing (outer)	None
tread depth (mm)	8
General comments	basically brand new

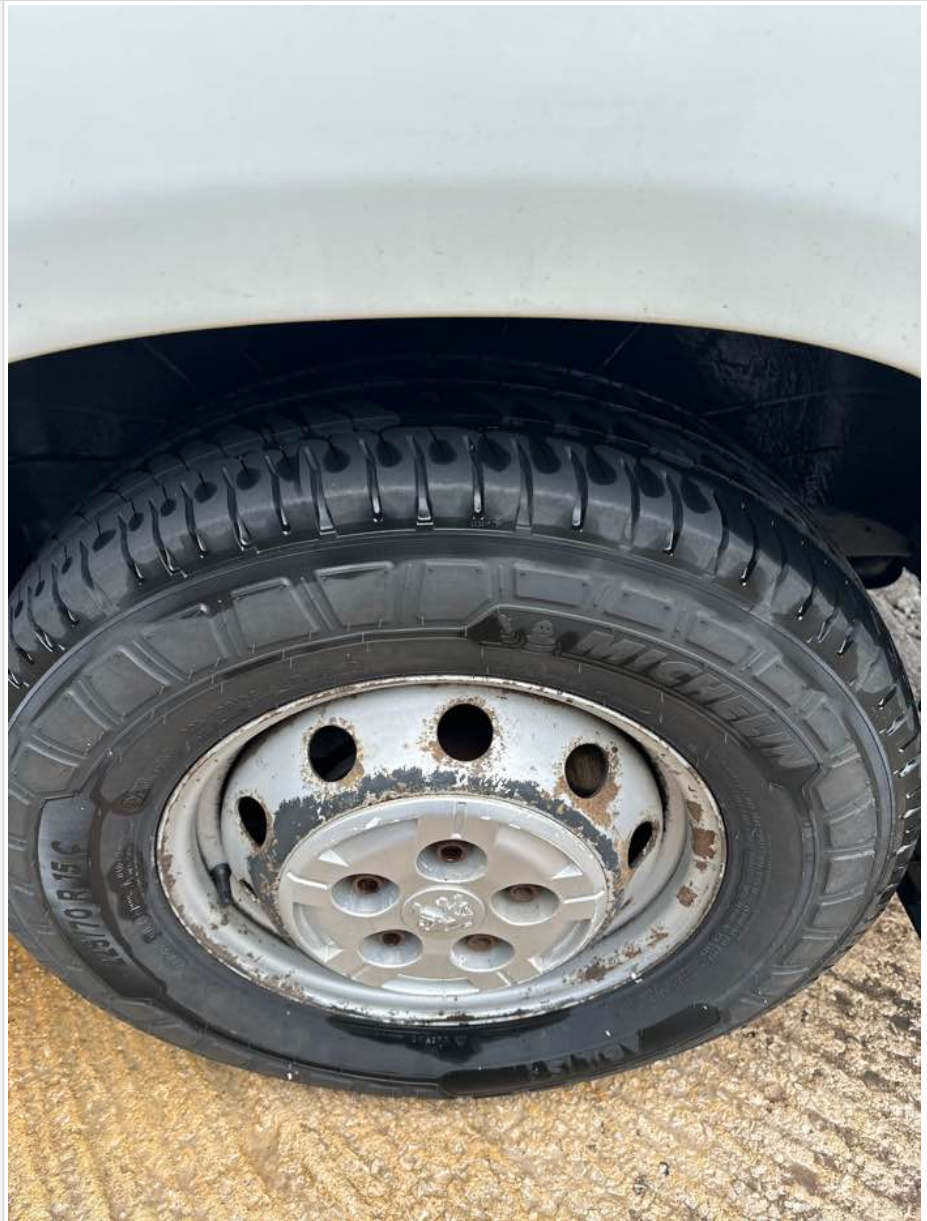
Off side rear

Age (month/year) Manufactured	43/21
Make, brand.	Michelin
Tyre size	Not here (see comment)
Pressure 1	
Pressure 2	
Wearing / Perishing (inner)	none
Wearing / Perishing (outer)	None
tread depth (mm)	8
General comments	basically brand new, 225/70/15

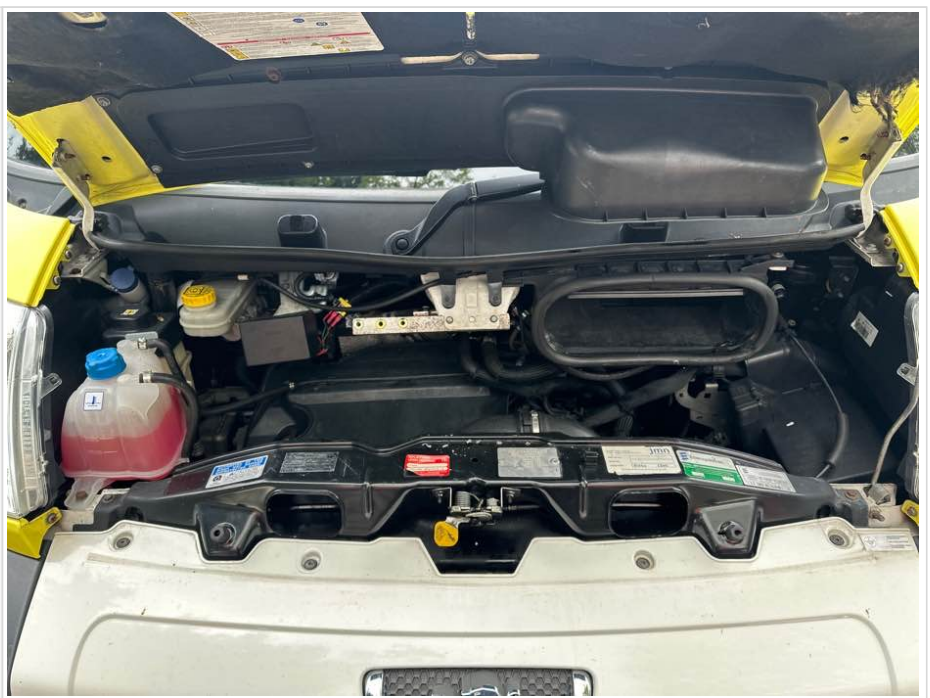
<p>Engine bay photo</p>

Fuel level	1/2 Full
Oil level	Full
Oil conditon	Clean
Start up, chassis battery check	Started without jump pack
Start-up from cold	Instant
Exhaust smoke from cold	Normal
Output Voltage of Alternator test	13.8
Chain or Belt driven engine?	Belt
If belt any proof of change?	
Coolant condition	Clean
Coolant level	Full
Anti-freeze temperature check	-16
Washer fluid	Full
Brake fluid	Full
Power steering fluid	Maximum
Dashboard warning light	No warning lights
OBD Scan results
