Basevan.com Inspection Report 2025

Vehicle registration	HF05FZC
Vehicle chassis no.	SEYZMUSZGDN109824
Miles (if in km, multiply by 0.62)	31208
Make	LDV
Model	CONVOY
Transmission	5 speed
Factory immobiliser installed	Yes
Speed limiter installed	No
Drive configuration	RWD
Gross Vehicle Weight (kg)	3050
Towing capacity	1650
Tow bar installed	No

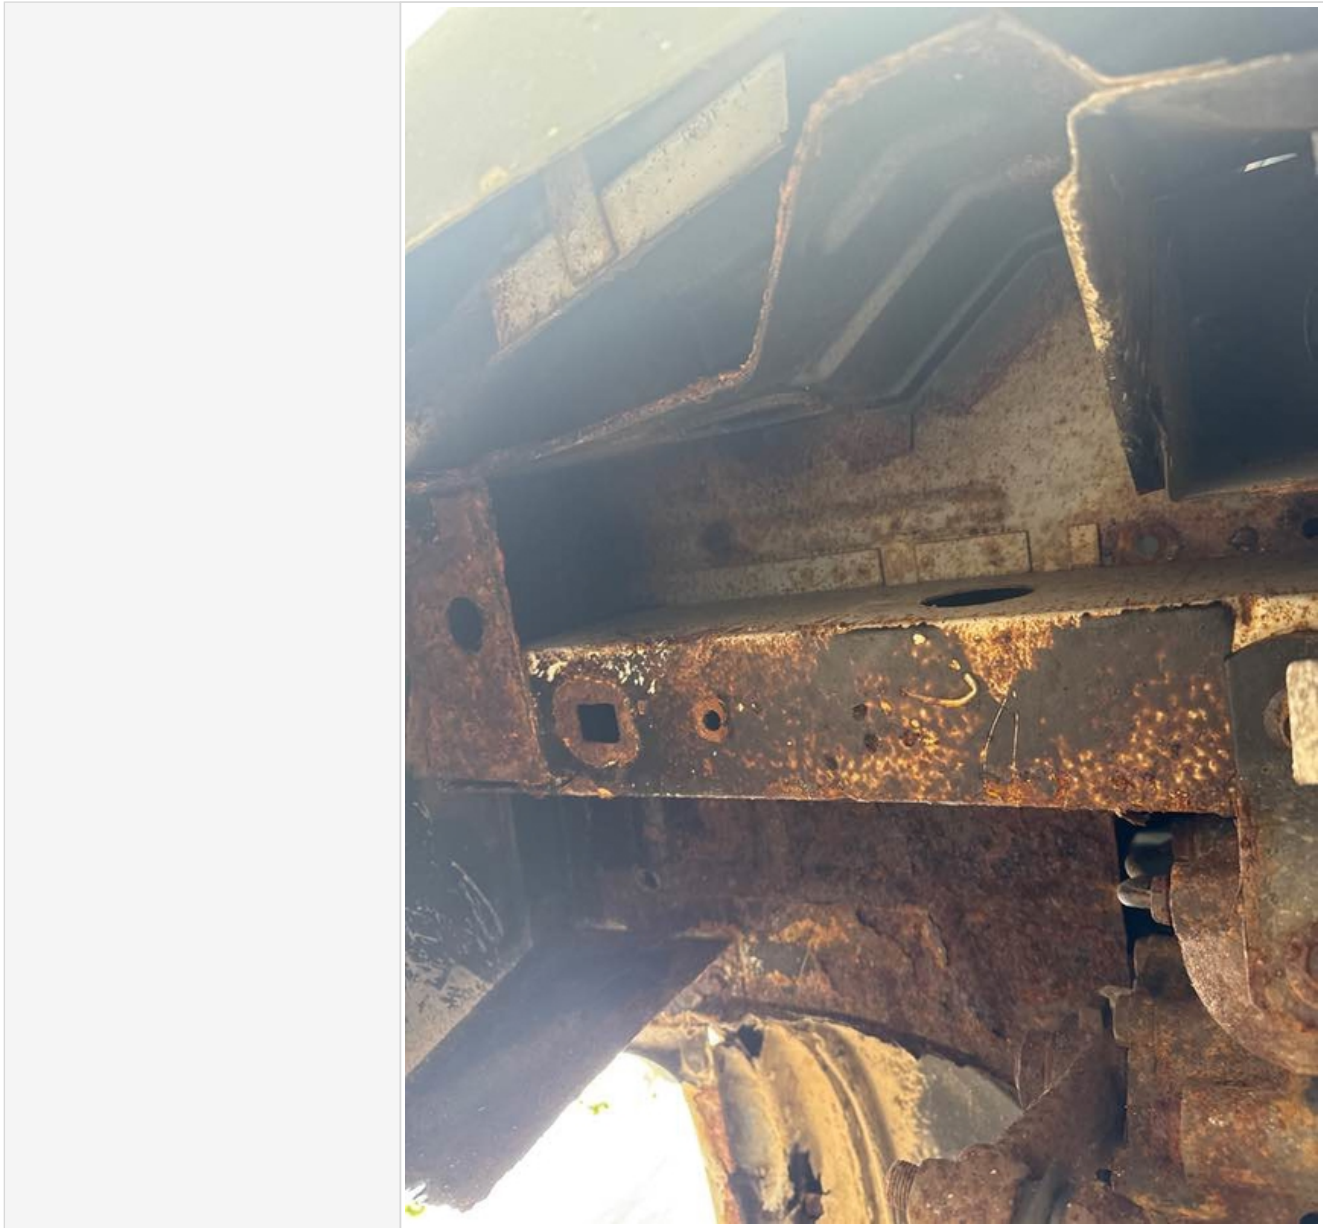
Off side front

Age (month/year) Manufactured	32/17
Make, brand.	Other (comment)
Tyre size	185/R14
Pressure 1	30
Pressure 2	48
Wearing / Perishing (inner)	none
Wearing / Perishing (outer)	None
tread depth (mm)	6
General comments	Good tyre

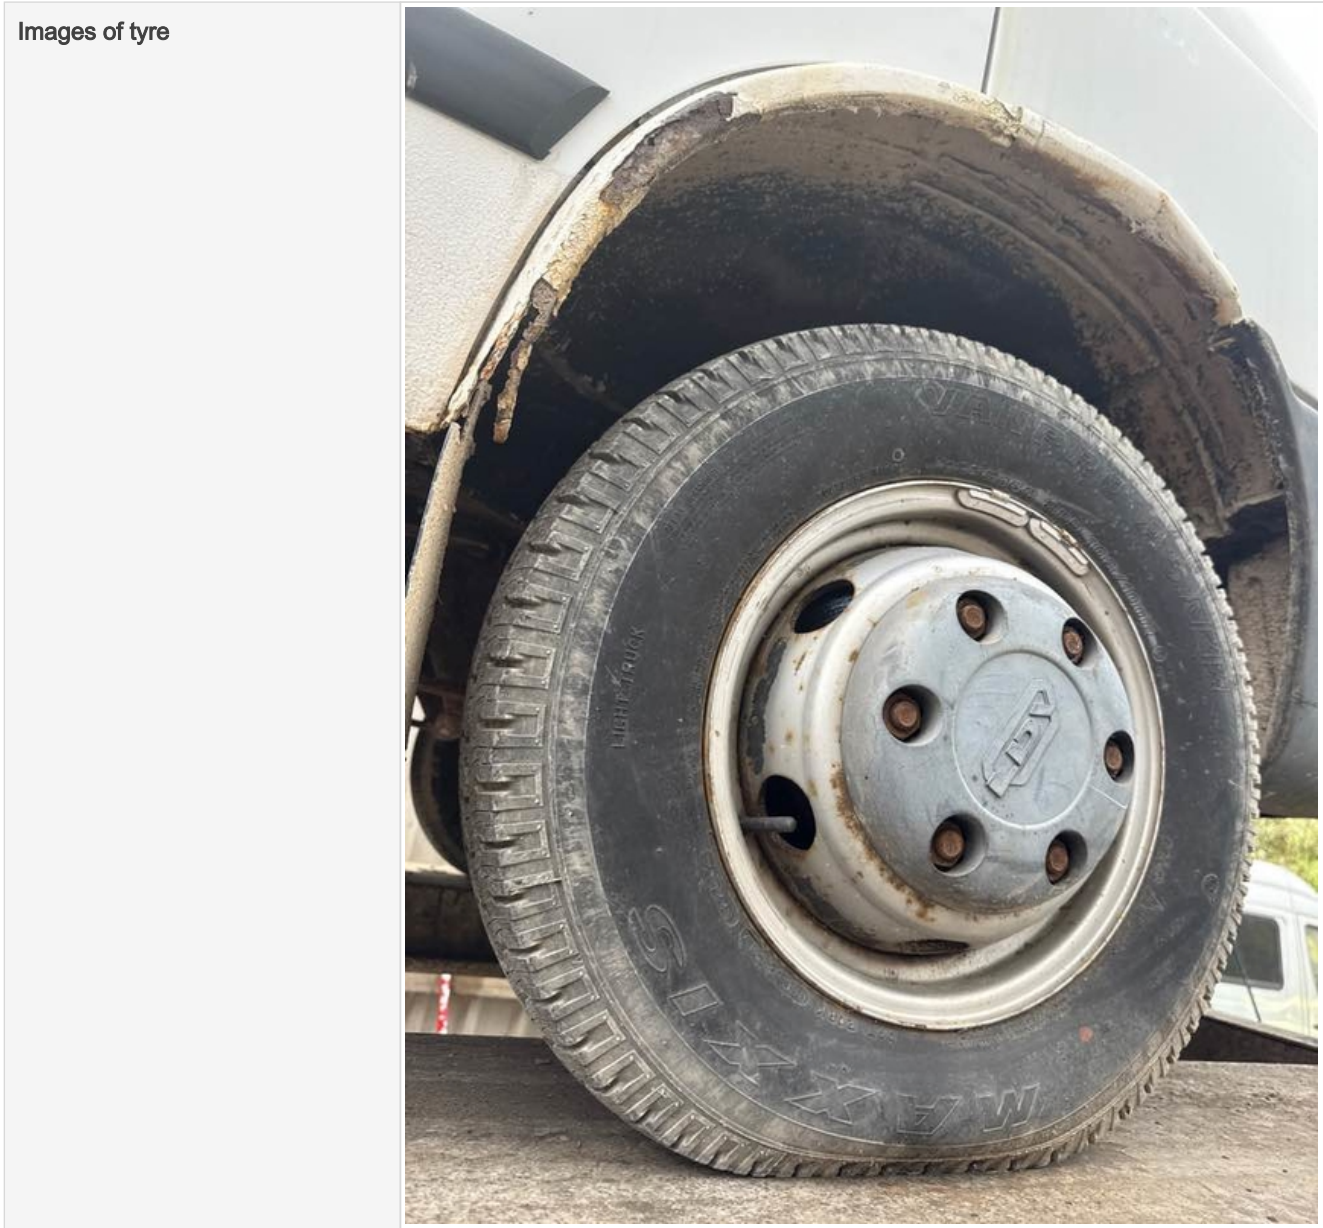
Near side front

Age (month/year) Manufactured	25/13
Make, brand.	Other (comment)
Tyre size	185/R14
Pressure 1	33
Pressure 2	48
Wearing / Perishing (inner)	Slight
Wearing / Perishing (outer)	Slight
tread depth (mm)	5
General comments	Good tyre

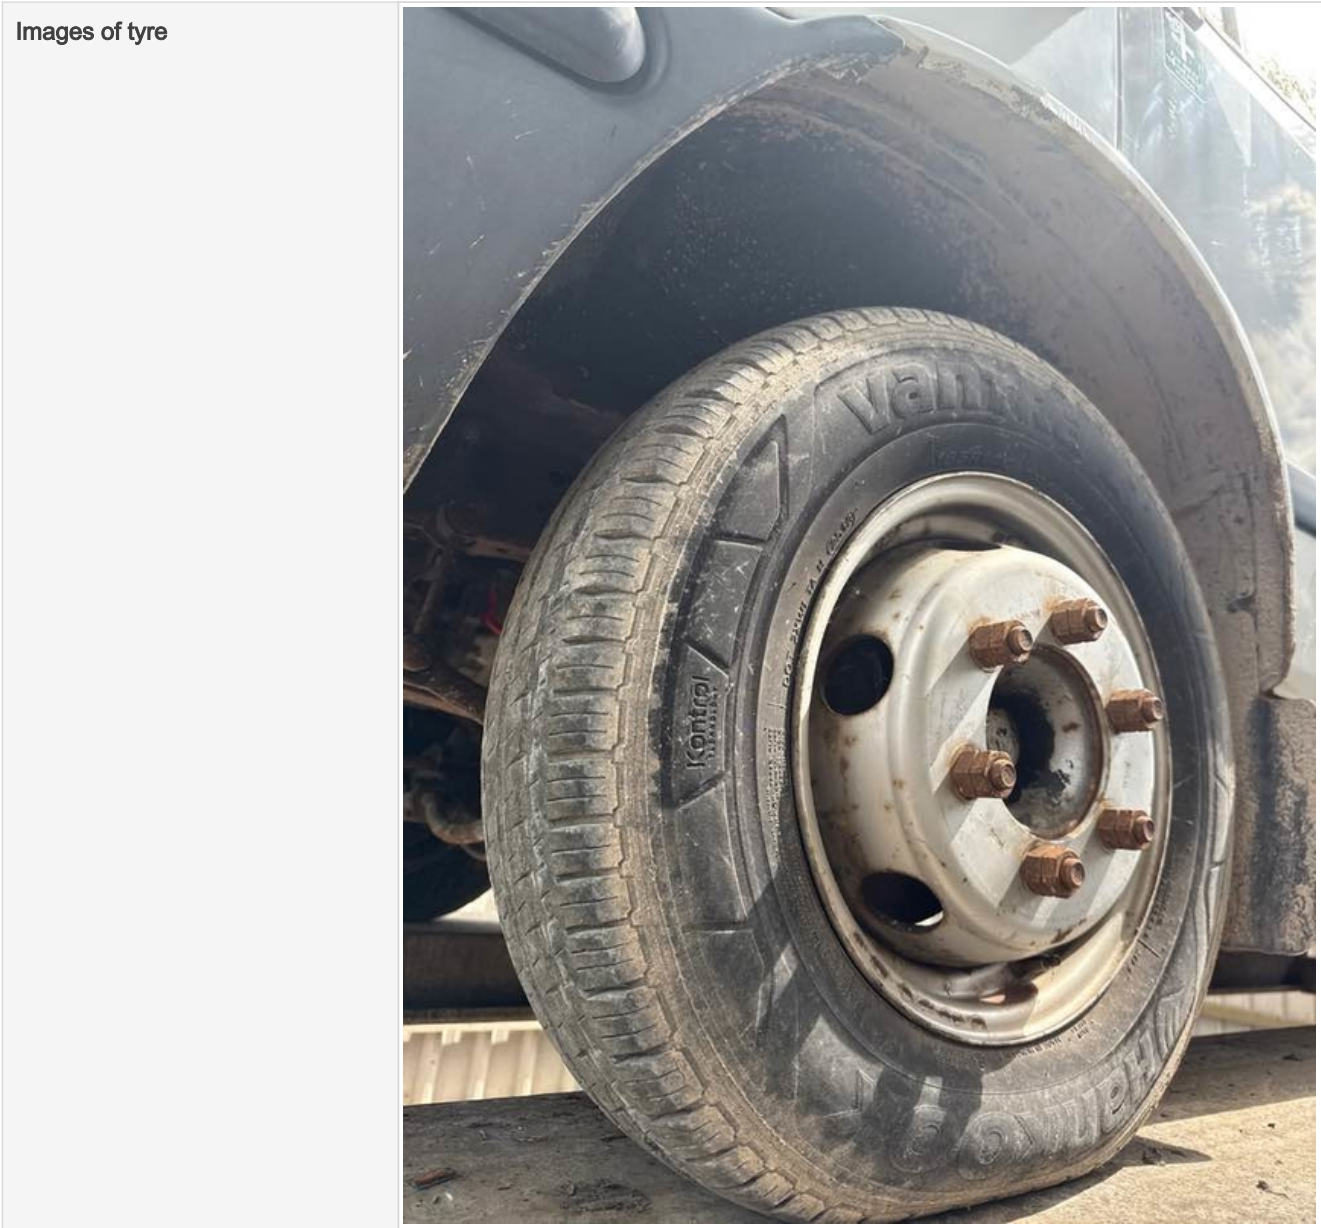
near side rear

Age (month/year) Manufactured	
Make, brand.	
Tyre size	185/R14
Pressure 1	
Pressure 2	
Wearing / Perishing (inner)	Replace soon
Wearing / Perishing (outer)	Slight
tread depth (mm)	5
General comments	Okay, but is wearing and appears old tyre, slight buckle in rim.

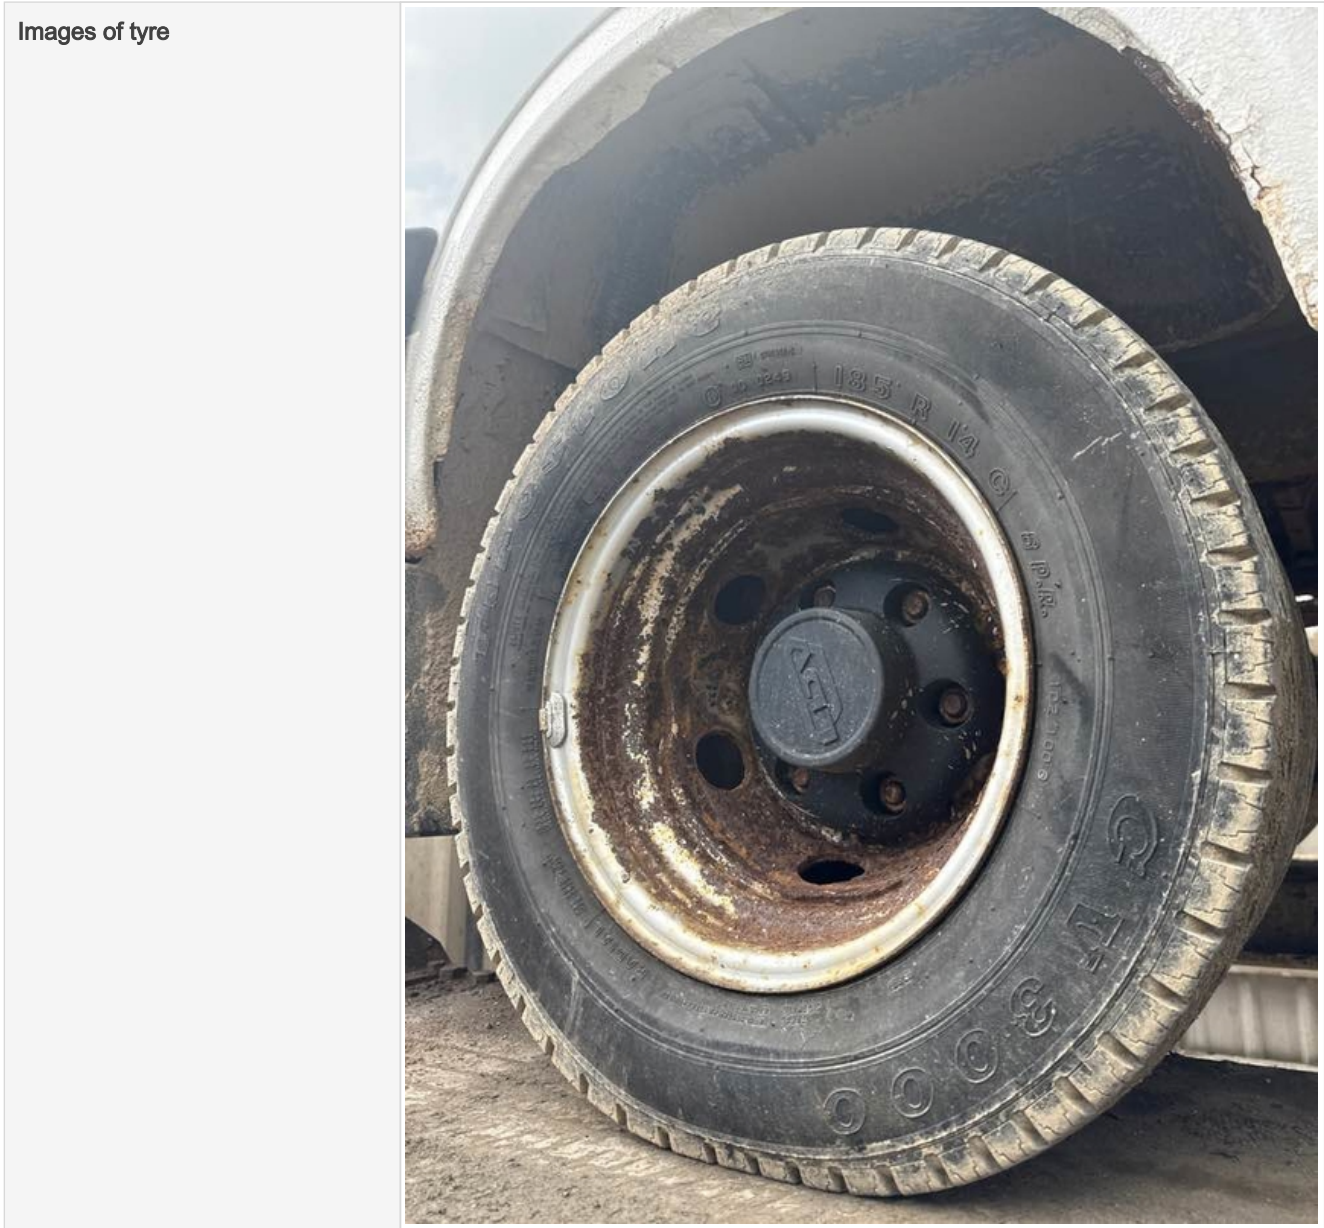
off side Inner (for twin wheel vans)

Is the vehicle a twin wheel axle? (if no don't fill out)	Yes
Age (month/year) Manufactured	
Make, brand.	Other (comment)
Tyre size	185/R14
Pressure 1	
Pressure 2	
Wearing / Perishing (inner)	none
Wearing / Perishing (outer)	None

tread depth (mm)	5
General comments	Good tyre
Images of tyre

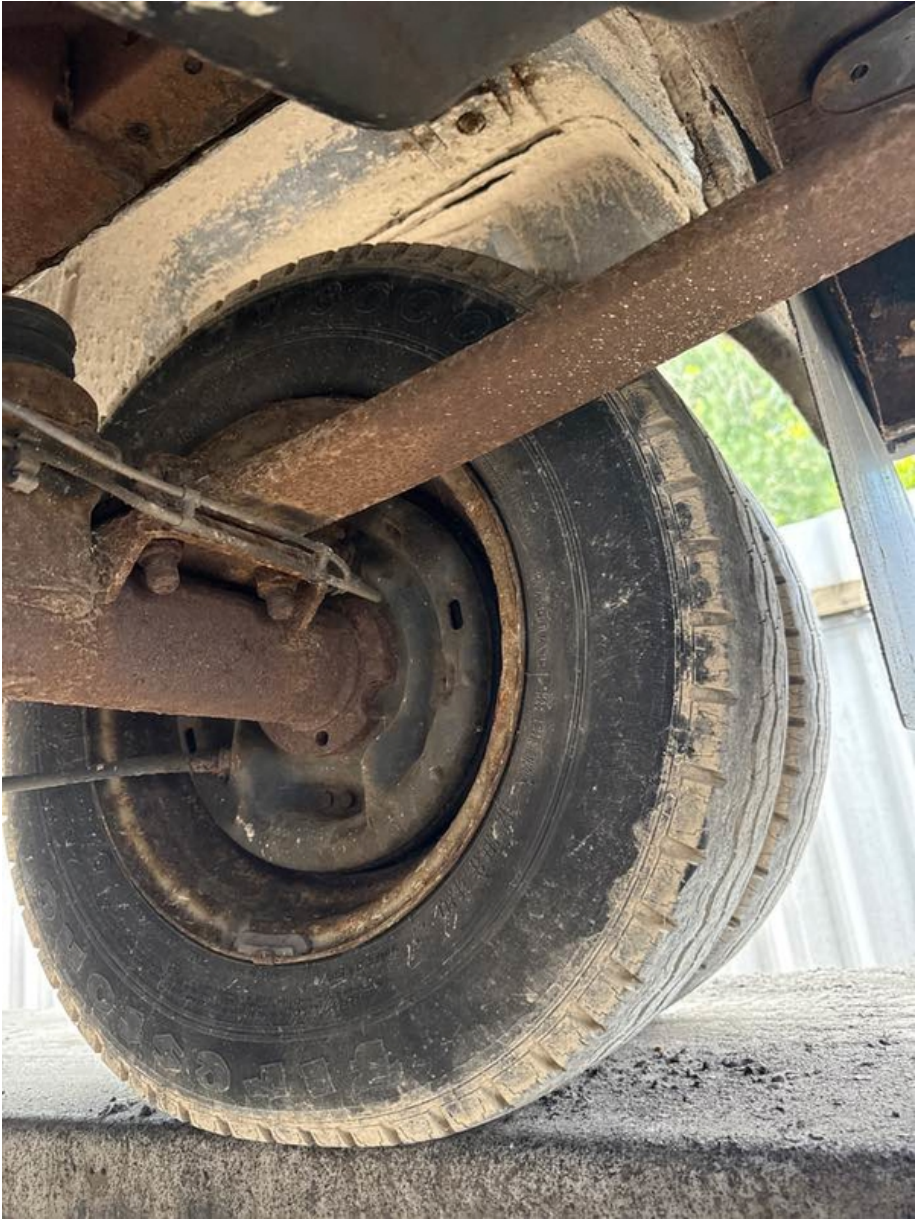
near side Inner (for twin wheel vans)

Is the vehicle a twin wheel axle? (if no don't fill out)	Yes
Age (month/year) Manufactured	
Make, brand.	Other (comment)
Tyre size	185/R14
Pressure 1	
Pressure 2

Wearing / Perishing (inner)	none
Wearing / Perishing (outer)	None
tread depth (mm)	4
General comments	Not bad plenty of life left
Images of tyre
