Basevan.com General Inspection

Vollidio dotalio	
Vehicle registration	BD56HLH
Vehicle chassis no.	WVWZZZ7HZ7H057996
Miles (if in km, multiply by 0.62)	40,895
Make	Volkswagen
Model	T5 Transporter
Transmission	Manual, 6 speed
Factory immobiliser installed	Yes
Speed limiter installed	No
Drive configuration	FWD
Gross Vehicle Weight (kg)	3000
Towing capacity	2200kg
Tow bar installed	No

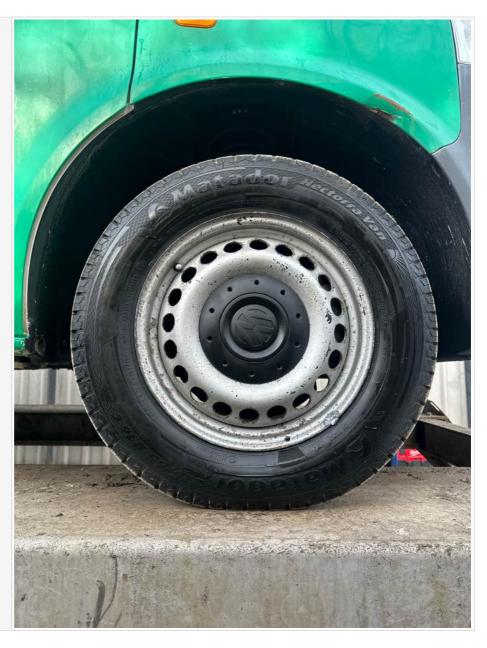
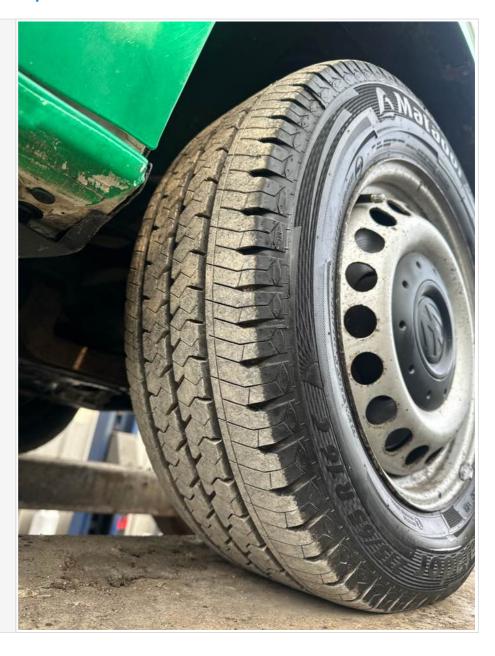
Off side front

Age (month/year) Manufactured	13/24
Make, brand.	Budget
Tyre size	215/75/R16
Pressure 1	
Pressure 2	
Wearing / Perishing (inner)	none
Wearing / Perishing (outer)	None
tread depth (mm)	9
General comments	MINT barely used

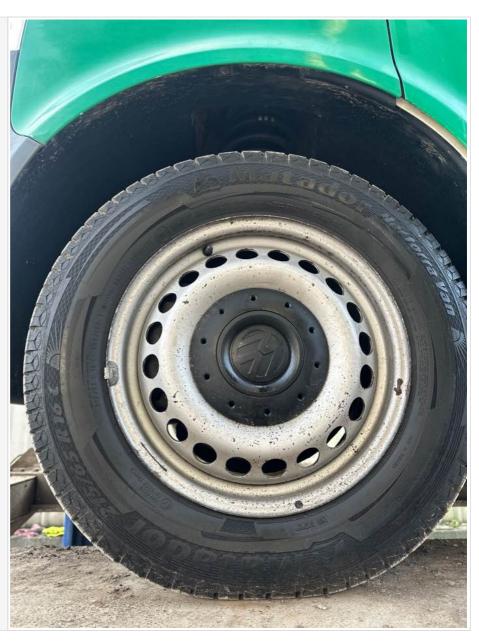
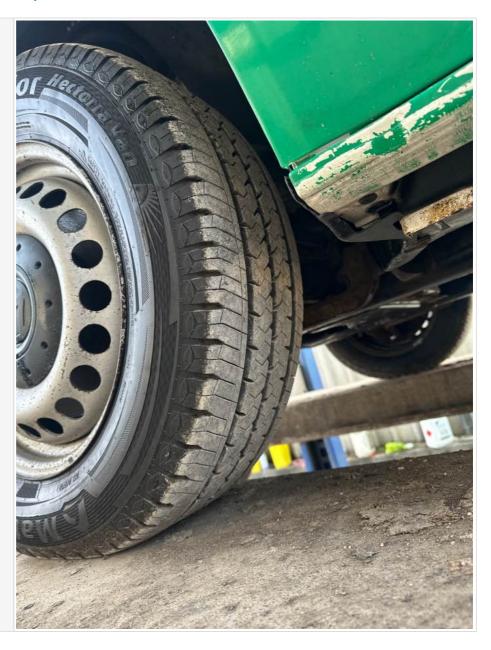
Near side front

Age (month/year) Manufactured	13/24
Make, brand.	Budget
Tyre size	215/75/R16
Pressure 1	
Pressure 2	
Wearing / Perishing (inner)	none
Wearing / Perishing (outer)	None
tread depth (mm)	9
General comments	MINT barely used

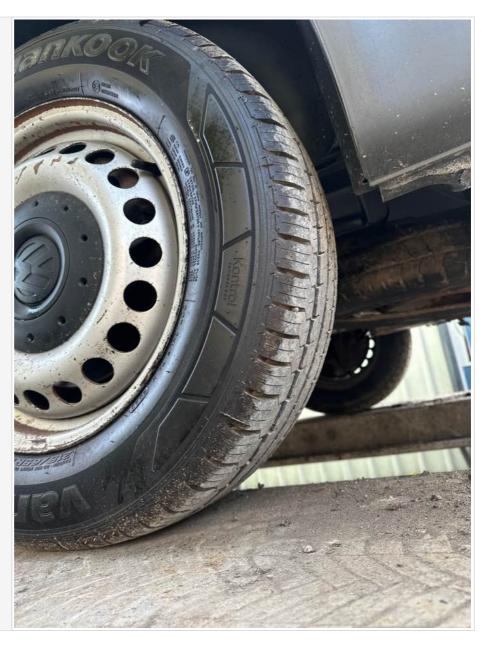
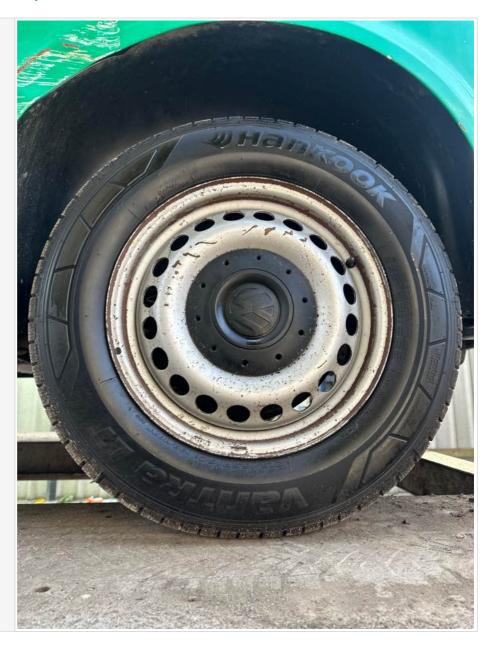
near side rear

Age (month/year) Manufactured	25/23
Make, brand.	Hankook
Tyre size	215/75/R16
Pressure 1	
Pressure 2	
Wearing / Perishing (inner)	none
Wearing / Perishing (outer)	None
tread depth (mm)	7
General comments	good tyres, fantastic condition

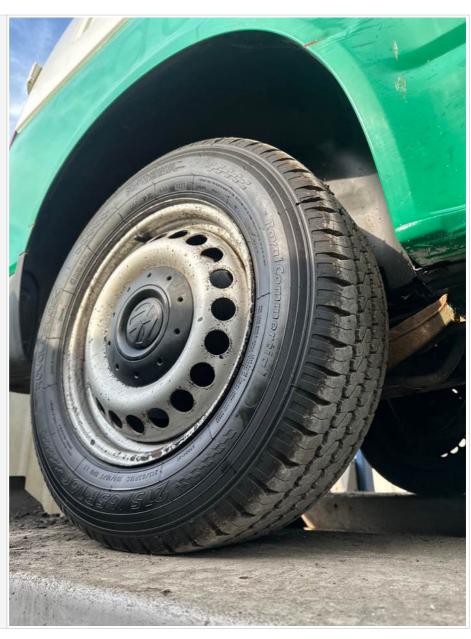
Off side rear

On older real	
Age (month/year) Manufactured	12/23
Make, brand.	Budget
Tyre size	215/75/R16
Pressure 1	
Pressure 2	
Wearing / Perishing (inner)	none
Wearing / Perishing (outer)	None
tread depth (mm)	7
General comments	mint barely used tyre

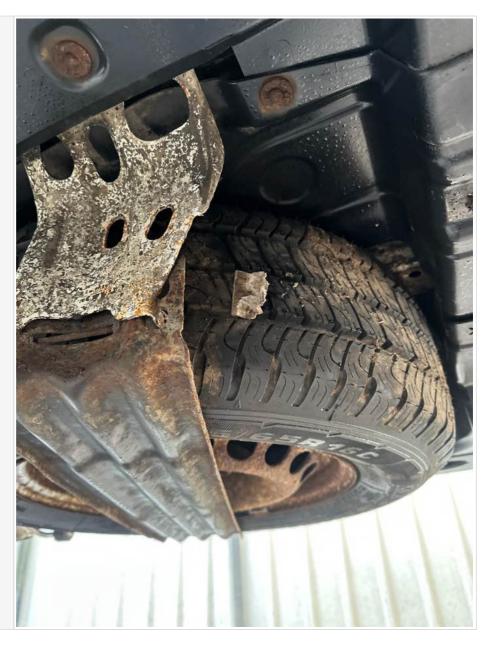
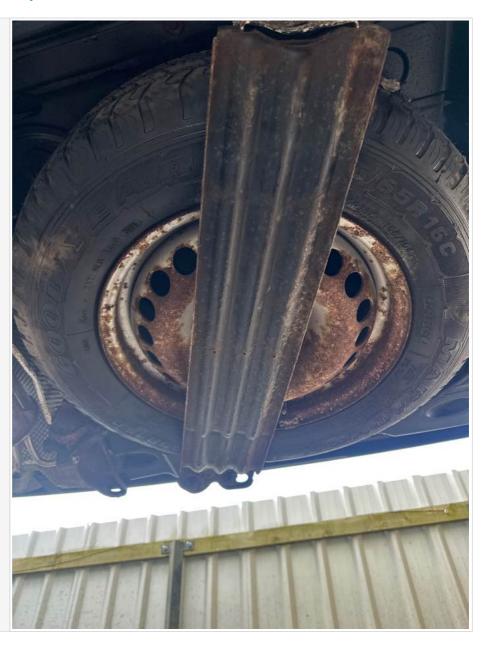
Spare wheel

oparo wricer	
Spare installed? (If no, don't fill out)	Yes
Age (month/year) Manufactured	39/06
Make, brand.	Good Year
Tyre size	215/75/R16
Pressure 1	
Pressure 2	
Wearing / Perishing (inner)	none
Wearing / Perishing (outer)	None
tread depth (mm)	9
General comments	sticker still present

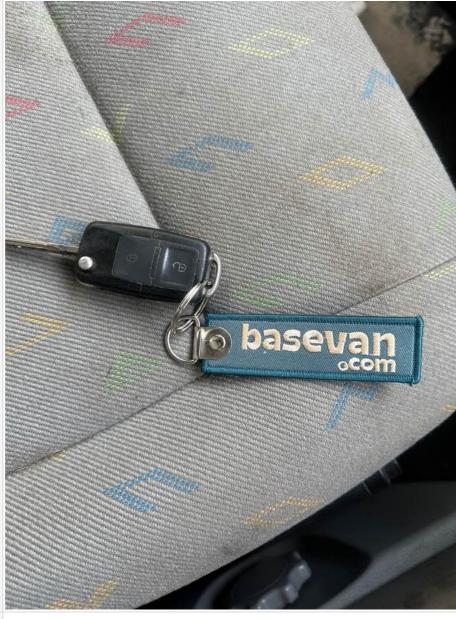
Vehicle locks, all doors lock, however there is an issue with unlocking the vehicle through remote central locking - Workshop to inspect, possible fob fault

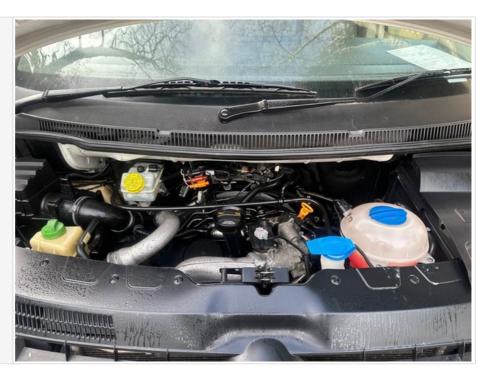
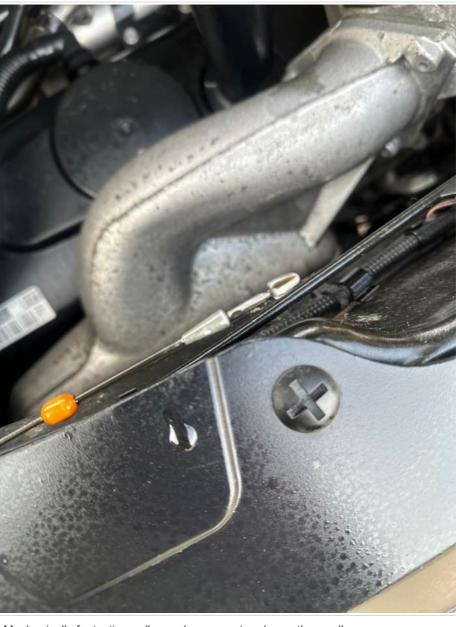
Engine bay photo

Mechanically fantastic, really good van. great underneath aswell
