Basevan.com General Inspection

Vehicle registration	LX11CNY
Vehicle chassis no.	VF1MAF4CR44821041
Miles (if in km, multiply by 0.62)	91678
Make	Renault
Model	Master
Transmission	Manual, 6 speed
Factory immobiliser installed	Yes
Speed limiter installed	N/A
Drive configuration	FWD
Gross Vehicle Weight (kg)	3500
Towing capacity	2500
Tow bar installed	No

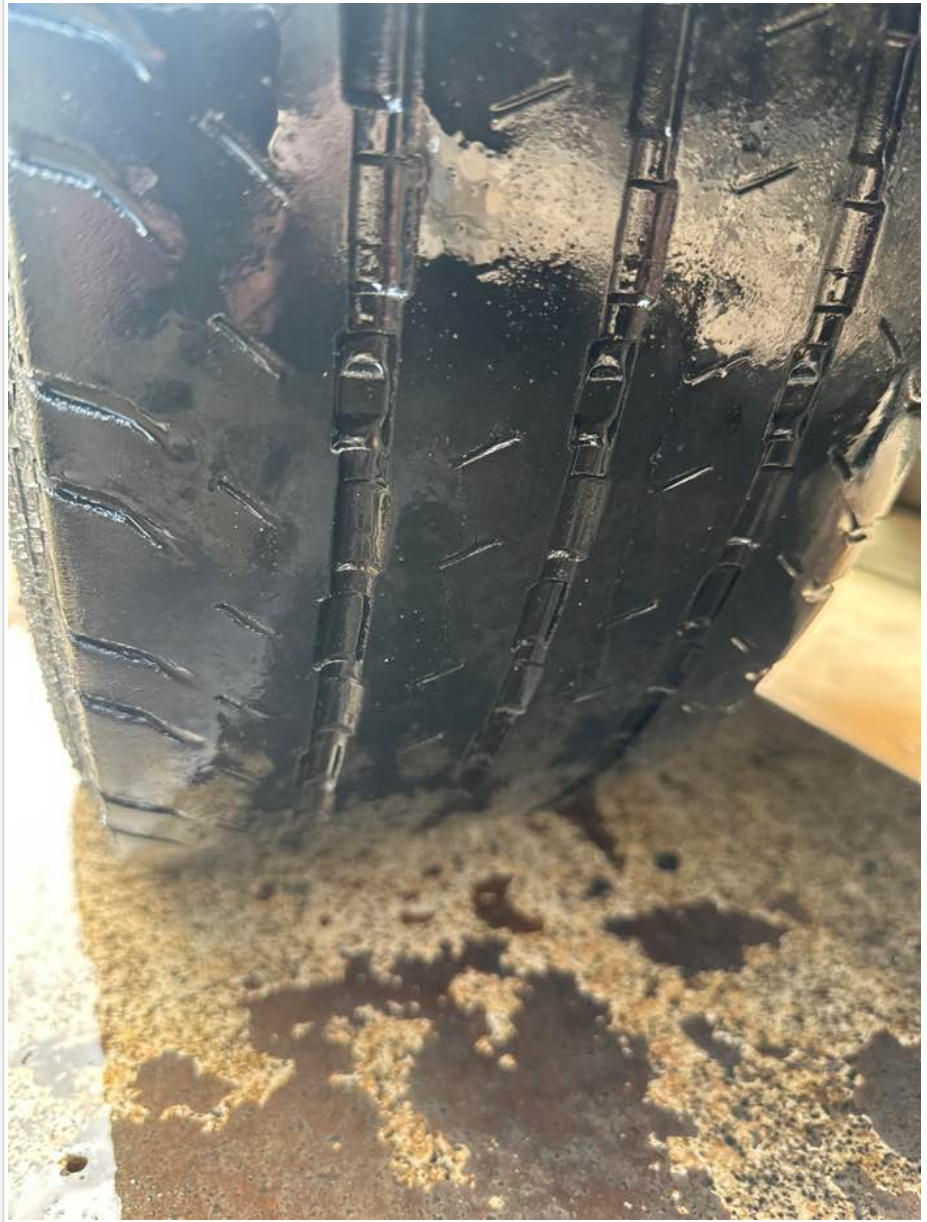
Off side front

Age (month/year) Manufactured	01/20
Make, brand.	Continental
Tyre size	225/65/R16
Pressure 1	35
Pressure 2	
Wearing / Perishing (inner)	Replace soon
Wearing / Perishing (outer)	Replace soon
tread depth (mm)	3
General comments

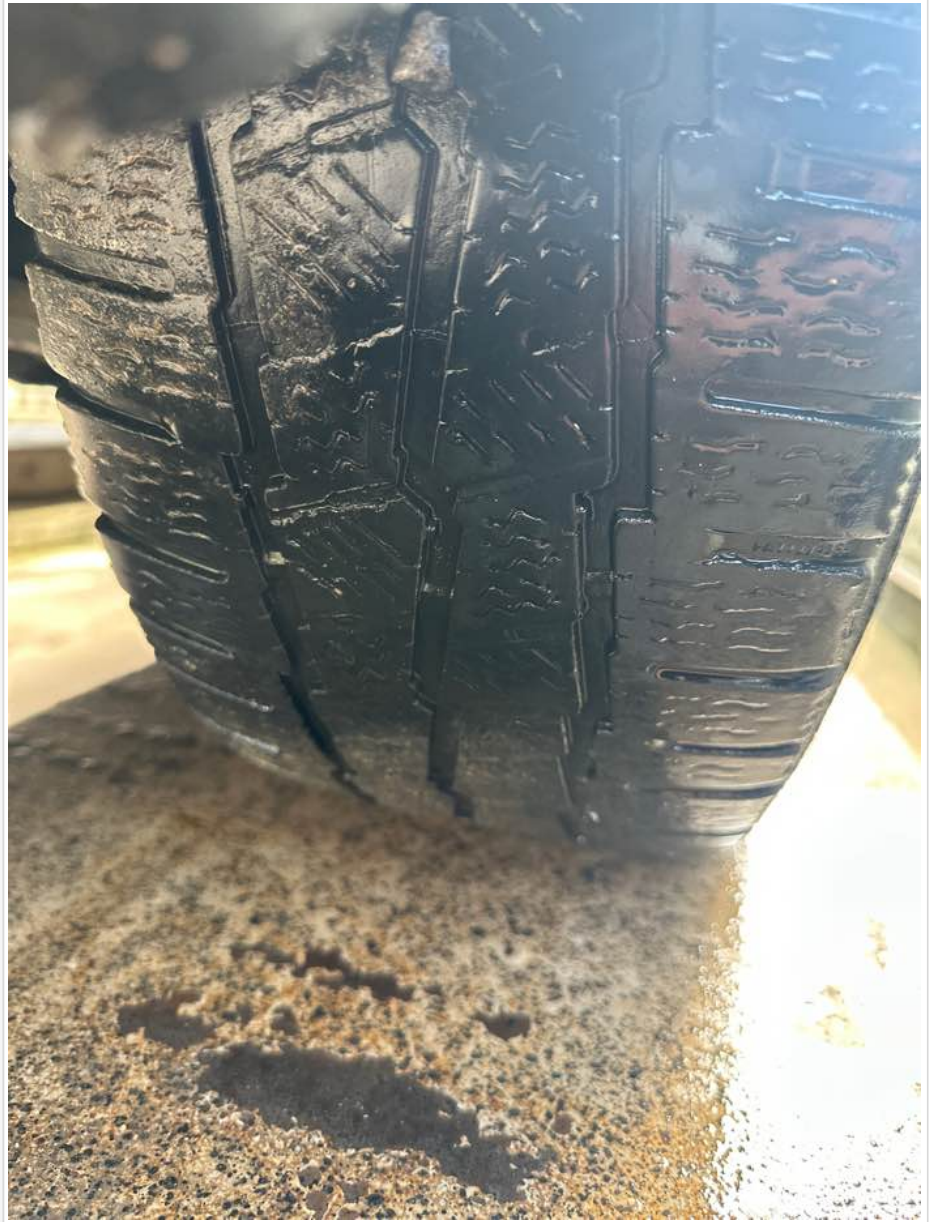
Near side front

Age (month/year) Manufactured	38/18
Make, brand.	Michelin
Tyre size	235/65/R16
Pressure 1	44
Pressure 2	
Wearing / Perishing (inner)	Medium
Wearing / Perishing (outer)	Medium
tread depth (mm)	4
General comments

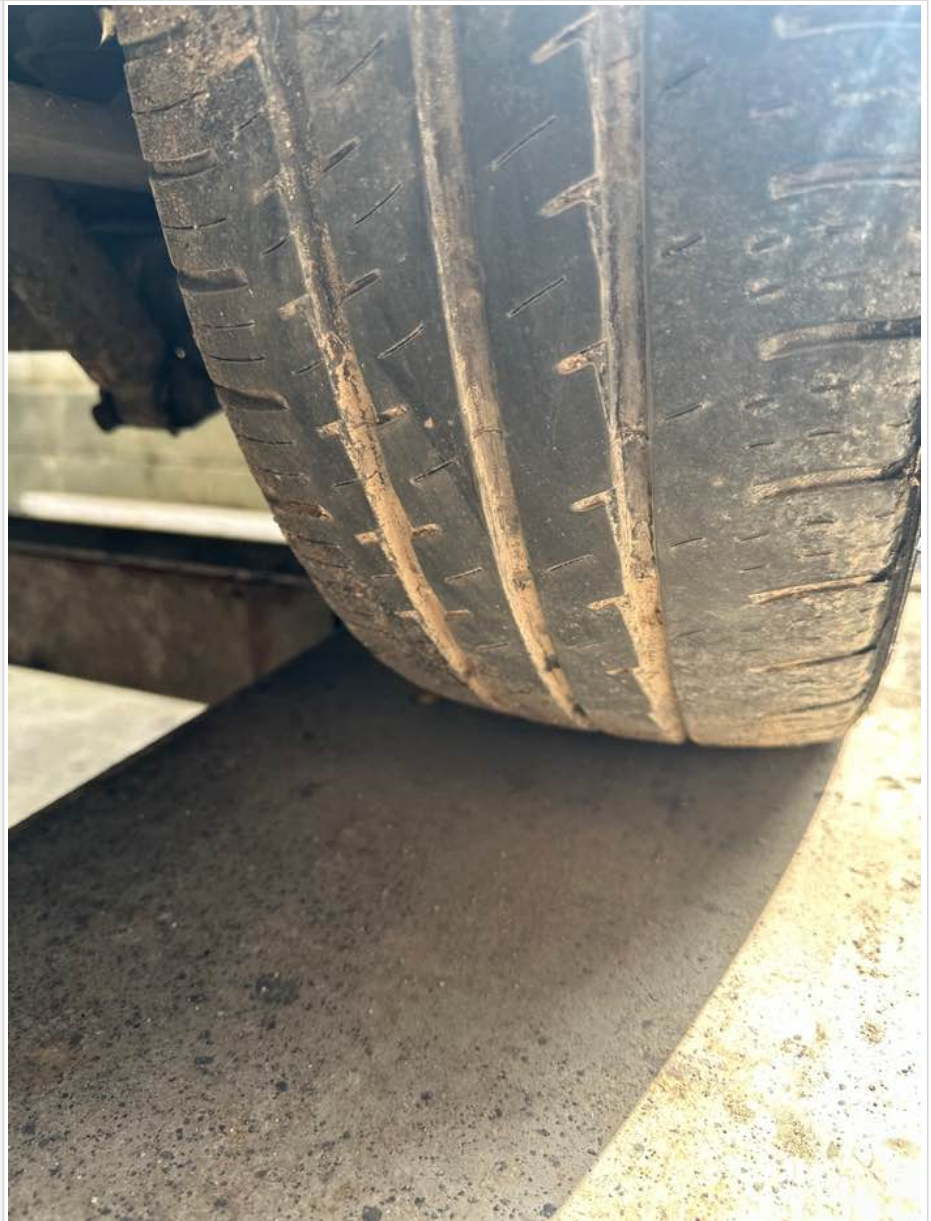
near side rear

Age (month/year) Manufactured	37/20
Make, brand.	Hankook
Tyre size	235/65/R16
Pressure 1	50
Pressure 2	
Wearing / Perishing (inner)	Slight
Wearing / Perishing (outer)	Slight
tread depth (mm)	7
General comments

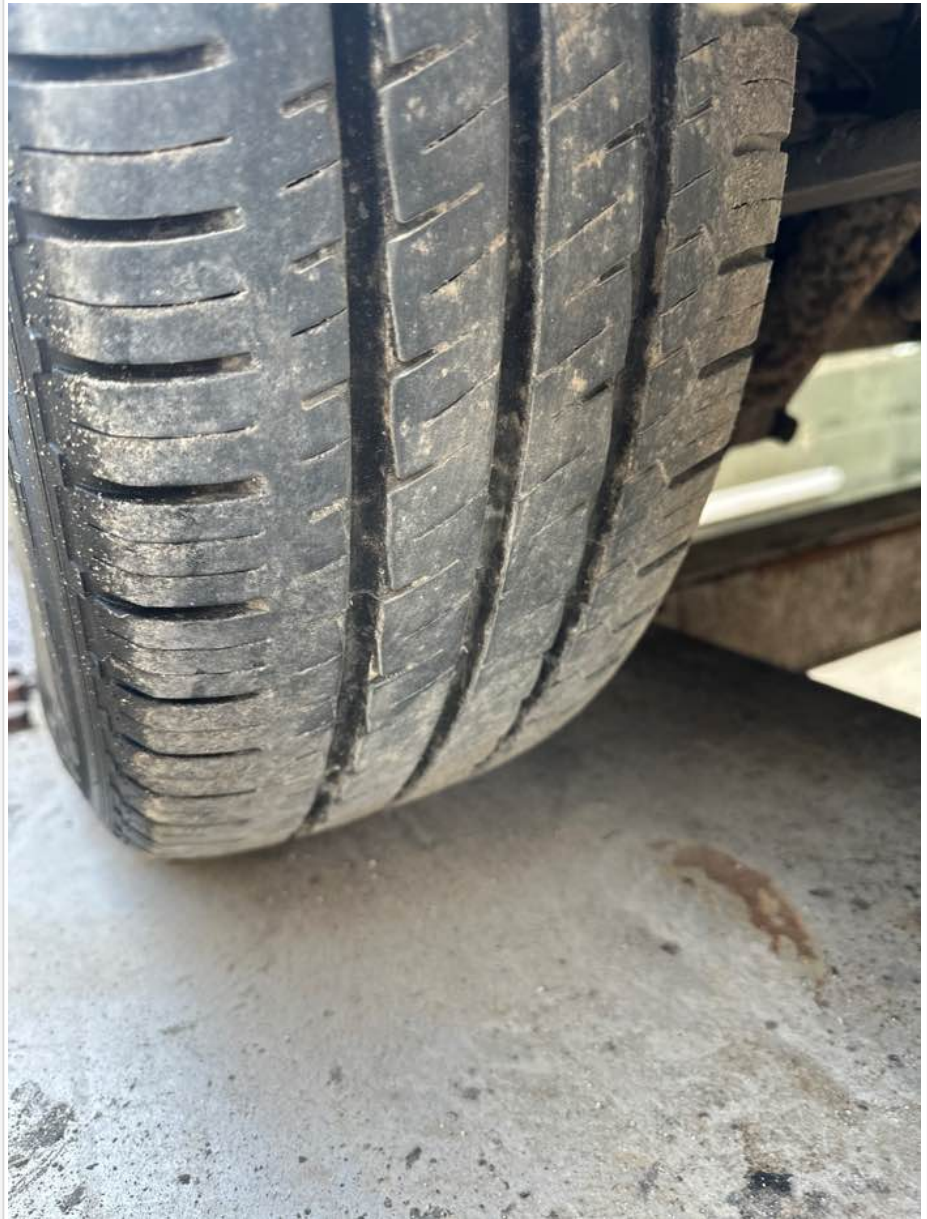
Off side rear

Age (month/year) Manufactured	32/20
Make, brand.	Hankook
Tyre size	225/65/R16
Pressure 1	50
Pressure 2	
Wearing / Perishing (inner)	Slight
Wearing / Perishing (outer)	Slight
tread depth (mm)	7
General comments

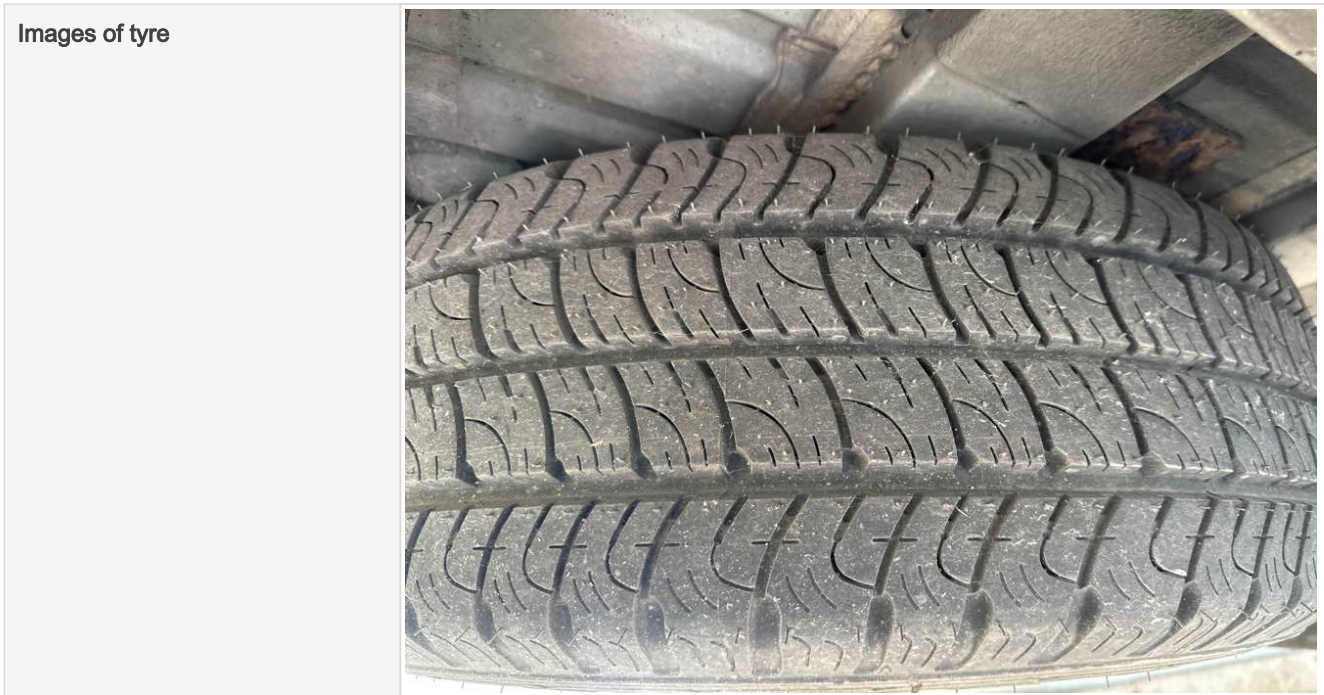
Spare wheel

Spare installed? (if no, don't fill out)	Yes
Age (month/year) Manufactured	50/10
Make, brand.	Good Year
Tyre size	225/65/R16
Pressure 1	30
Pressure 2	
Wearing / Perishing (inner)	none
Wearing / Perishing (outer)	None
tread depth (mm)	10
General comments

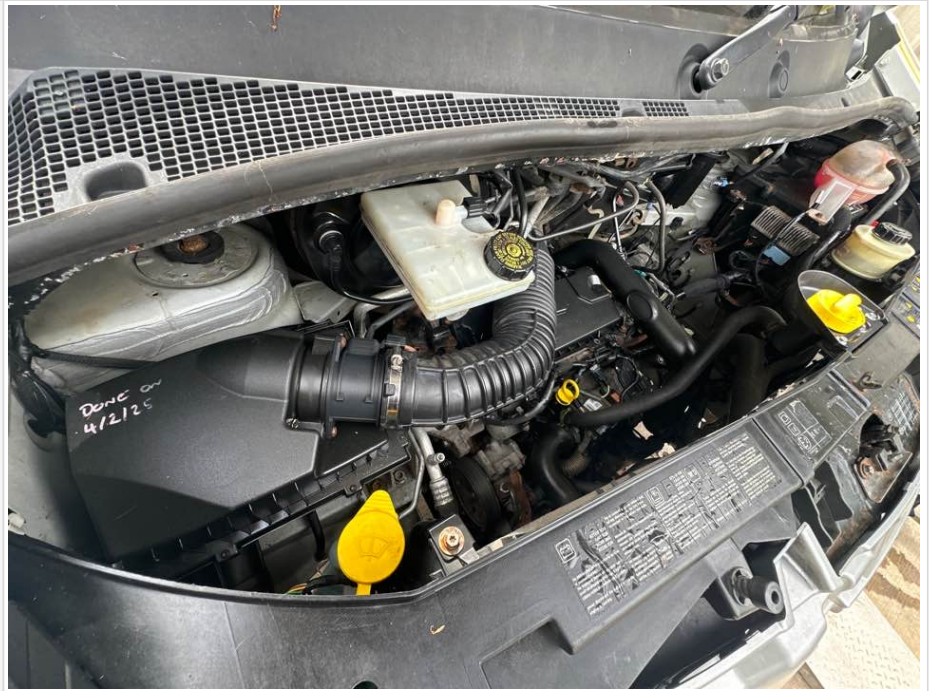
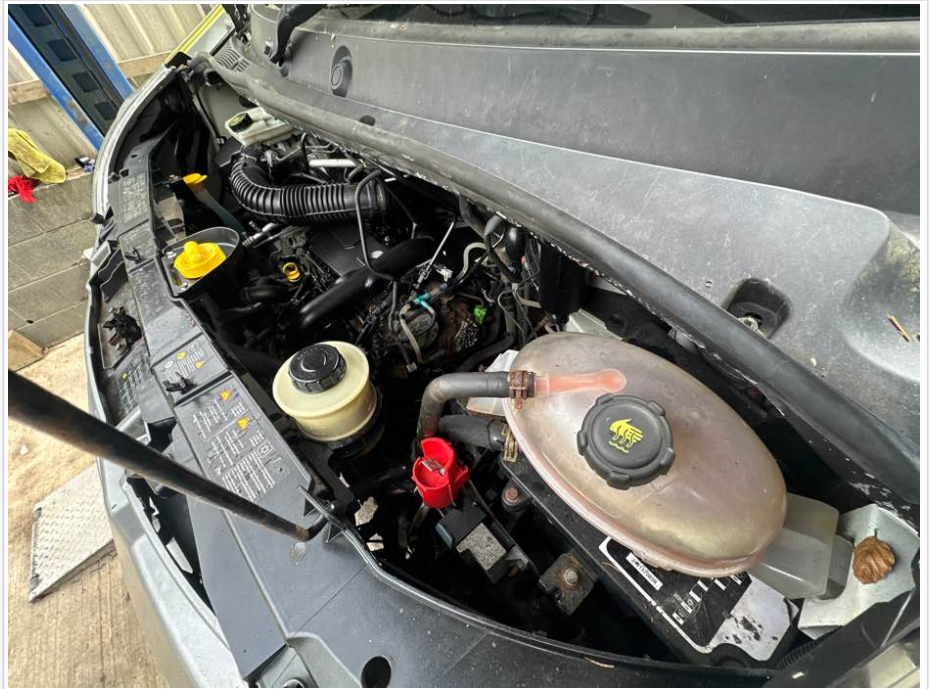
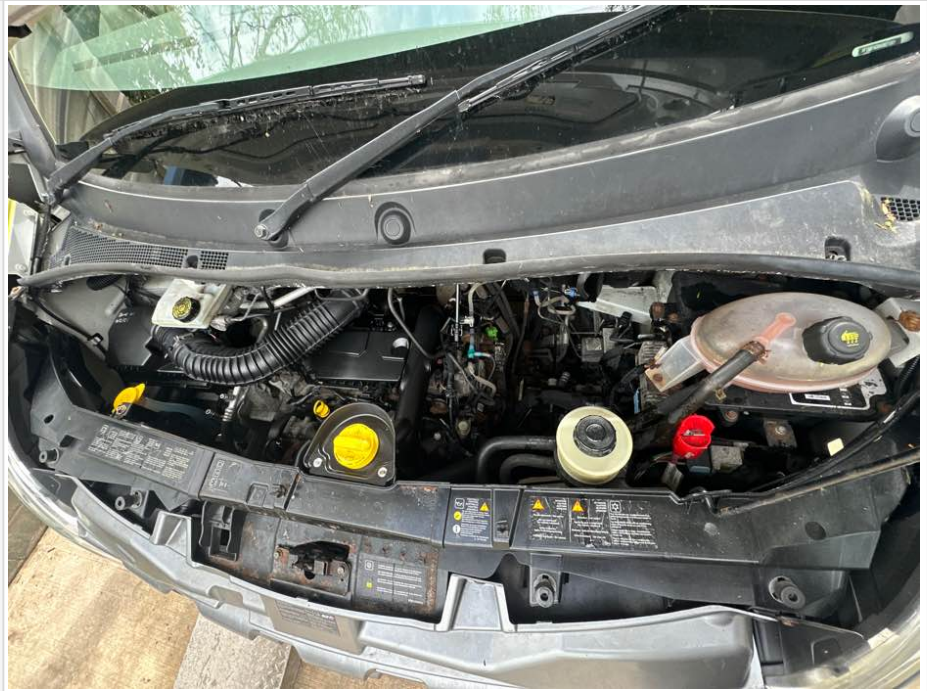
Engine bay photo

Fuel level	Full
Oil level	Full
Oil condition	Clean
Start up, chassis battery check	Started, but required boost pack
Start-up from cold	2 seconds
Exhaust smoke from cold	Normal
Output Voltage of Alternator test	14.1
Chain or Belt driven engine?	Chain
If belt any proof of change?	
Coolant condition	Dirty, Clean
Coolant level	Full
Anti-freeze temperature check	-23
Washer fluid	Full
Brake fluid	Full
Power steering fluid	Maximum
Dashboard warning light	No warning lights
OBD Scan results
