## Basevan.com General Inspection

Vehicle registration	WJ19YDV
Vehicle chassis no.	ZFA25000002J91634
Miles (if in km, multiply by 0.62)	212299
Make	Fiat
Model	Ducato
Transmission	Manual, 6 speed
Factory immobiliser installed	Yes
Speed limiter installed	N/A
Drive configuration	FWD
Gross Vehicle Weight (kg)	4250
Towing capacity	2250
Tow bar installed	No

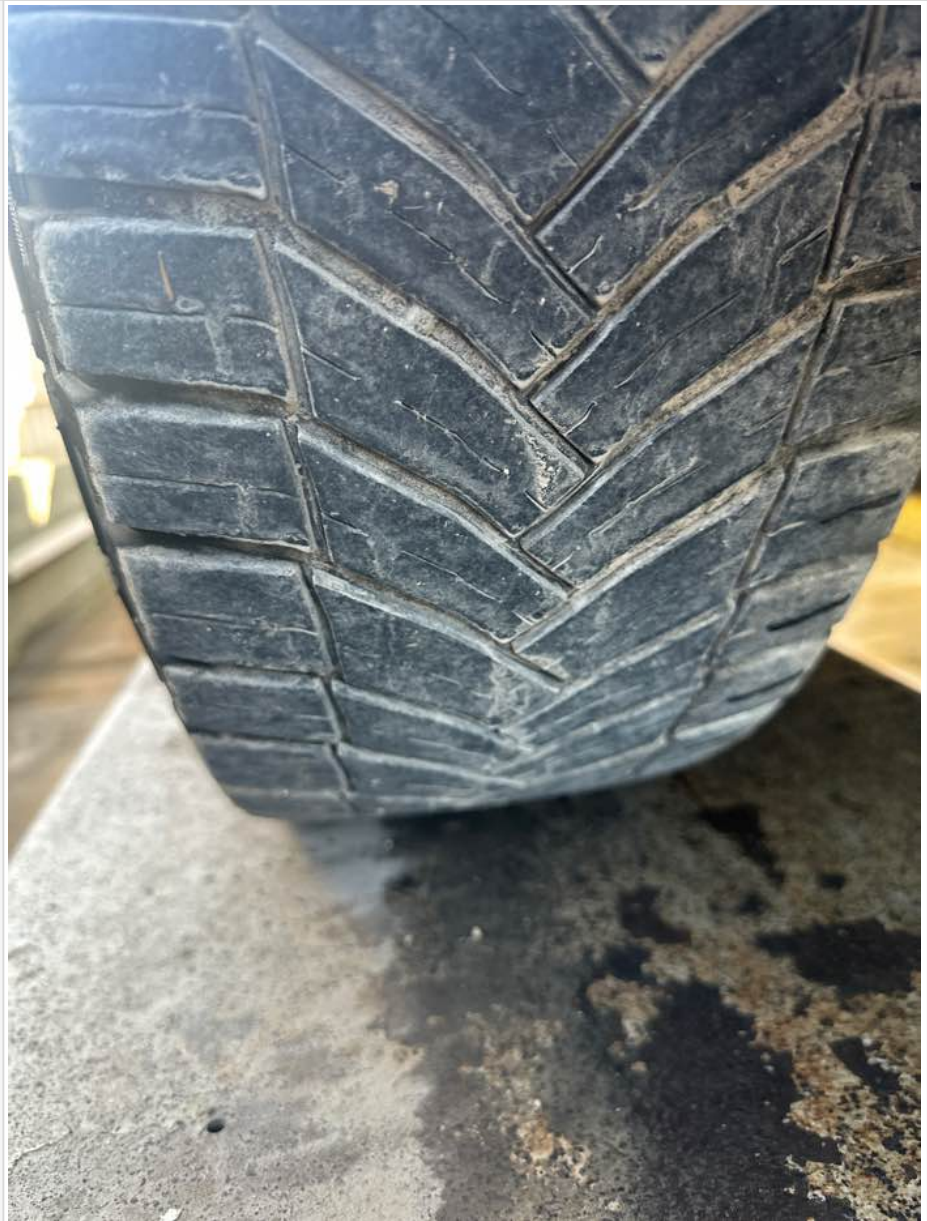
### Off side front

Age (month/year) Manufactured	19/24
Make, brand.	Michelin
Tyre size	225/75/R16
Pressure 1	68
Pressure 2	
Wearing / Perishing (inner)	Medium
Wearing / Perishing (outer)	Medium
tread depth (mm)	4
General comments

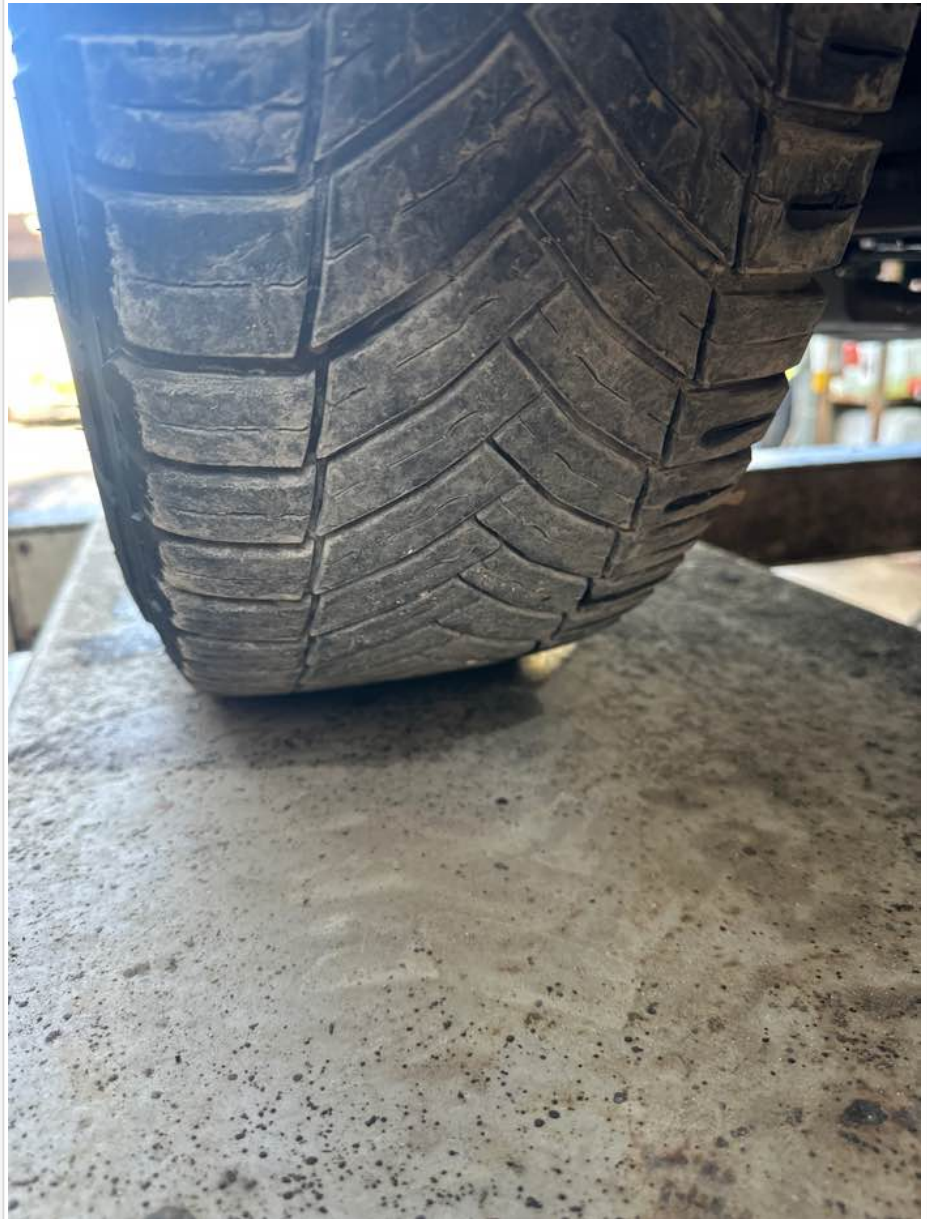
### Near side front

Age (month/year) Manufactured	19/24
Make, brand.	Michelin
Tyre size	225/75/R16
Pressure 1	68
Pressure 2	
Wearing / Perishing (inner)	Medium
Wearing / Perishing (outer)	Medium
tread depth (mm)	5
General comments

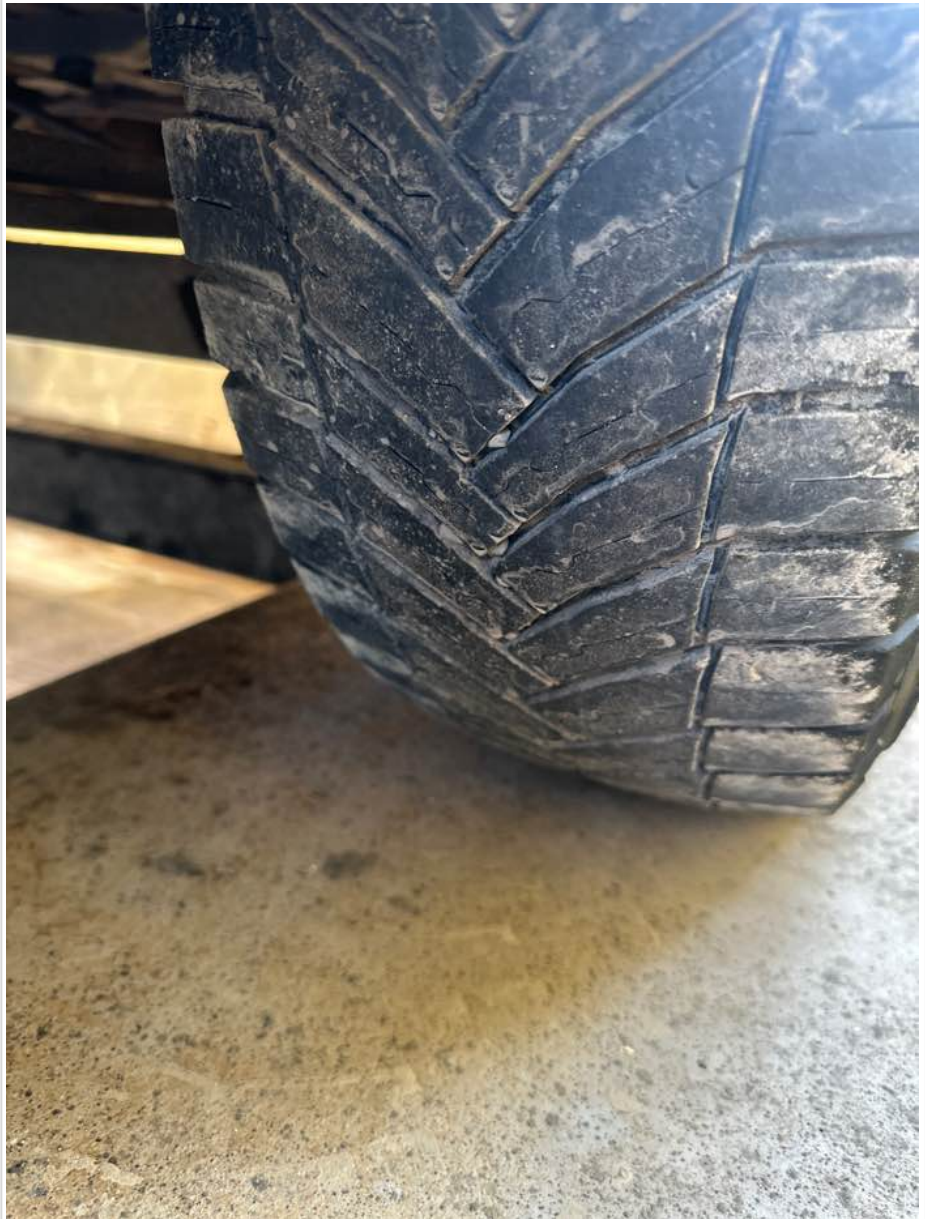
### near side rear

Age (month/year) Manufactured	25/23
Make, brand.	Michelin
Tyre size	225/75/R16
Pressure 1	78
Pressure 2	
Wearing / Perishing (inner)	Slight
Wearing / Perishing (outer)	Slight
tread depth (mm)	7
General comments

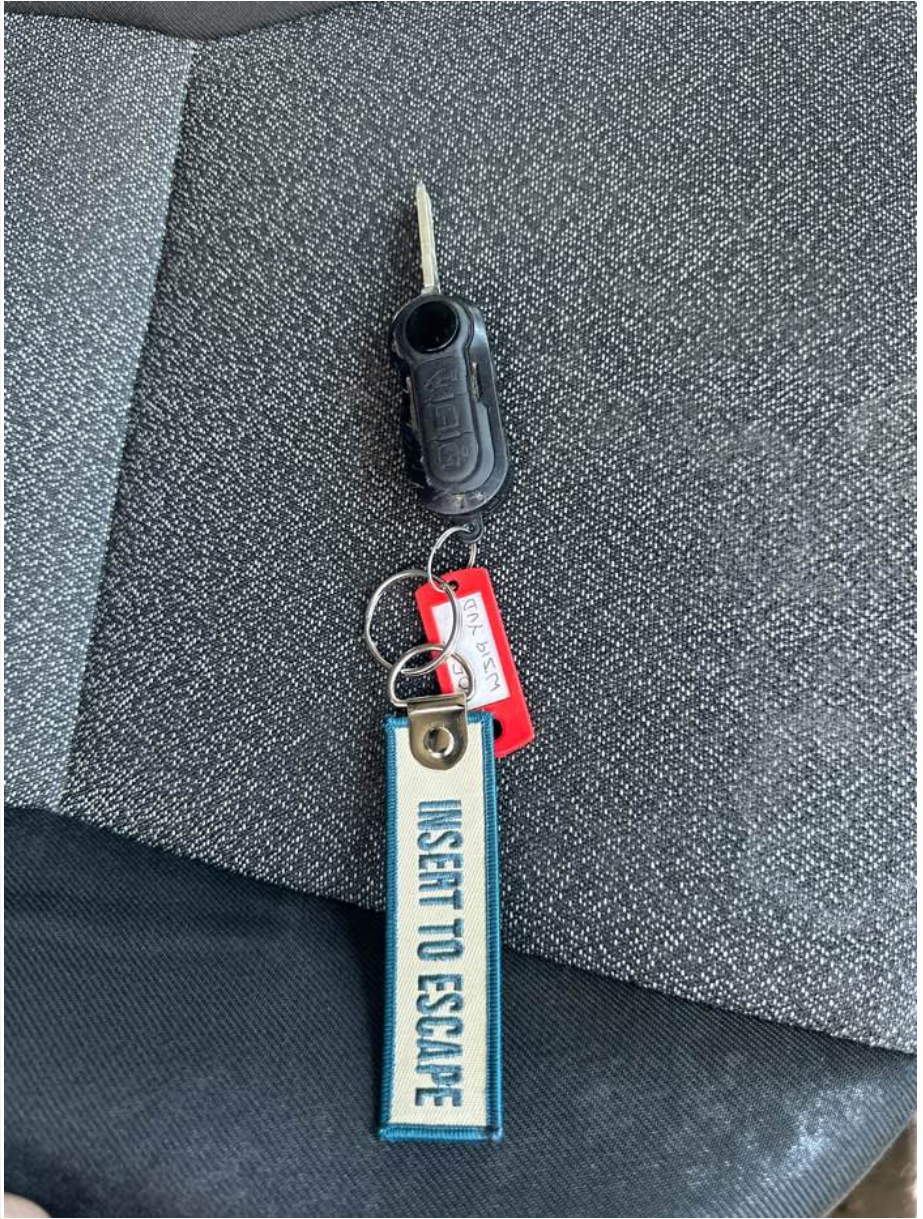
Factory central locking fitted?	Yes
Response from key fob?	No
Response from in-cab locking button?	Yes
Do all the doors lock from central locking function?	None

Select the following doors that lock.	O/S Front
Method of locking	Key
In conclusion can all the doors be locked in some way and thus the vehicle can be left unattended at night safely?	No
How many keys present at time of inspection?

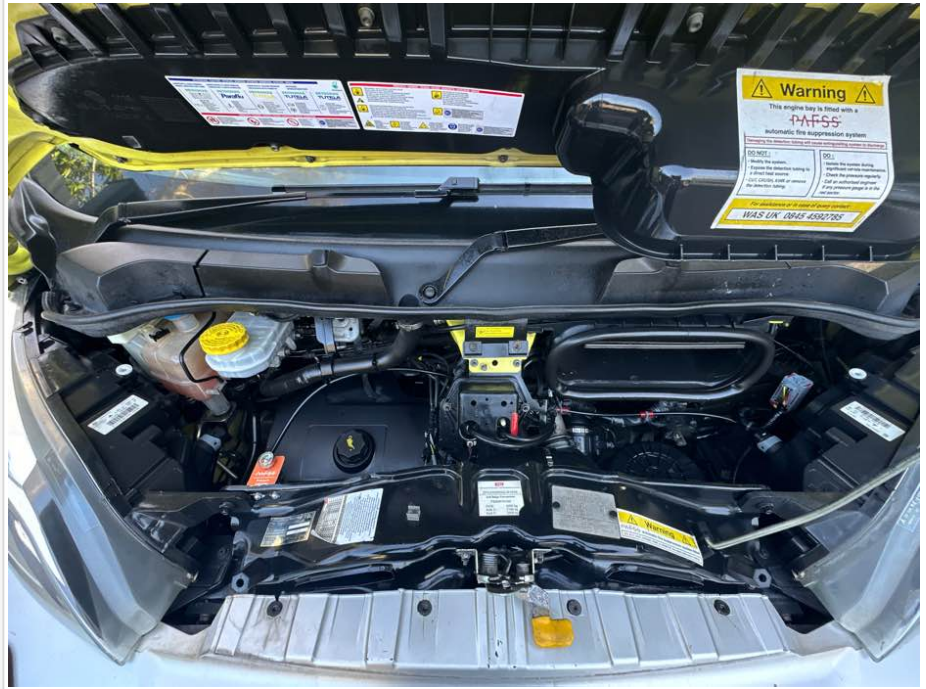
### Engine bay photo

Fuel level	1/2 Full
Oil level	Medium
Oil conditon	Service due soon
Start up, chassis battery check	Started without jump pack
Start-up from cold	3 seconds
Exhaust smoke from cold	Normal
Output Voltage of Alternator test	14.1
Chain or Belt driven engine?	Belt
If belt any proof of change?	N/A
Coolant condition	Clean
Coolant level	Full
Anti-freeze temperature check	-17
Washer fluid	Full
Brake fluid	Full
Power steering fluid	Maximum
Dashboard warning light	No warning lights
OBD Scan results
