Inspection details

Vehicle registration	VX58CVN
Vehicle chassis no.	WBD9066552S269892
Miles (if in km, multiply by 0.62)	87026
Make	Mercedes
Model	Sprinter
Transmission	Manual, 6 speed
Factory immobiliser installed	Yes
Speed limiter installed	N/A
Drive configuration	RWD
Gross Vehicle Weight (kg)	5000
Towing capacity	2000
Tow bar installed	No

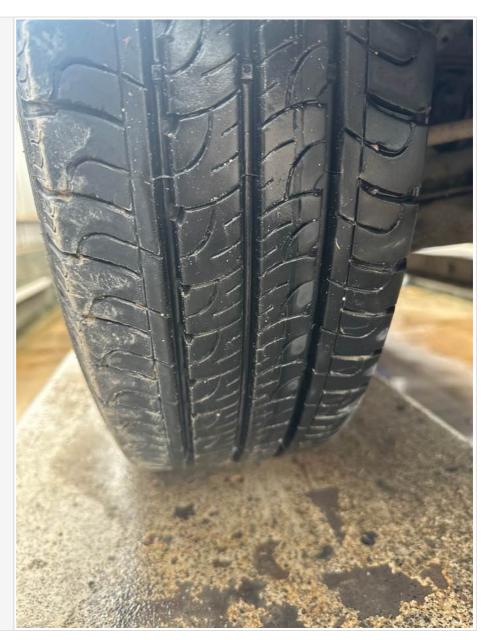
Off side front

Age (month/year) Manufactured	39/21
Make, brand.	Good Year
Tyre size	205/75/R16
Pressure 1	60
Pressure 2	
Wearing / Perishing (inner)	none
Wearing / Perishing (outer)	None
tread depth (mm)	8
General comments

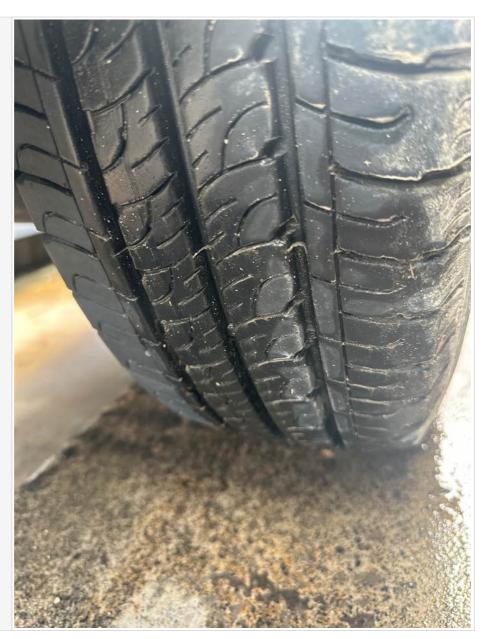
Near side front

Age (month/year) Manufactured	04/21
Make, brand.	Good Year
Tyre size	
Pressure 1	55
Pressure 2	
Wearing / Perishing (inner)	none
Wearing / Perishing (outer)	None
tread depth (mm)	8
General comments

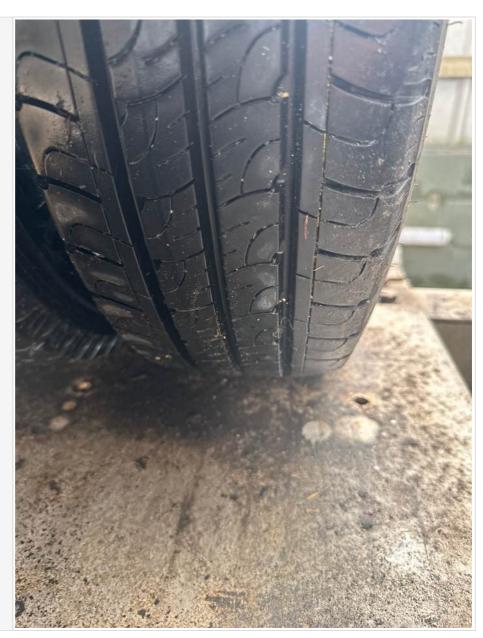
near side rear

Age (month/year) Manufactured	03/23
Make, brand.	Good Year
Tyre size	205/75/R16
Pressure 1	54
Pressure 2	
Wearing / Perishing (inner)	none
Wearing / Perishing (outer)	None
tread depth (mm)	8
General comments

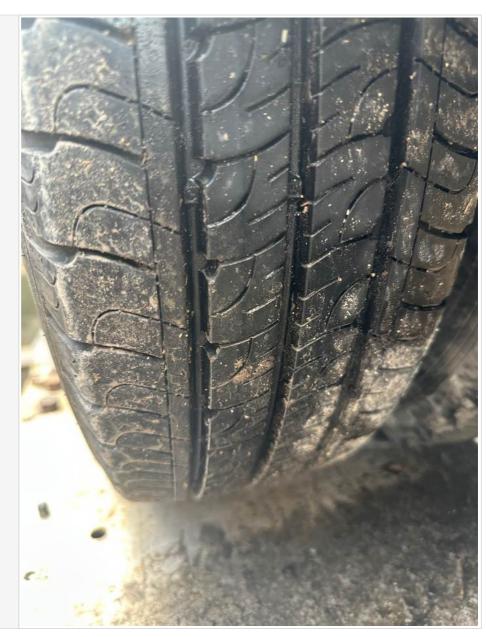
Off side rear

Age (month/year) Manufactured	03/23
Make, brand.	Good Year
Tyre size	205/75/R16
Pressure 1	56
Pressure 2	
Wearing / Perishing (inner)	none
Wearing / Perishing (outer)	None
tread depth (mm)	9
General comments

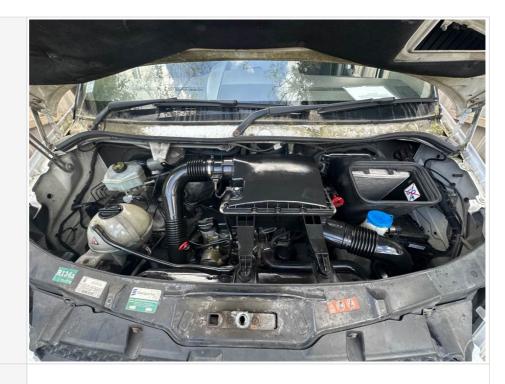
Engine bay photo

Fuel level	1/2 Full	
Oil level	Full	
Oil conditon	Clean	
Start up, chassis battery check	Started without jump pack	
Start-up from cold	3 seconds	
Exhaust smoke from cold	Normal	
Output Voltage of Alternator test	14.1	
Chain or Belt driven engine?	Chain	
If belt any proof of change?		
Coolant condition	Clean	
Coolant level	Full	
Anti-freeze temperature check	-23	
Washer fluid	Full	
Brake fluid	Full	
Power steering fluid	Maximum	
Dashboard warning light	No warning lights	
OBD Scan results
