Basevan.com General Inspection

Vehicle registration	YX15DXD
Vehicle chassis no.	ZFA25000002672019
Miles (if in km, multiply by 0.62)	82,369
Make	FIAT
Model	DUCATO
Transmission	Manual, 6 speed
Factory immobiliser installed	Yes
Speed limiter installed	No
Drive configuration	FWD
Gross Vehicle Weight (kg)	4200
Towing capacity	
Tow bar installed	No

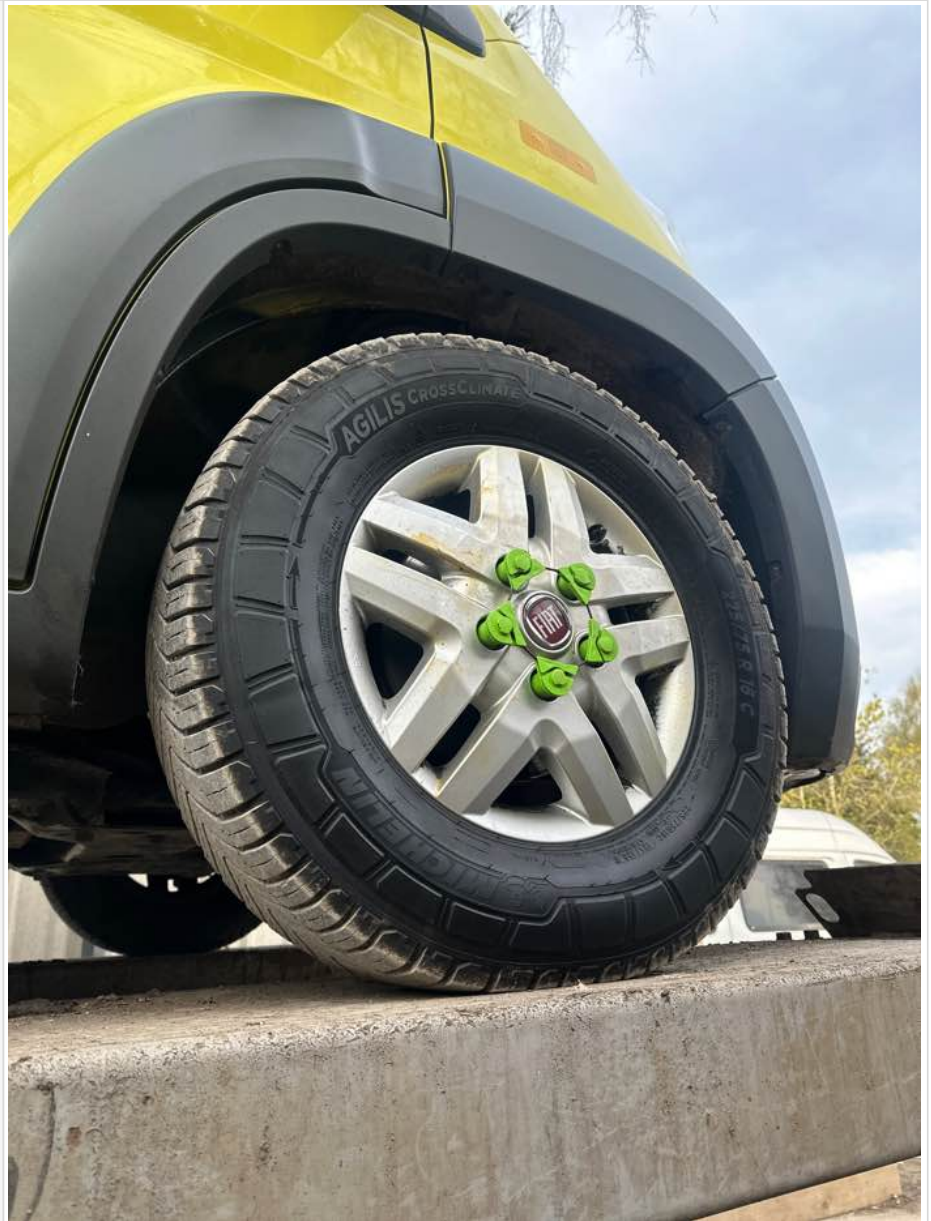
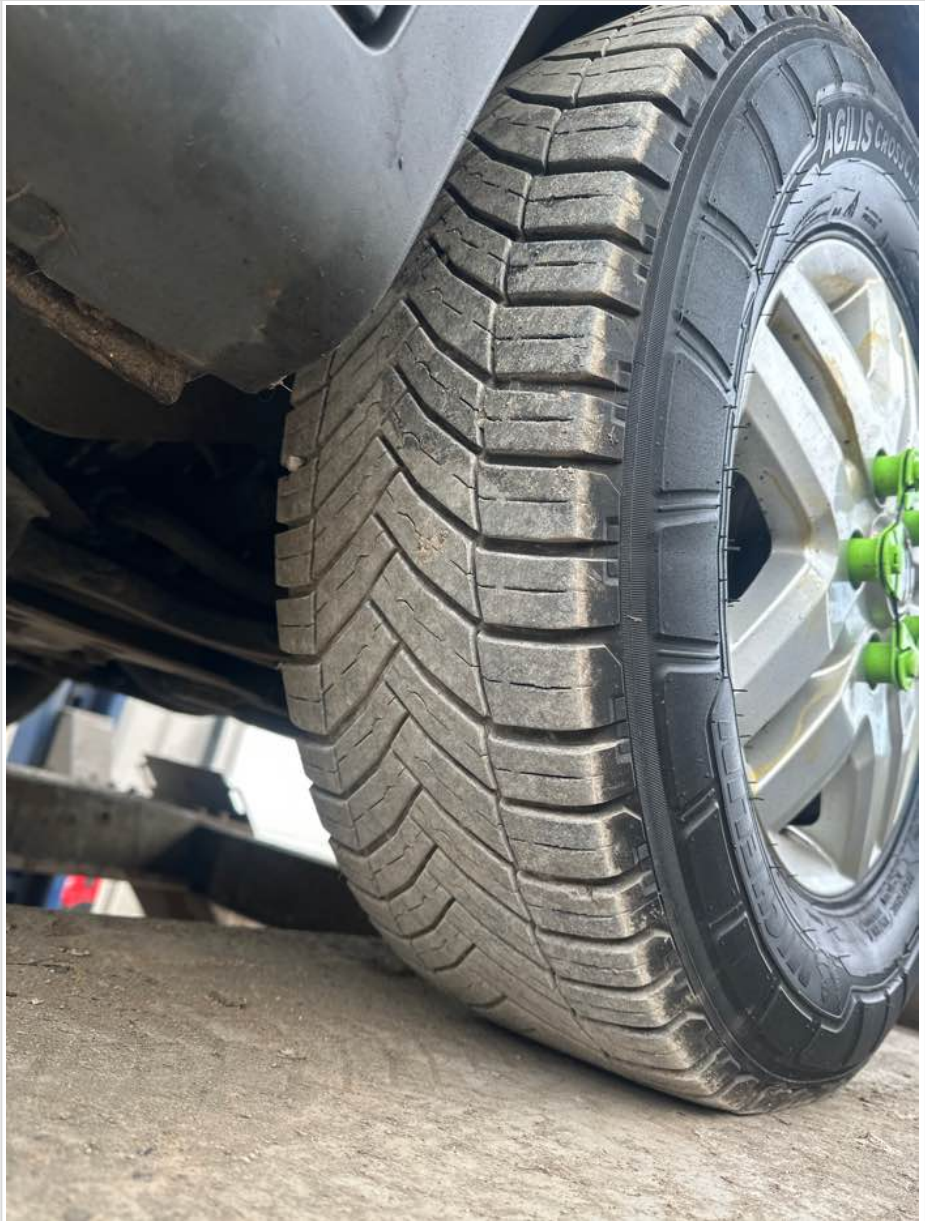
Off side front

Age (month/year) Manufactured	19/24
Make, brand.	Michelin
Tyre size	225/75/R16
Pressure 1	
Pressure 2	
Wearing / Perishing (inner)	none
Wearing / Perishing (outer)	None
tread depth (mm)	6
General comments	good recent tyre

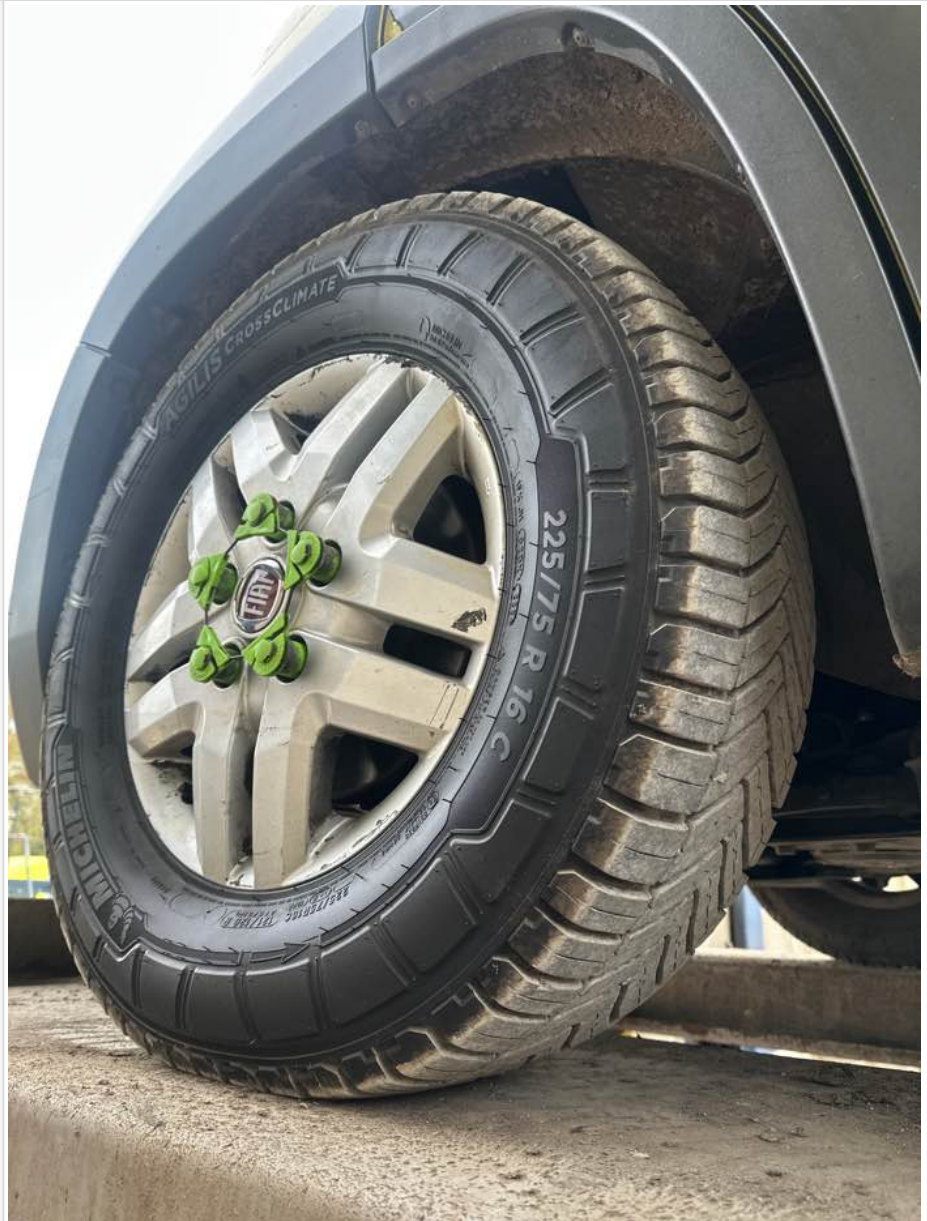
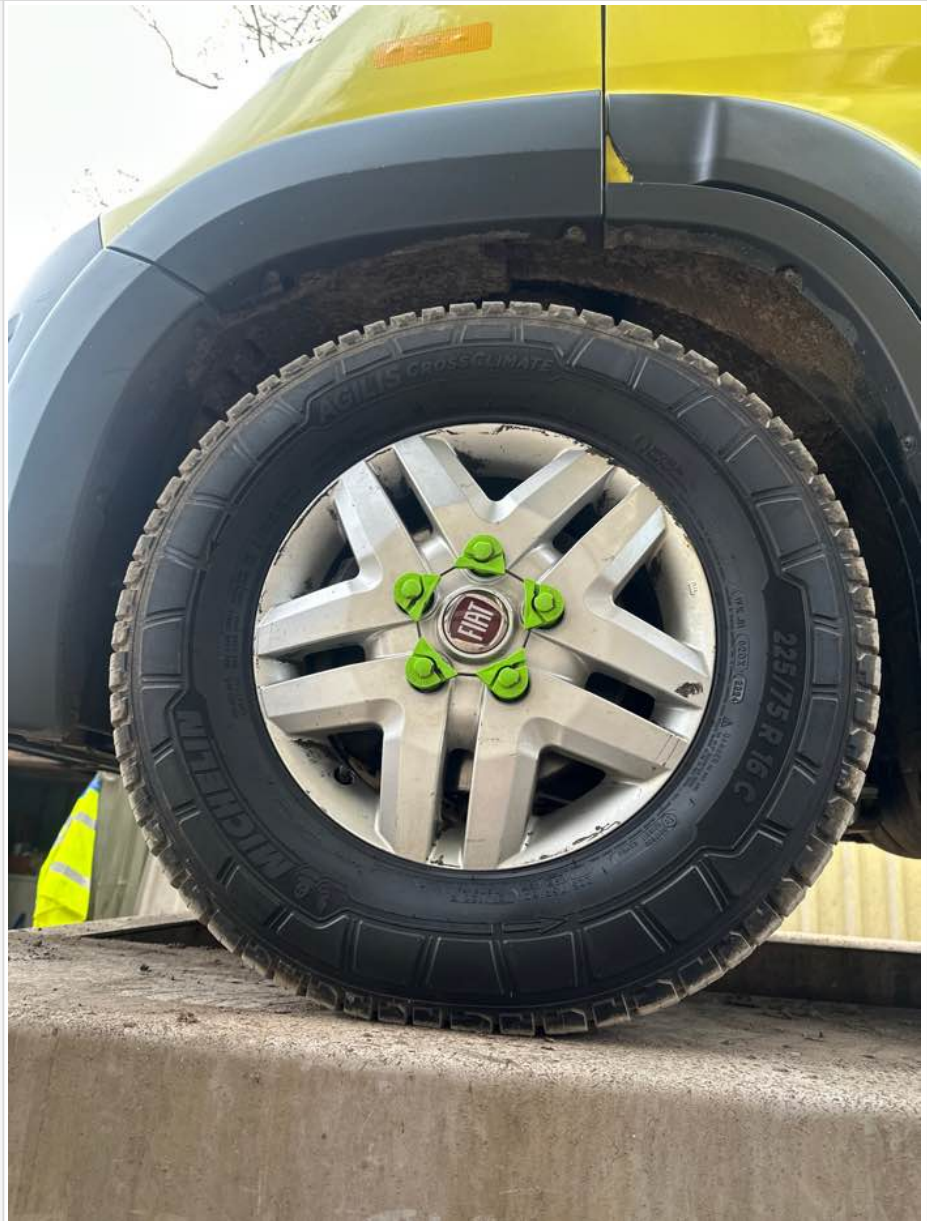
Near side front

Age (month/year) Manufactured	22/24
Make, brand.	Michelin
Tyre size	225/75/R16
Pressure 1	
Pressure 2	
Wearing / Perishing (inner)	none
Wearing / Perishing (outer)	None
tread depth (mm)	8
General comments	virtually new!

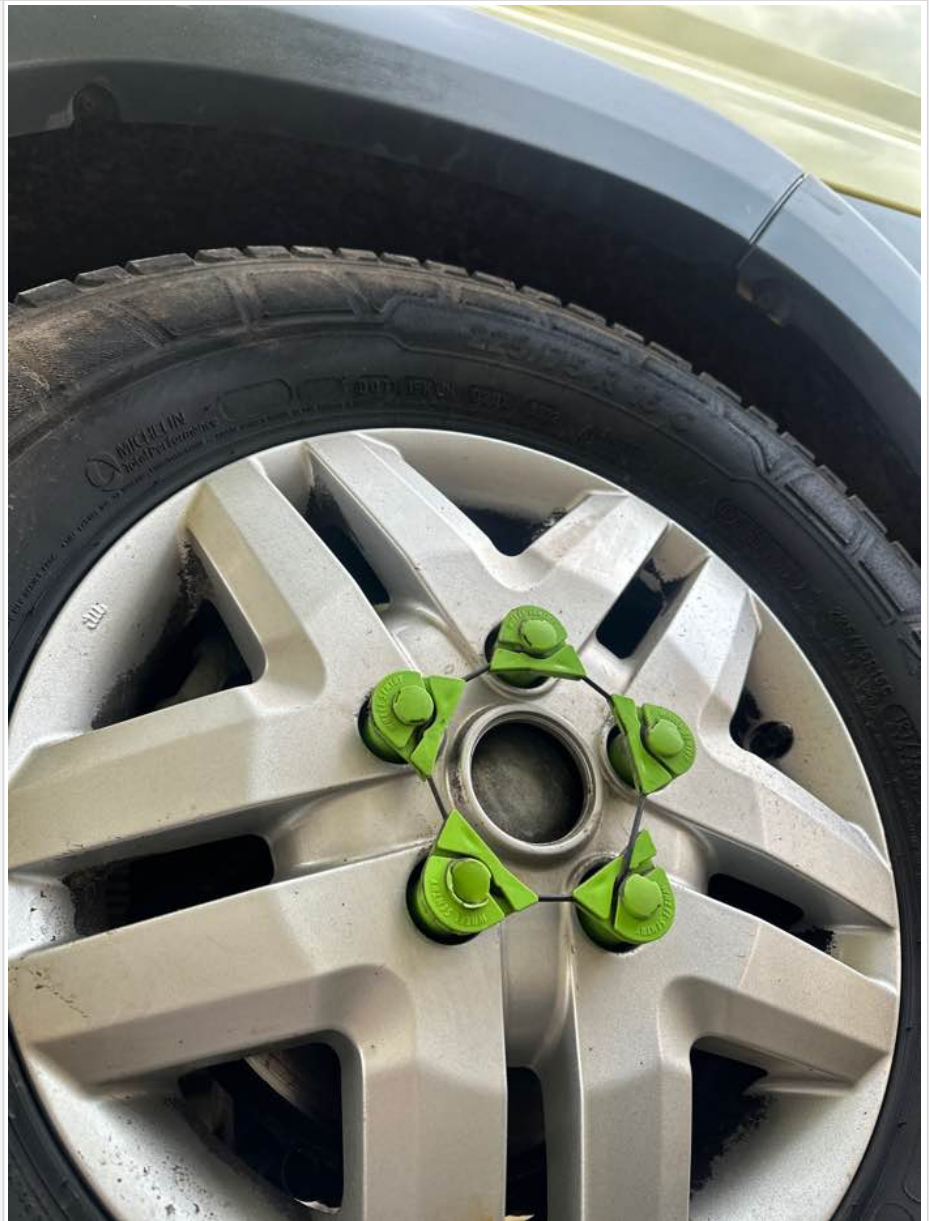
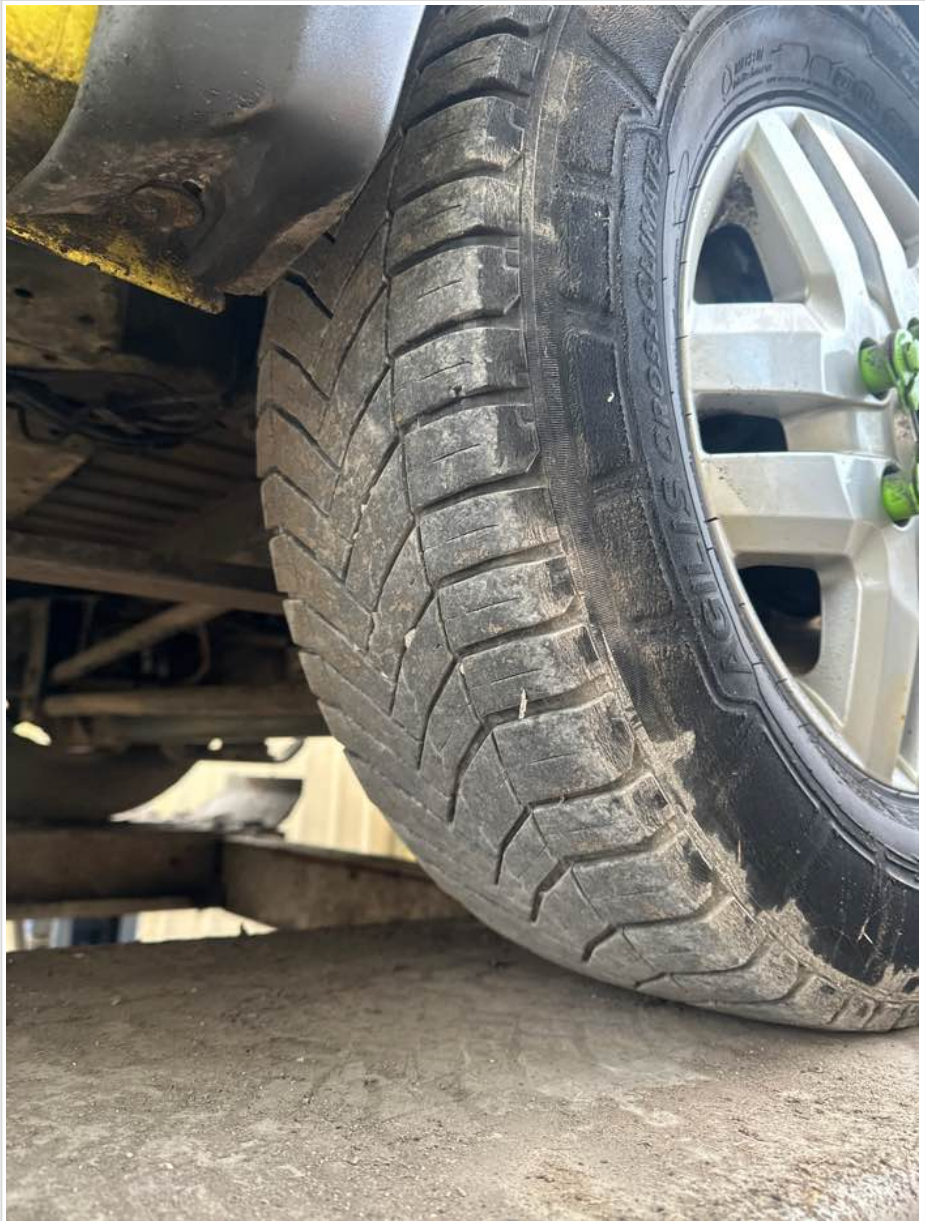
near side rear

Age (month/year) Manufactured	36/22
Make, brand.	Michelin
Tyre size	225/75/R16
Pressure 1	
Pressure 2	
Wearing / Perishing (inner)	none
Wearing / Perishing (outer)	Slight
tread depth (mm)	6
General comments	some kerb rashing outer shoulder

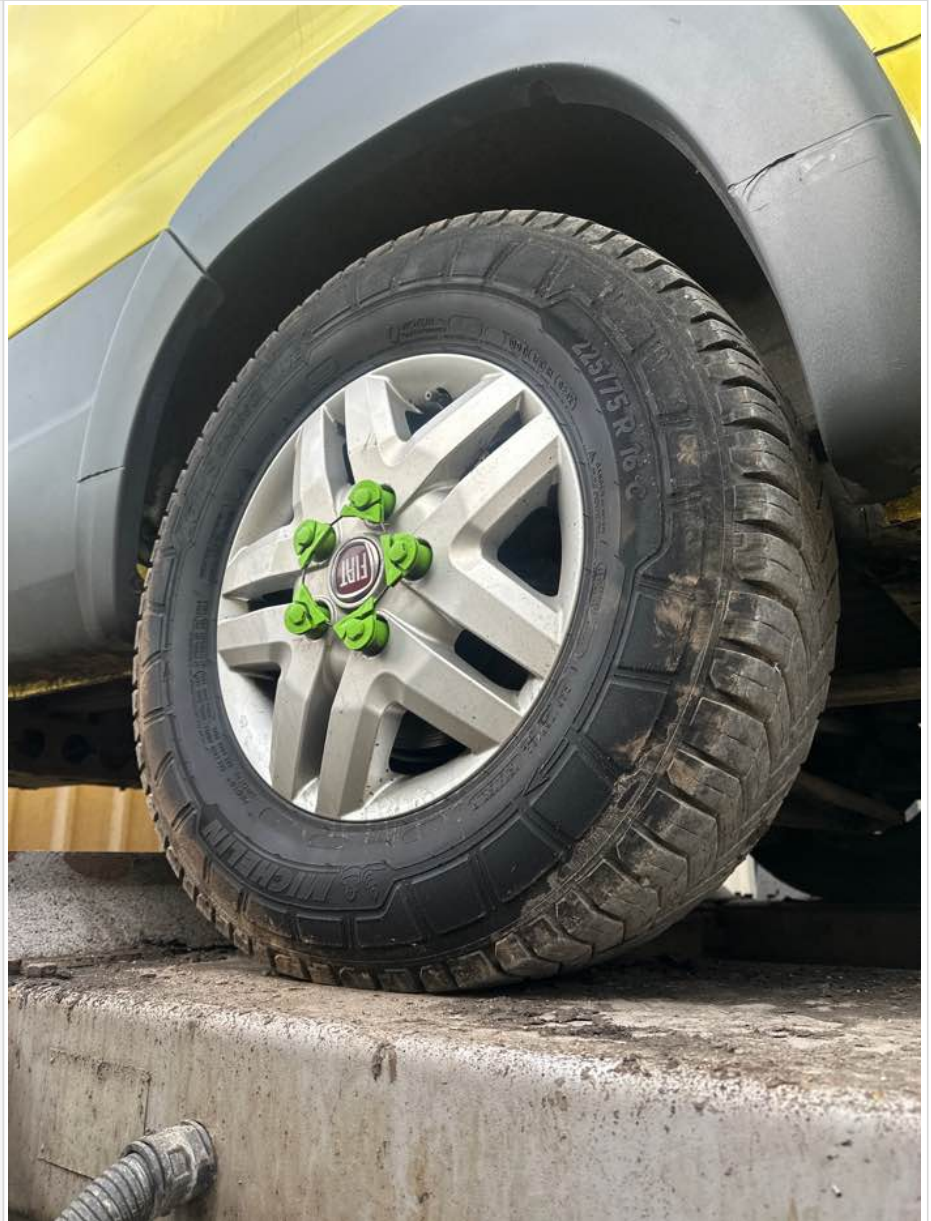
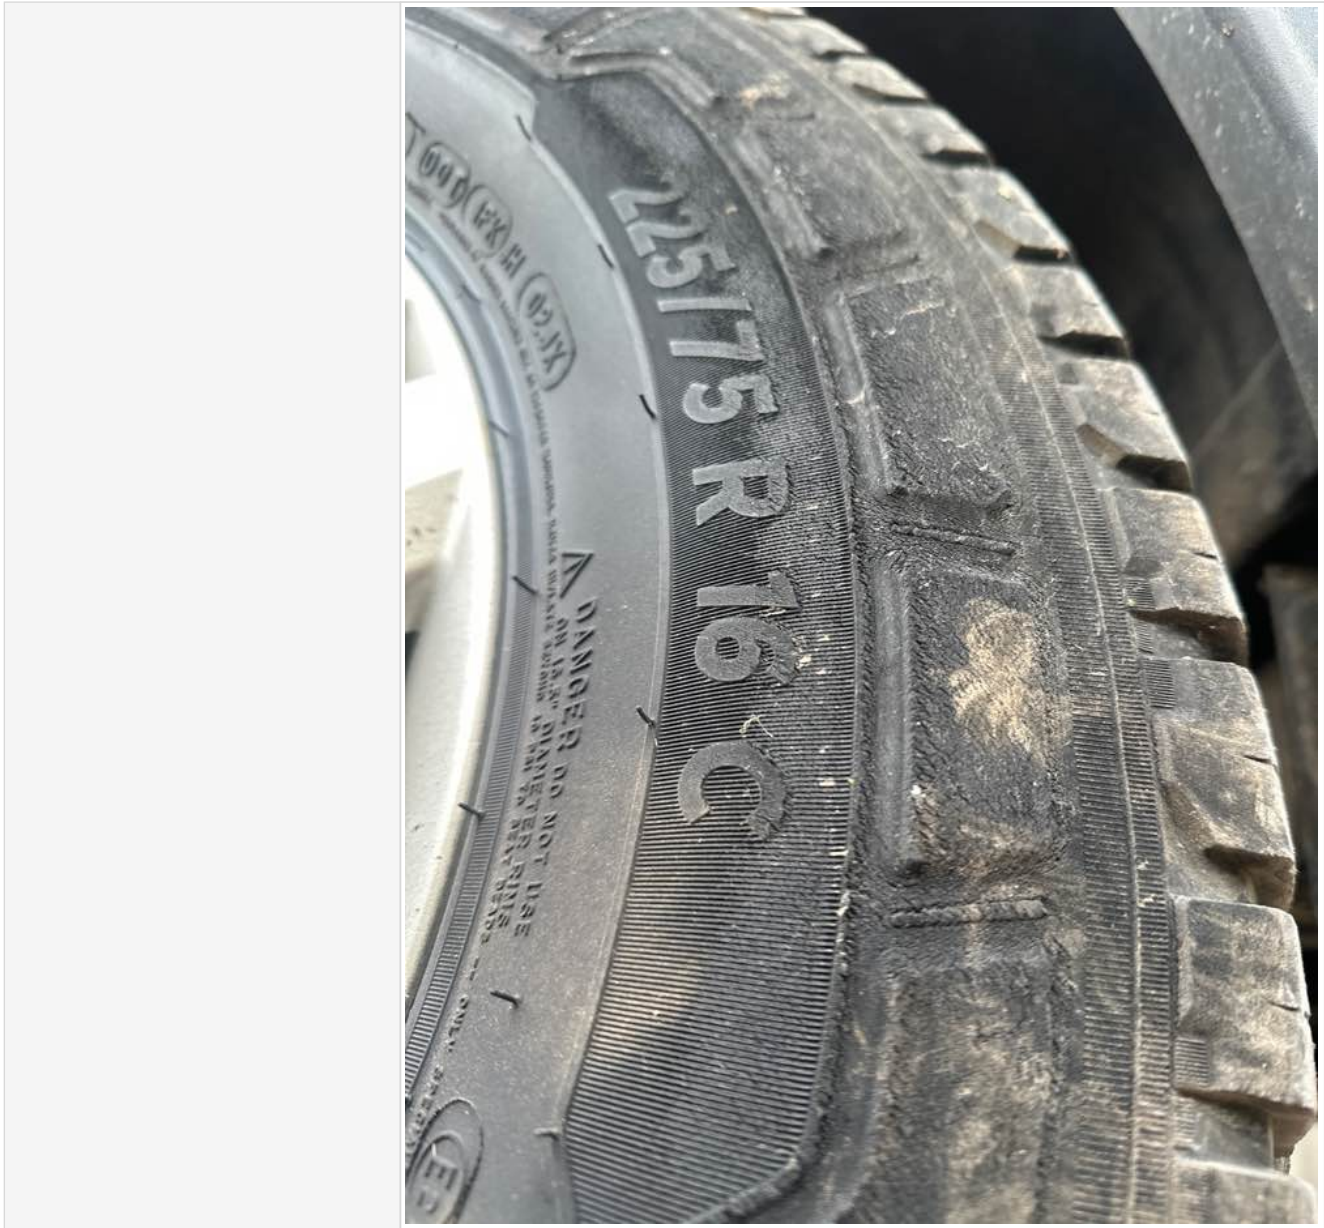
Off side rear

Age (month/year) Manufactured	09/23
Make, brand.	Michelin
Tyre size	225/75/R16
Pressure 1	
Pressure 2	
Wearing / Perishing (inner)	none
Wearing / Perishing (outer)	Slight
tread depth (mm)	5
General comments	some kerb rash outer

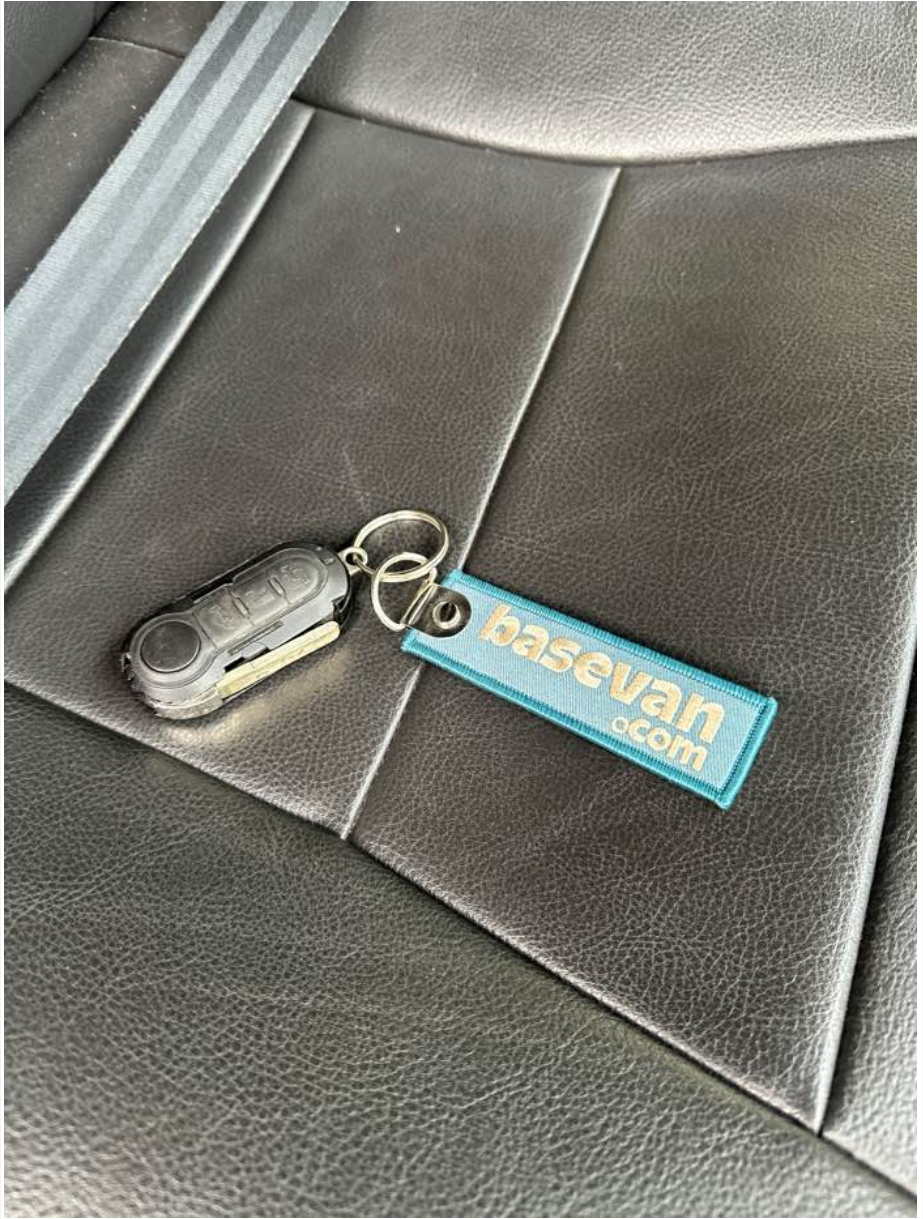
Comment	
	functions as should

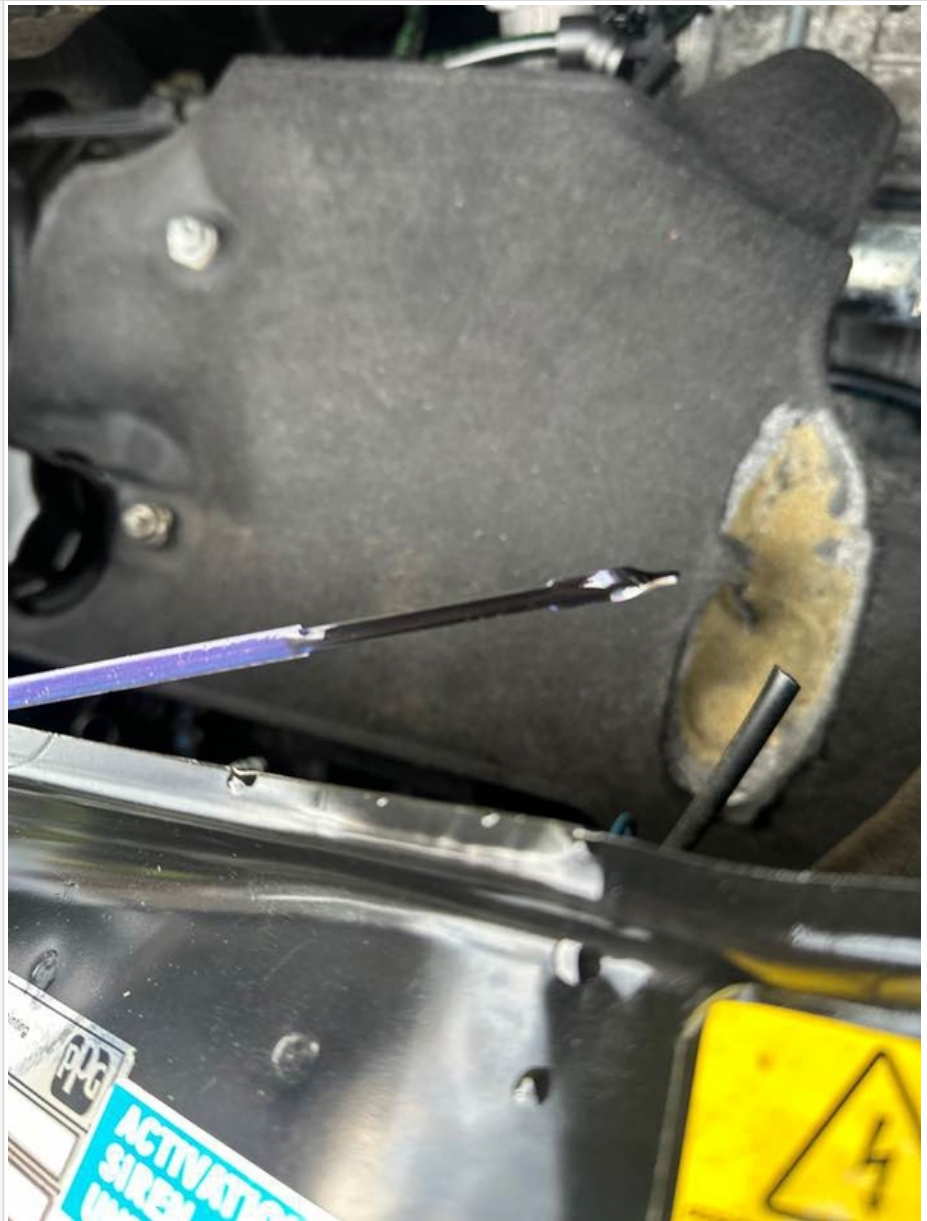
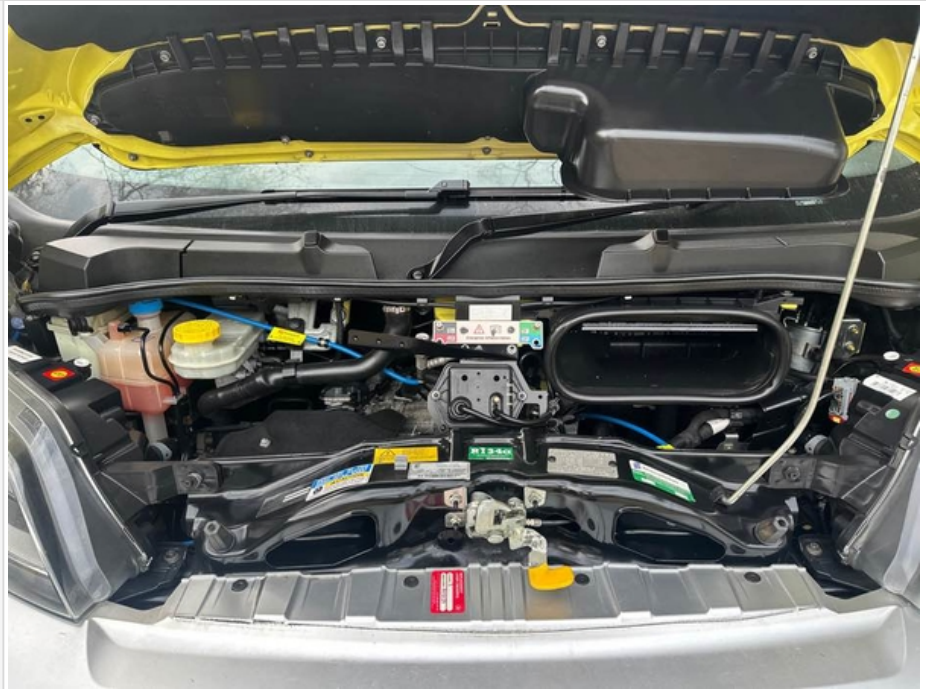
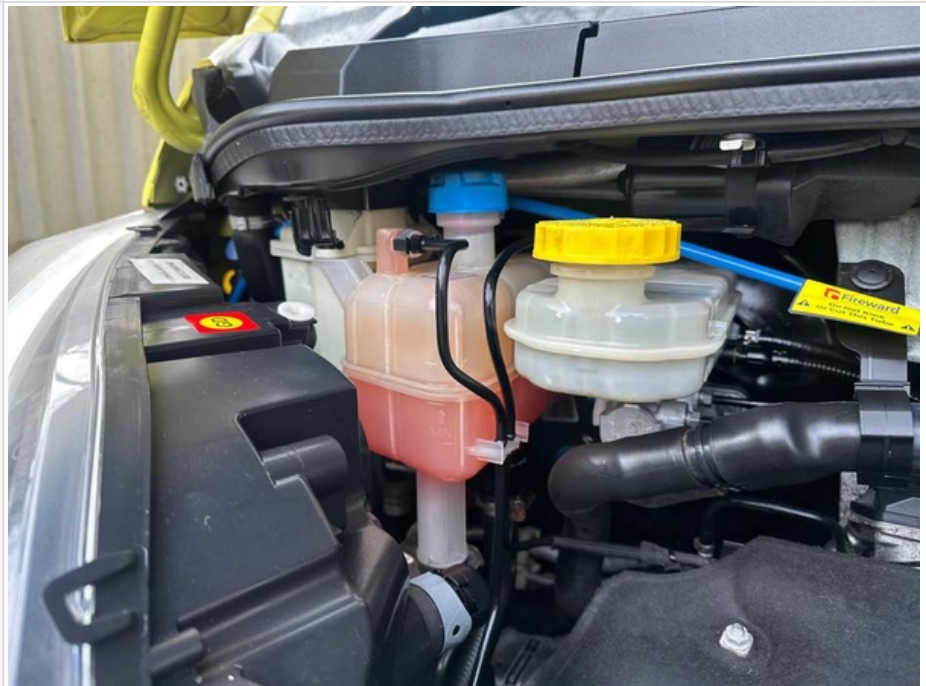
Engine bay photo

mechanically very good
