BaseVan Initial Inspection

Vehicle registration	NX16CUA
Vehicle chassis no.	
Miles (if in km, multiply by 0.62)	134608
Make	Vauxhall
Model	Movano
Transmission	Manual, 6 speed
Factory immobiliser installed	Yes
Speed limiter installed	No
Drive configuration	RWD
Gross vehicle weight	4600kg
Towing capacity	3000kg
Tow bar installed	No

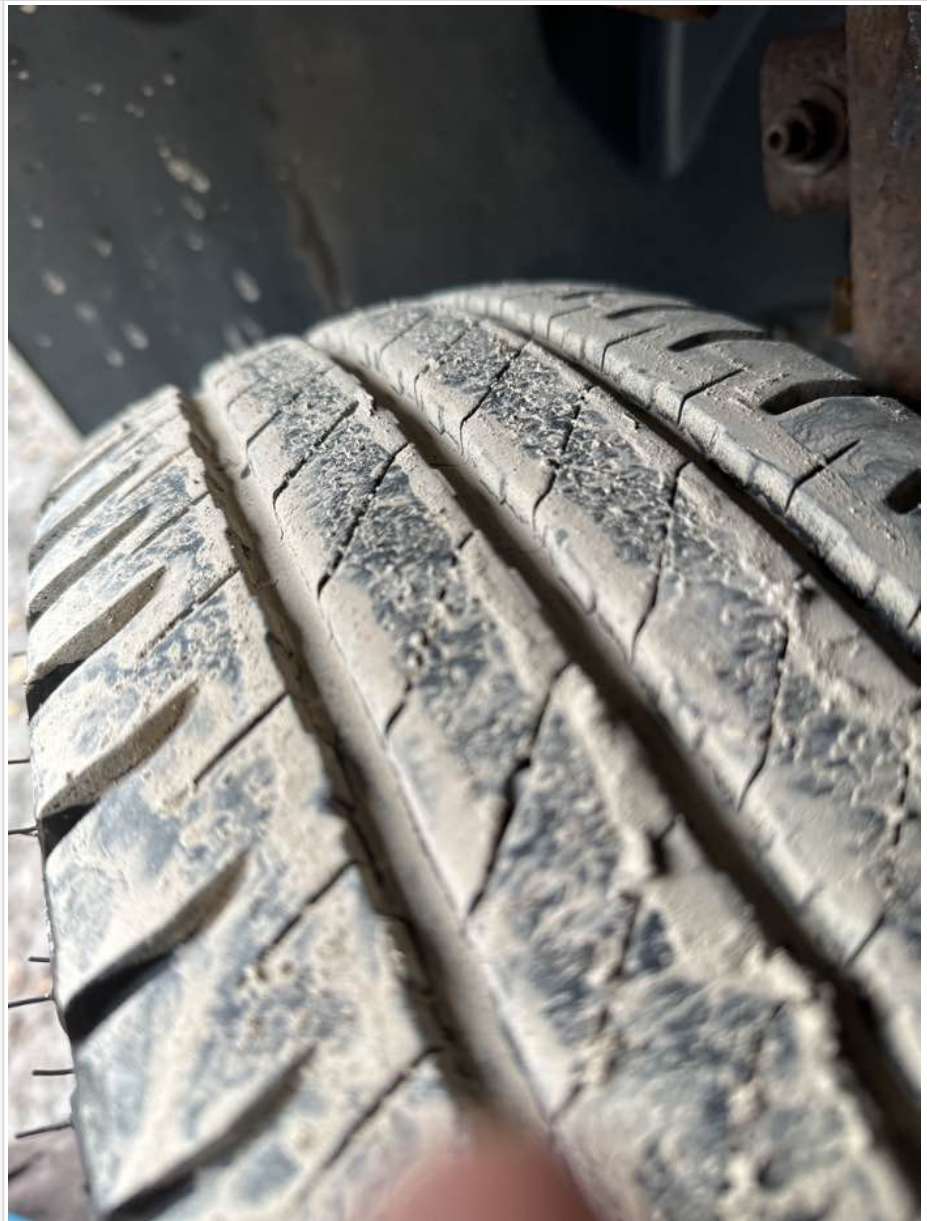
Off side front

Age (month/year) Manufactured	41/21
Make, brand.	Michelin
Tyre size	195/75/R16
Pressure 1	
Pressure 2	
Wearing / Perishing (inner)	none
Wearing / Perishing (outer)	None
tread depth (mm)	7
General comments	good tyre relatively new

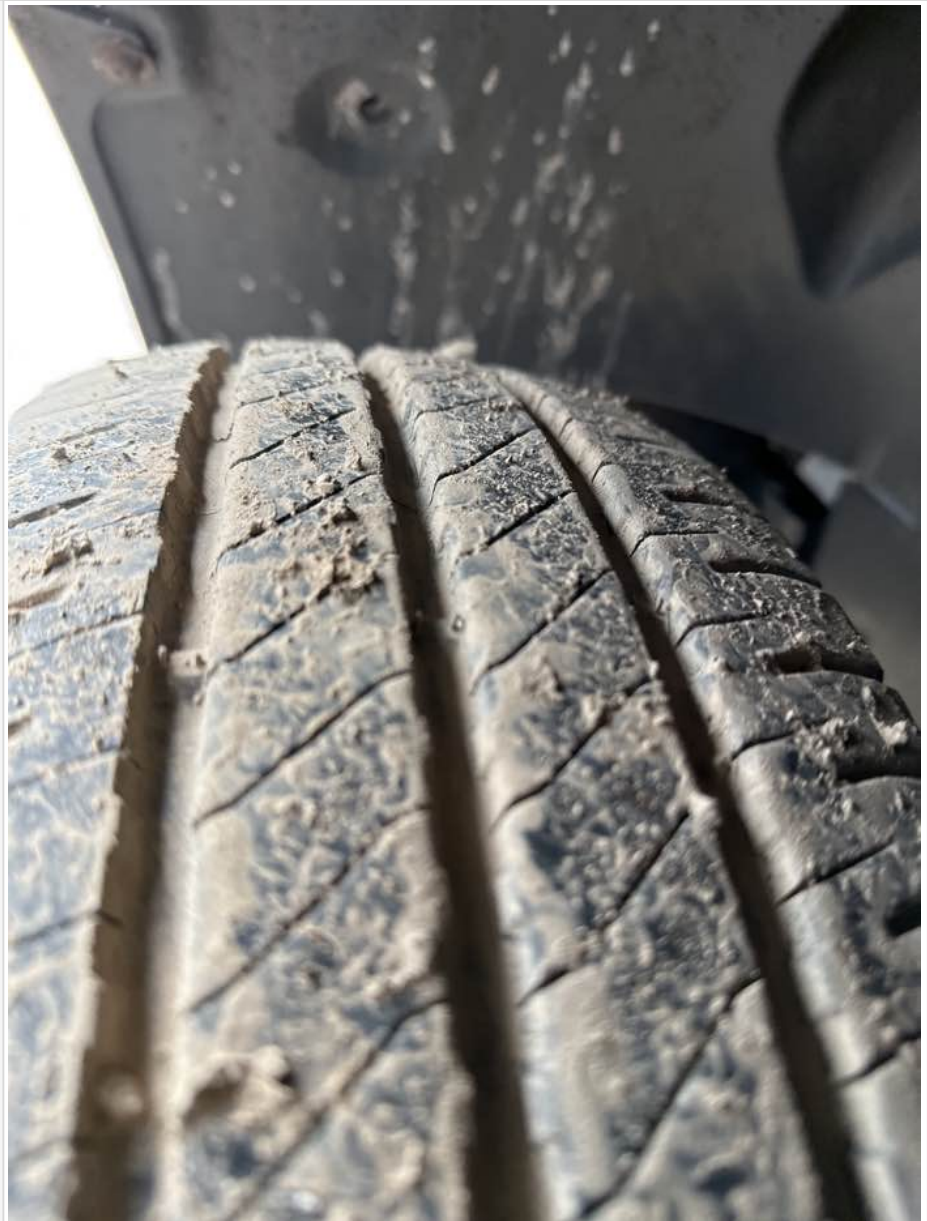
Near side front

Age (month/year) Manufactured	41/21
Make, brand.	Michelin
Tyre size	195/75/R16
Pressure 1	
Pressure 2	
Wearing / Perishing (inner)	none
Wearing / Perishing (outer)	None
tread depth (mm)	7
General comments	good tyre relatively new

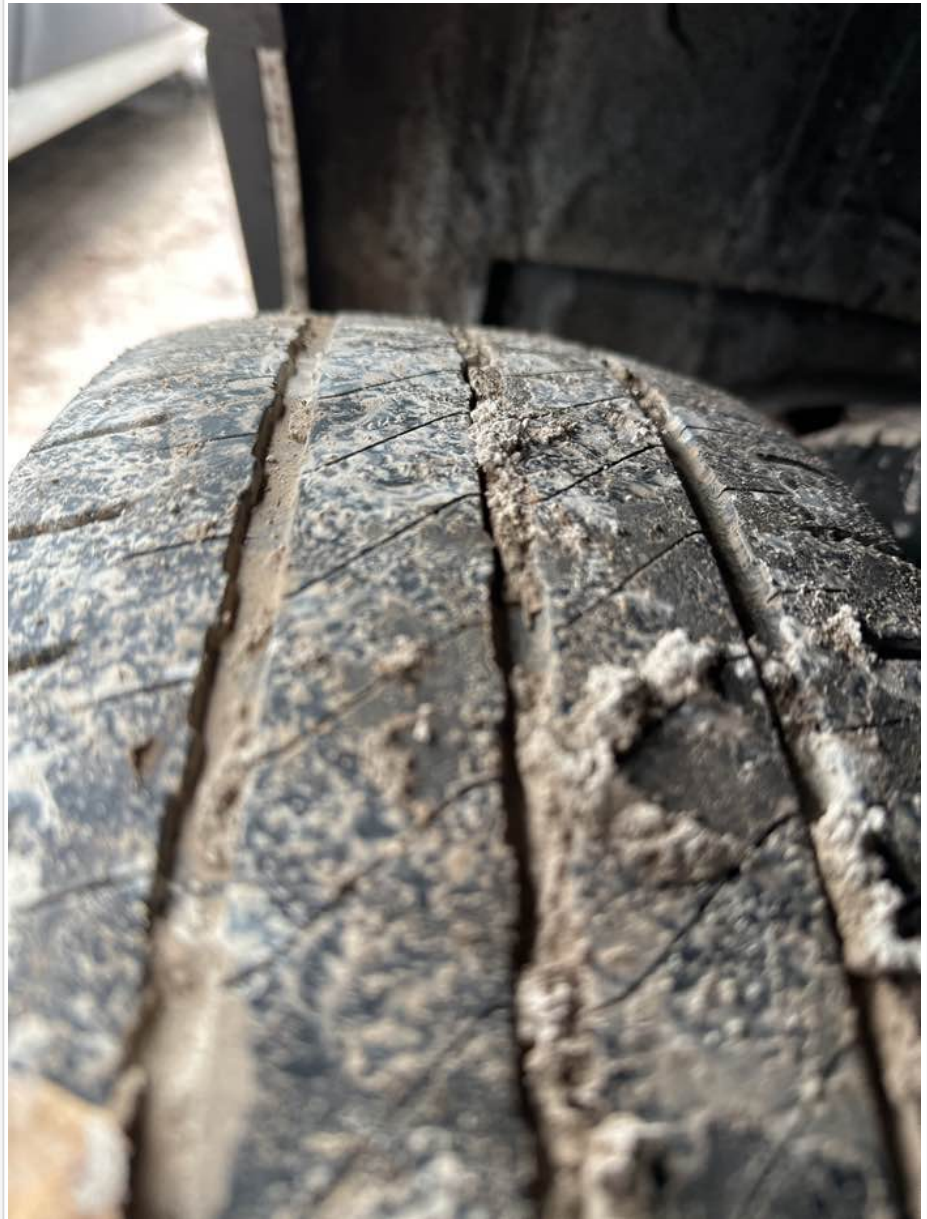
near side rear

Age (month/year) Manufactured	25/20
Make, brand.	Michelin
Tyre size	195/75/R16
Pressure 1	
Pressure 2	
Wearing / Perishing (inner)	none
Wearing / Perishing (outer)	None
tread depth (mm)	4
General comments	pretty good tyre some wear but good life left

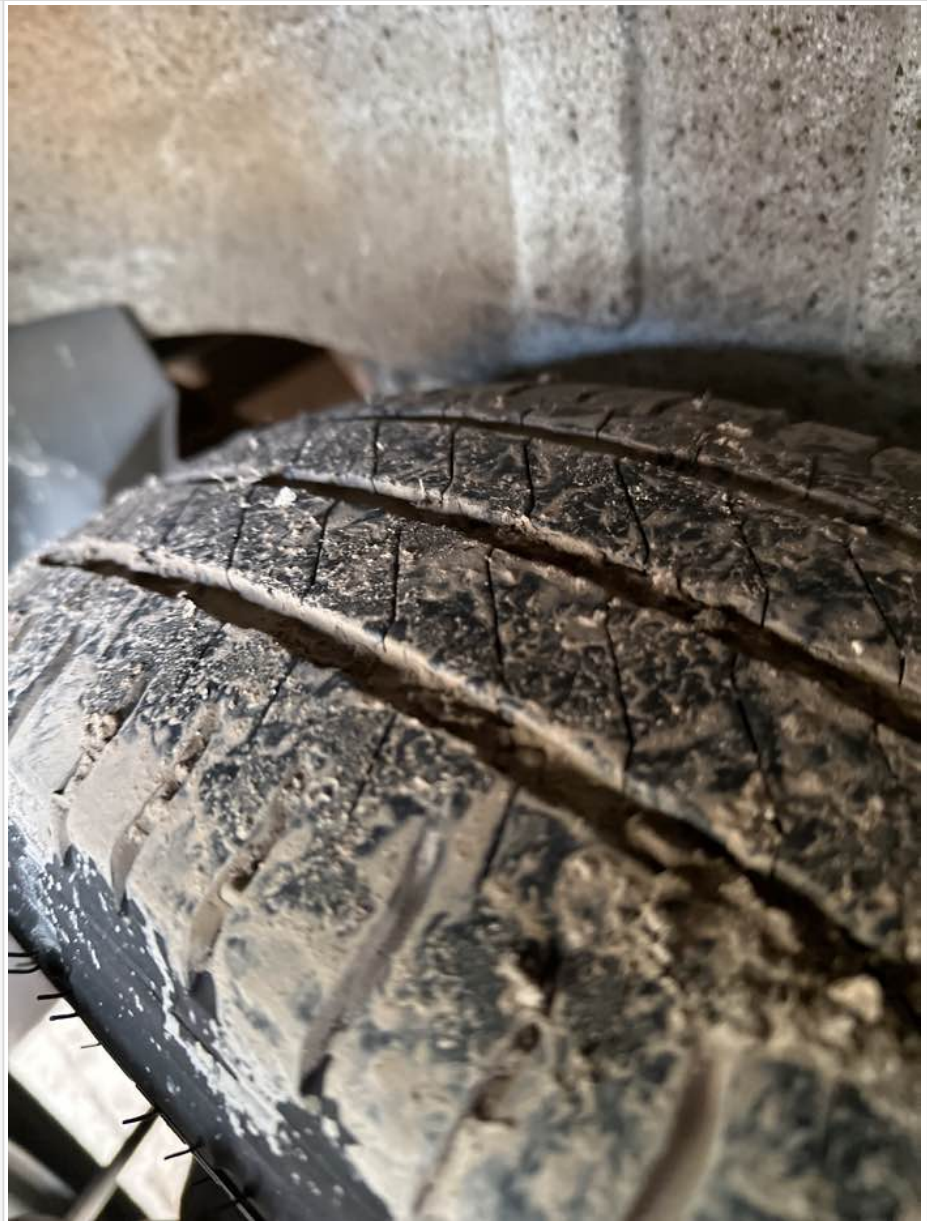
off side Inner (for twin wheel vans)

Is the vehicle a twin wheel axle? (if no don't fill out)	Yes
Age (month/year) Manufactured	25/20
Make, brand.	Michelin
Tyre size	195/75/R16
Pressure 1	
Pressure 2	
Wearing / Perishing (inner)	none
Wearing / Perishing (outer)	None
tread depth (mm)	5
General comments	decent tyre good life left

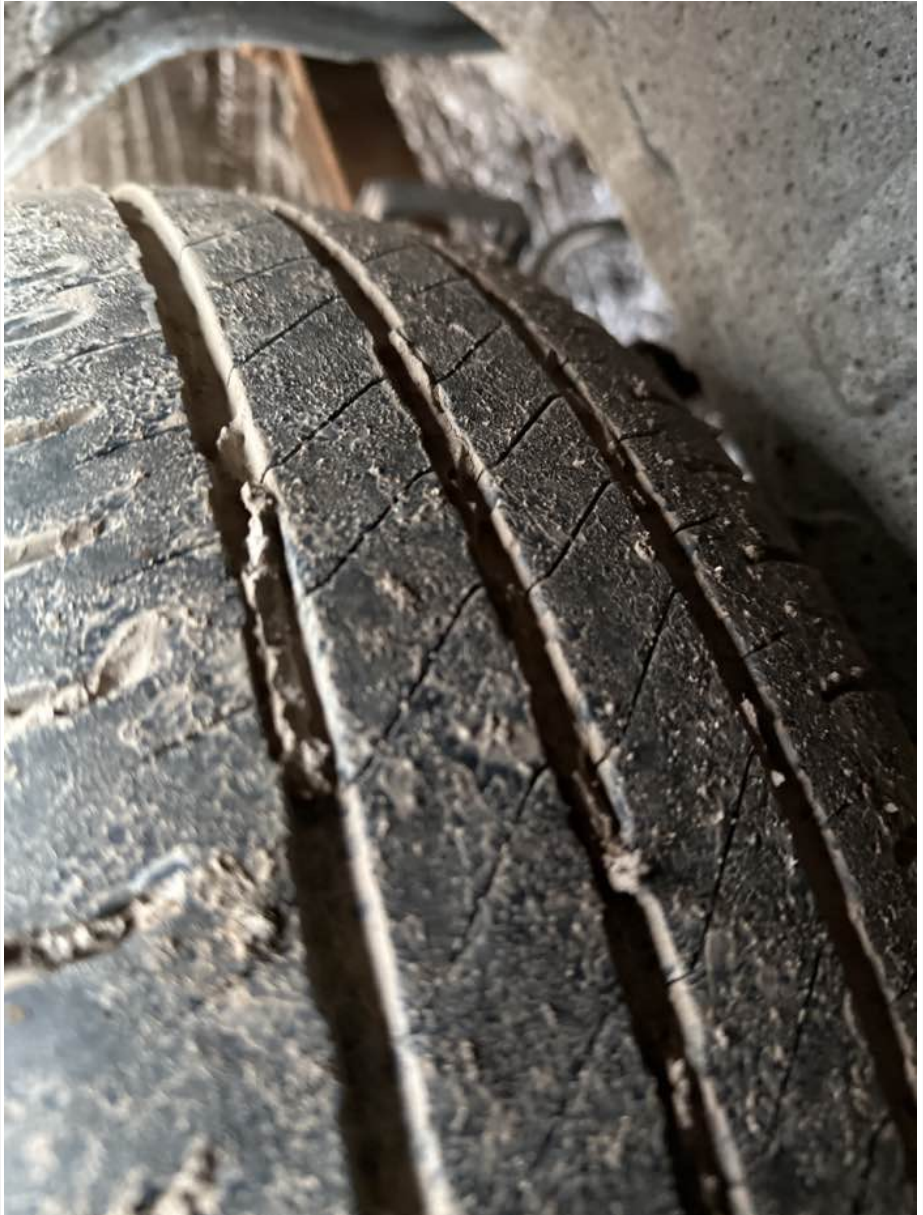
near side Inner (for twin wheel vans)

Is the vehicle a twin wheel axle? (if no don't fill out)	Yes
Age (month/year) Manufactured	25/20
Make, brand.	Michelin
Tyre size	195/75/R16
Pressure 1	
Pressure 2	
Wearing / Perishing (inner)	none
Wearing / Perishing (outer)	None

tread depth (mm)	5
General comments	good tyre good life left
Images of tyre

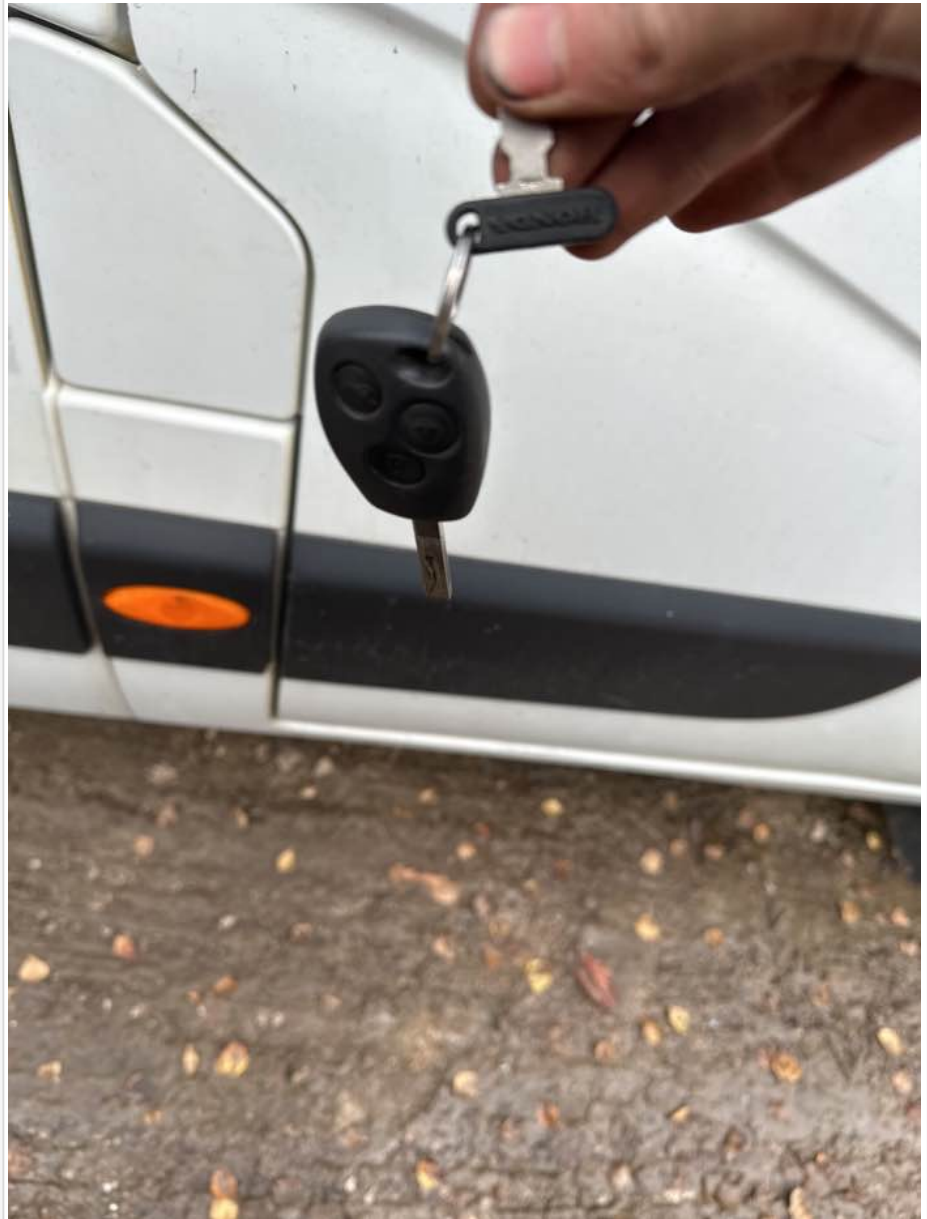
How many keys present at time of inspection?

all works well
