## BaseVan Initial Inspection

Vehicle registration	CU11FWV
Vehicle chassis no.	VF1MAF4DE44739509
Miles (if in km, multiply by 0.62)	249077
Make	Renault
Model	Master
Transmission	Manual, 6 speed
Factory immobiliser installed	Yes
Speed limiter installed	No
Drive configuration	FWD
Gross vehicle weight	3500kg
Towing capacity	2500kg
Tow bar installed	No

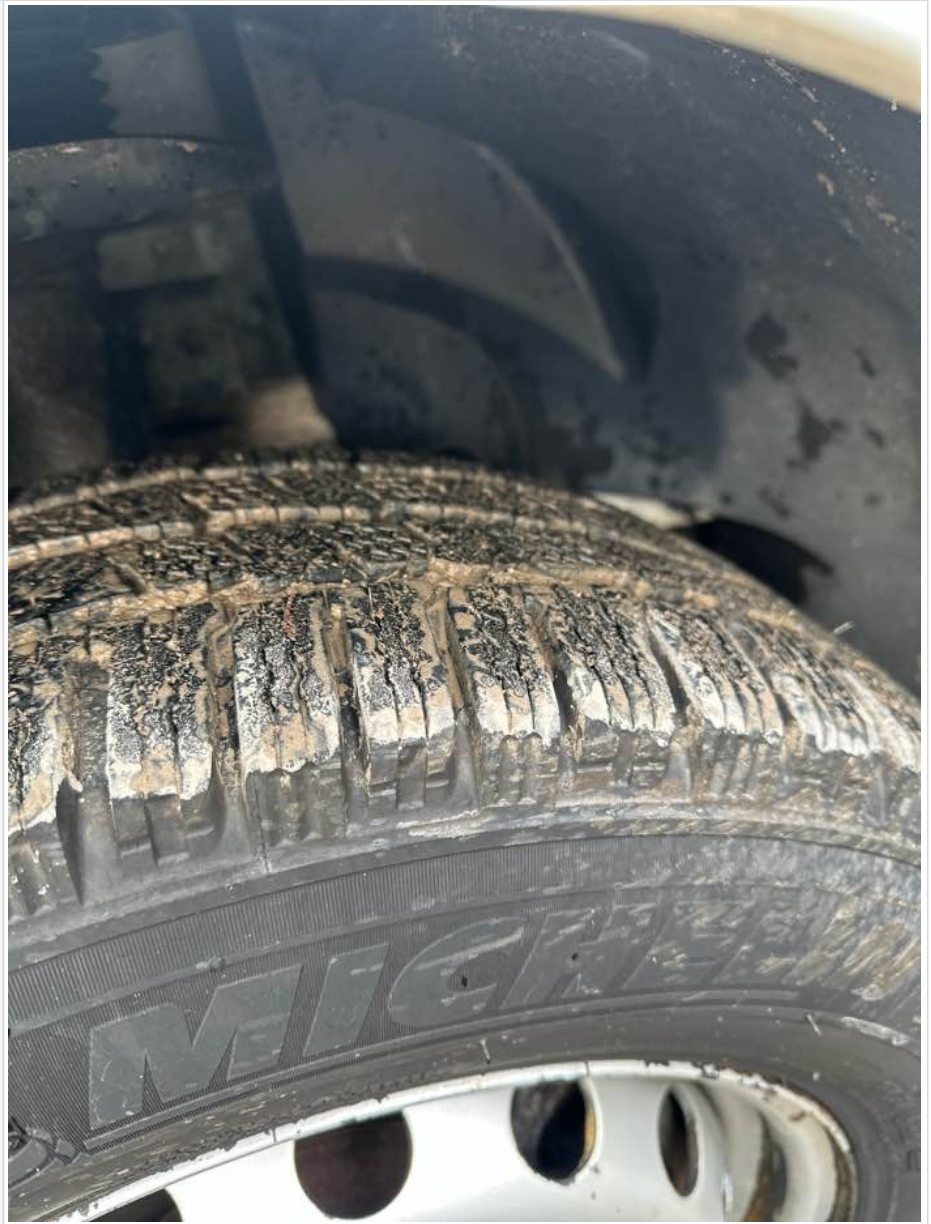
Images of tyre

Age (month/year) Manufactured	22/23
Make, brand.	Michelin
Tyre size	225/65/R16
Pressure 1	
Pressure 2	
Wearing / Perishing (inner)	none
Wearing / Perishing (outer)	None
tread depth (mm)	6
General comments	good tyre

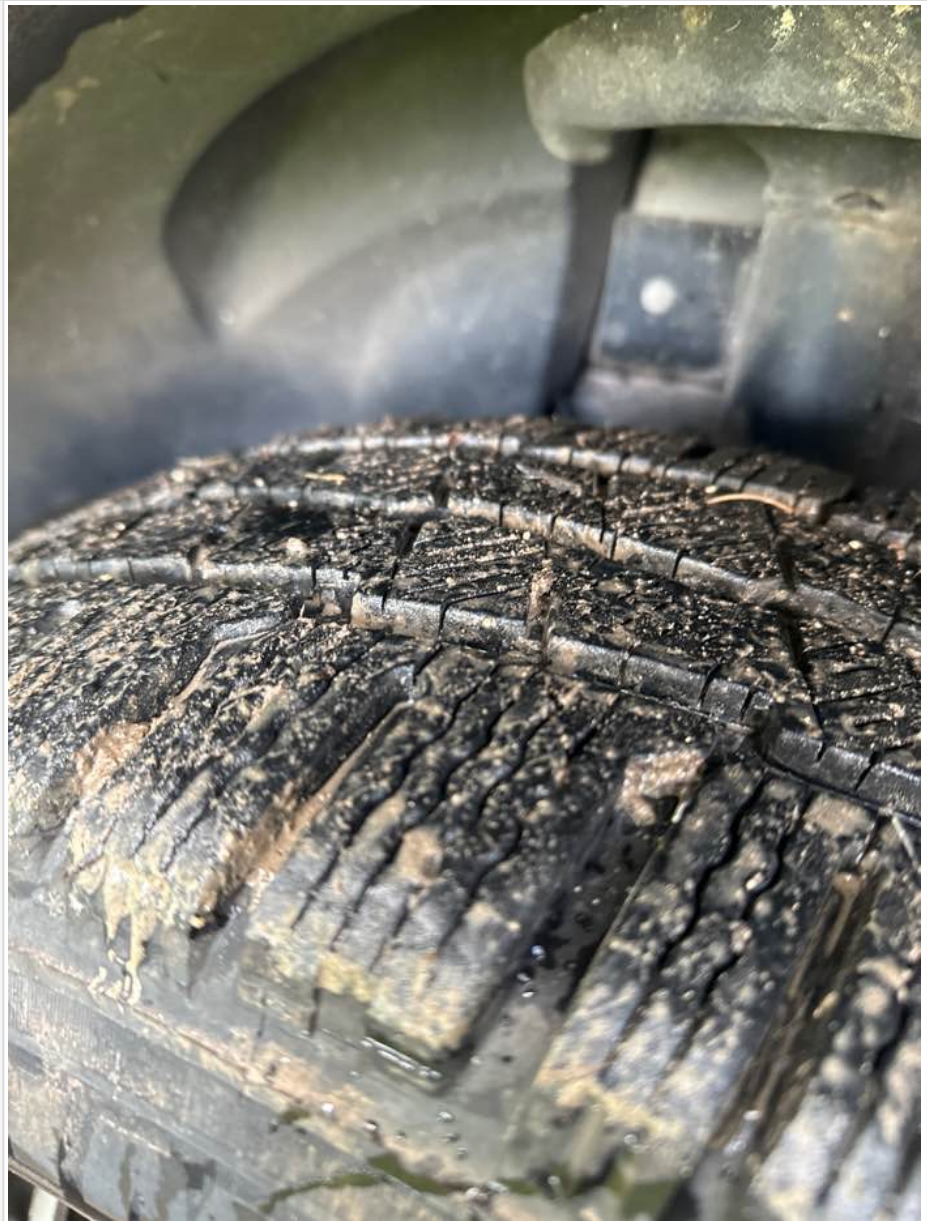
Images of tyre

Age (month/year) Manufactured	22/23
Make, brand.	Michelin
Tyre size	225/65/R16
Pressure 1	
Pressure 2	
Wearing / Perishing (inner)	none
Wearing / Perishing (outer)	None
tread depth (mm)	6
General comments	good tyre, even wear across fronts

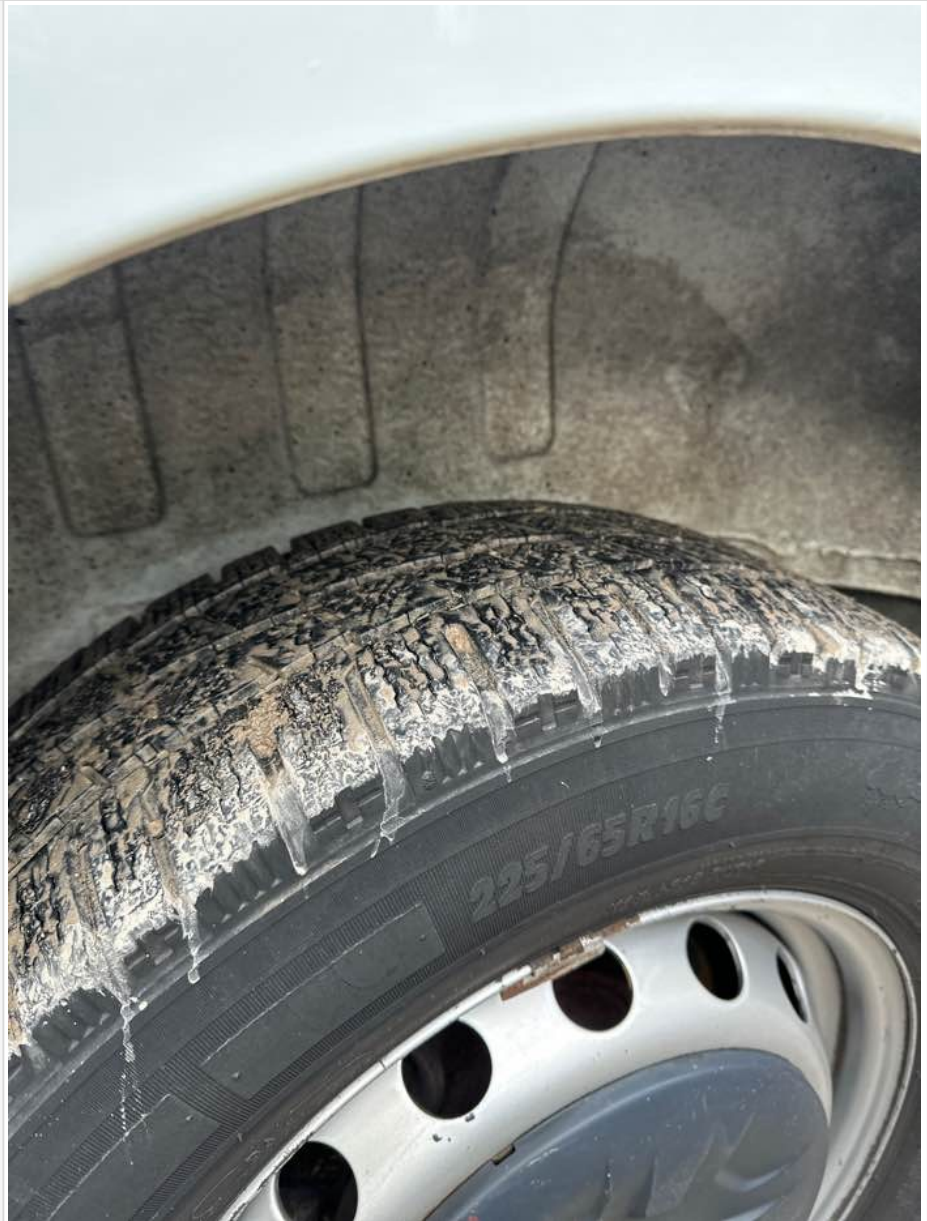
Images of tyre

Age (month/year) Manufactured	38/21
Make, brand.	Michelin
Tyre size	225/65/R16
Pressure 1	
Pressure 2	
Wearing / Perishing (inner)	none
Wearing / Perishing (outer)	None
tread depth (mm)	5
General comments	good tyre, used, even wear across reae

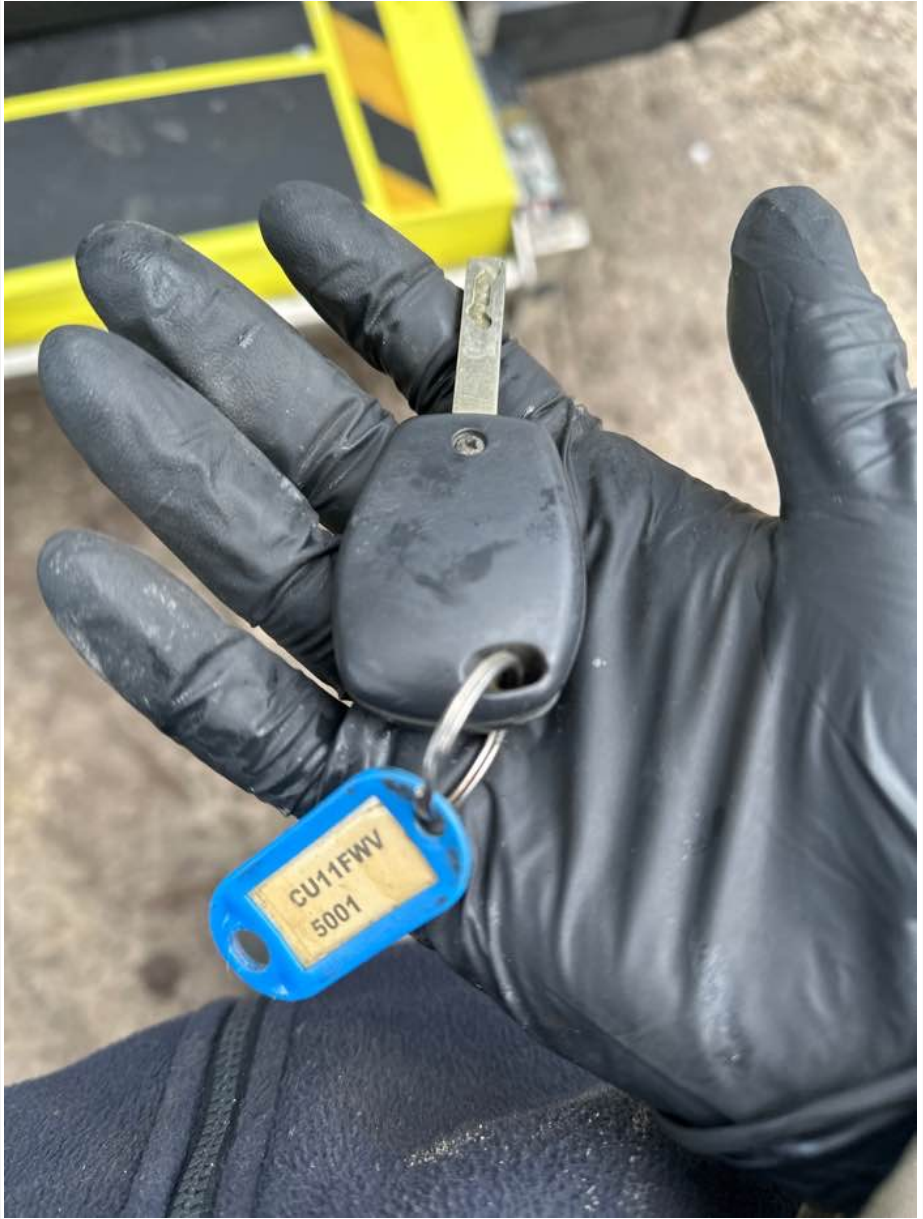
Select the following doors that lock.	N/S Front, O/S Front, N/S SL, N/S Rear, O/S Rear
Method of locking	Fob
In conclusion can all the doors be locked in some way and thus the vehicle can be left unattended at night safely?	Yes
How many keys present at time of inspection?

Comment	works as should

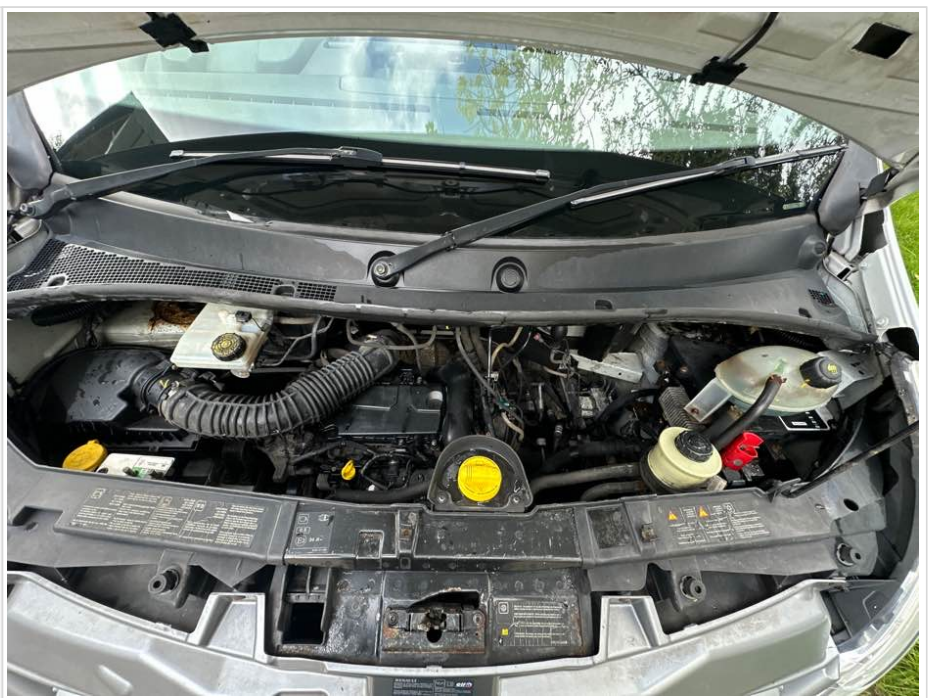
<p>Engine bay photo</p>

Fuel level	1/2 Full
Oil level	Full
Oil conditon	Clean
Start up, chassis battery check	Started without jump pack
Start-up from cold	Instant
Exhaust smoke from cold	Normal
Output Voltage of Alternator test	13.8
Chain or Belt driven engine?	Chain
If belt any proof of change?	-
Coolant condition	Clean
Coolant level	Full
Anti-freeze temperature check	-14
Washer fluid	Full
Brake fluid	Full
Power steering fluid	Maximum
Dashboard warning light	No warning lights
OBD Scan results

<p>Comment</p>	<p>mechanically very good!</p>
