Basevan.com General Inspection

Vehicle registration	HK09DGX
Vehicle chassis no.	BF1PDM2L639810849
Miles (if in km, multiply by 0.62)	102,269mi (164950km on tacho)
Make	Renault
Model	Master
Transmission	Manual, 6 speed
Factory immobiliser installed	Yes
Speed limiter installed	Yes
Drive configuration	FWD
Gross Vehicle Weight (kg)	3900
Towing capacity	1600
Tow bar installed	No

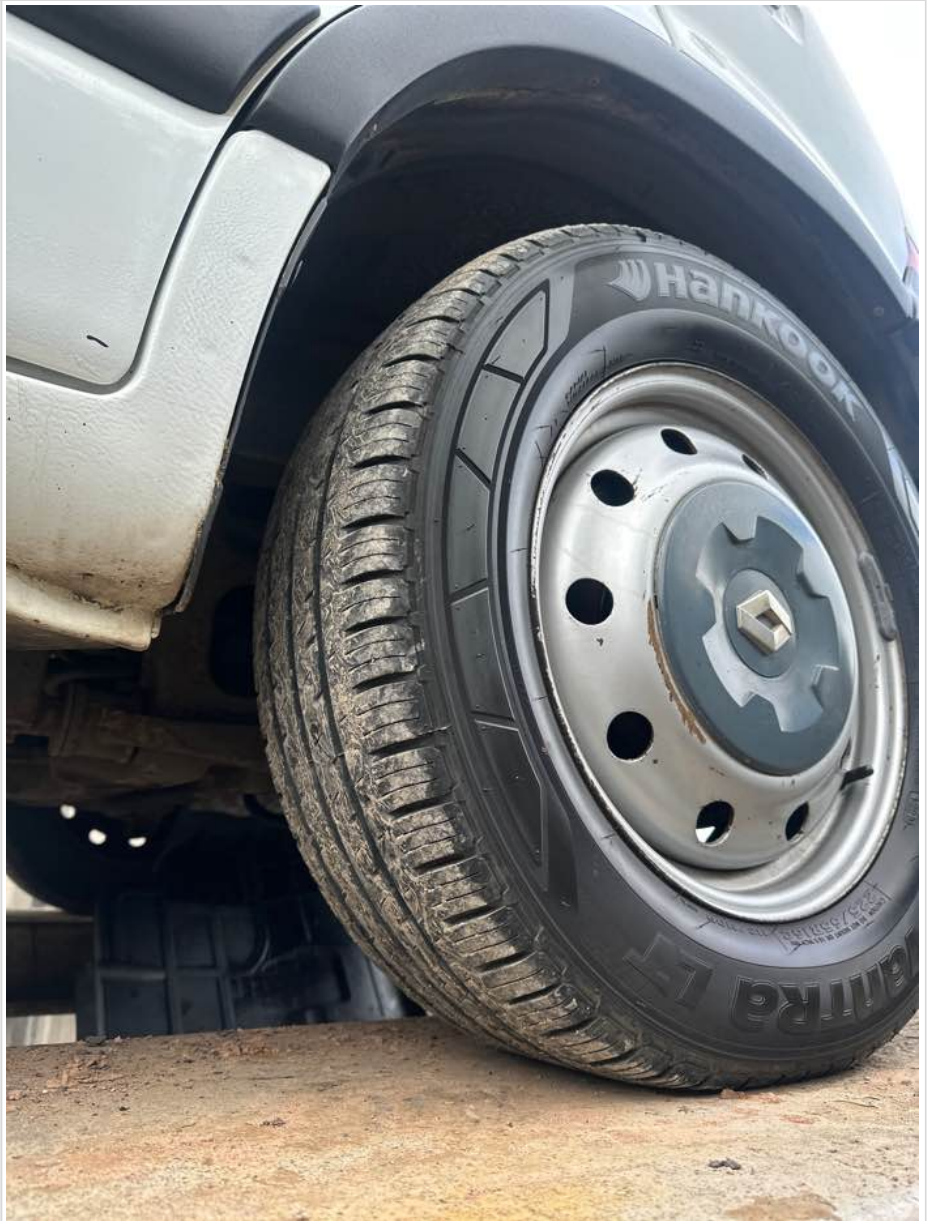
Off side front

Age (month/year) Manufactured	12/22
Make, brand.	Hankook
Tyre size	225/65/R16
Pressure 1	
Pressure 2	
Wearing / Perishing (inner)	none
Wearing / Perishing (outer)	None
tread depth (mm)	6
General comments	good tyre

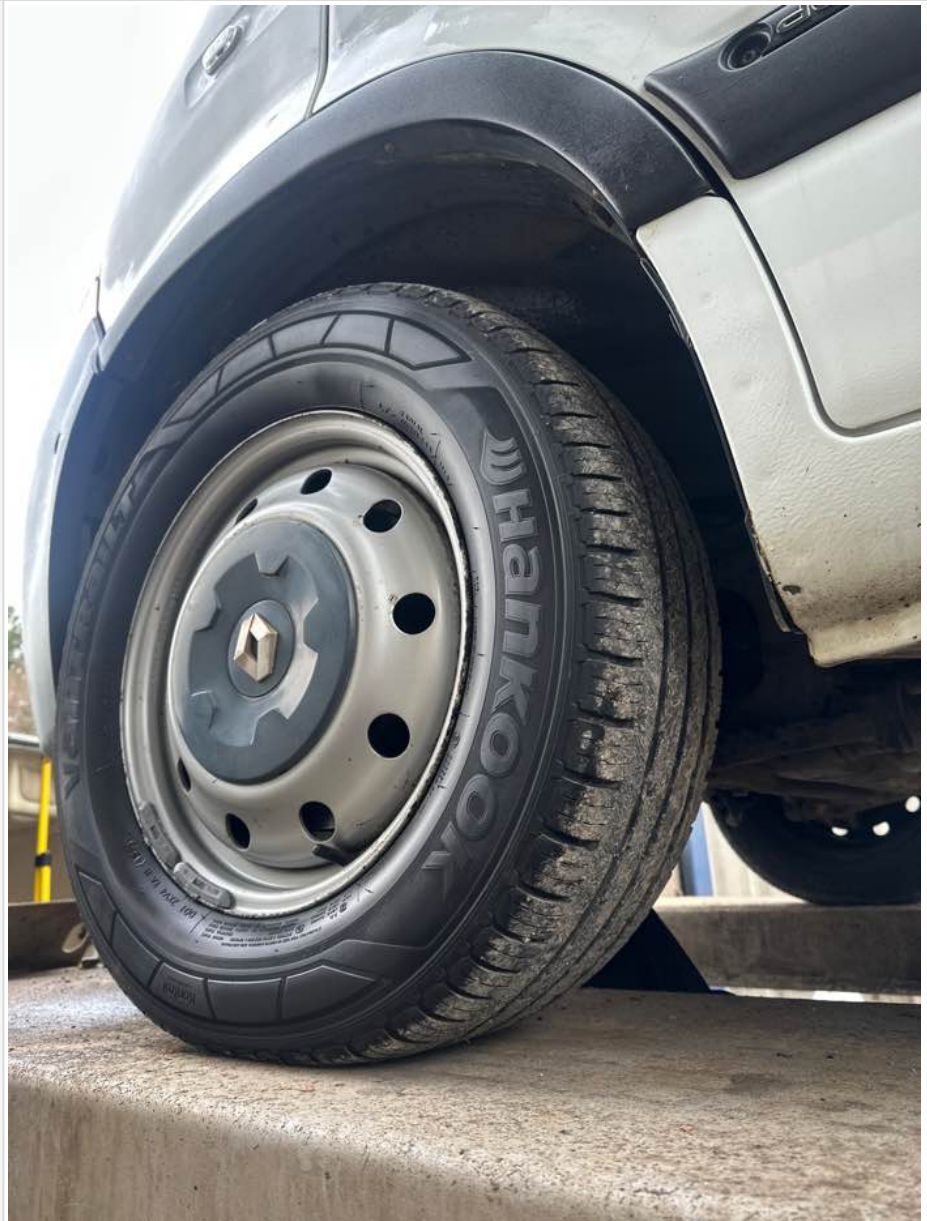
Near side front

Age (month/year) Manufactured	12/22
Make, brand.	Hankook
Tyre size	225/65/R16
Pressure 1	
Pressure 2	
Wearing / Perishing (inner)	none
Wearing / Perishing (outer)	None
tread depth (mm)	6
General comments	good tip of range tyre

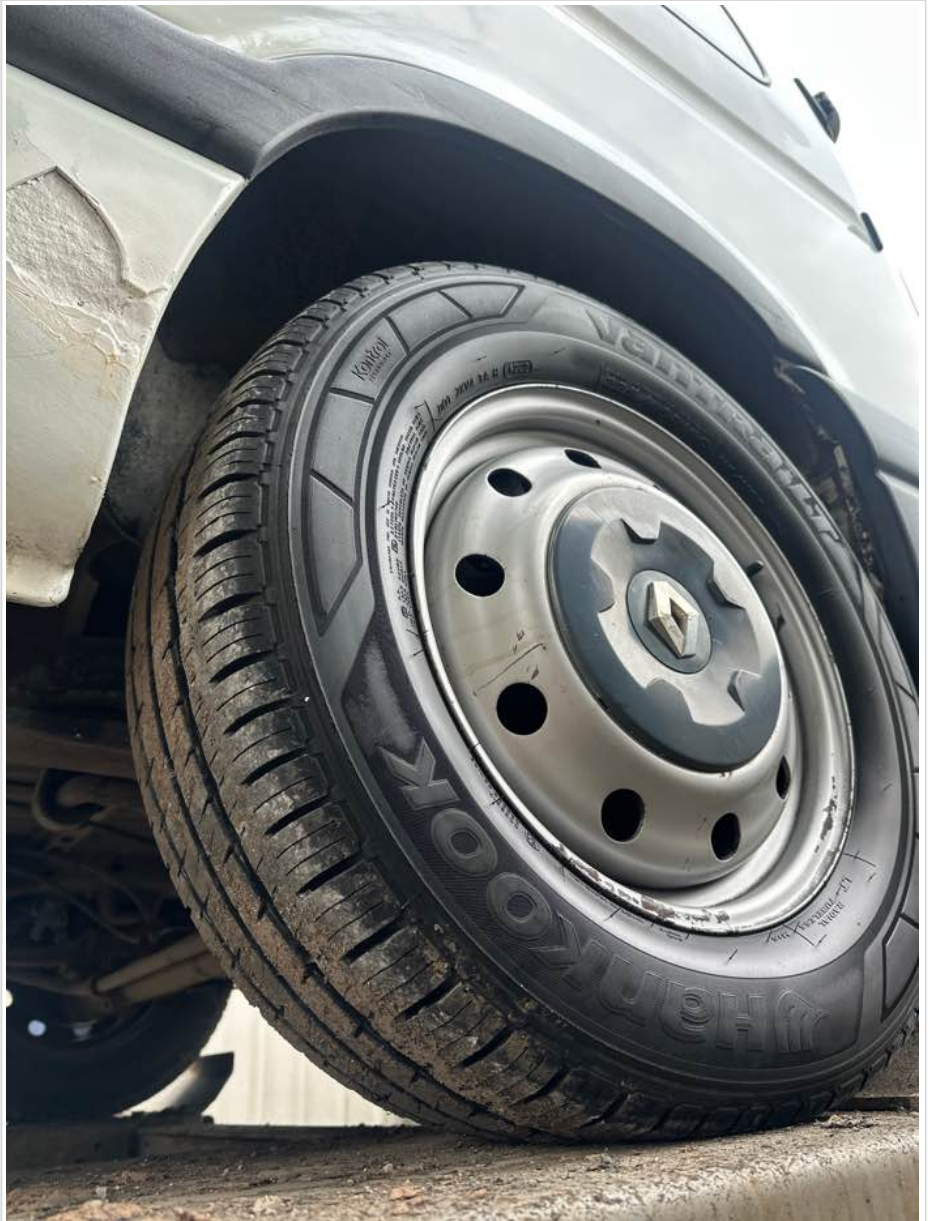
near side rear

Age (month/year) Manufactured	12/22
Make, brand.	Hankook
Tyre size	225/65/R16
Pressure 1	
Pressure 2	
Wearing / Perishing (inner)	none
Wearing / Perishing (outer)	None
tread depth (mm)	8
General comments	good tyre, absolutely mint

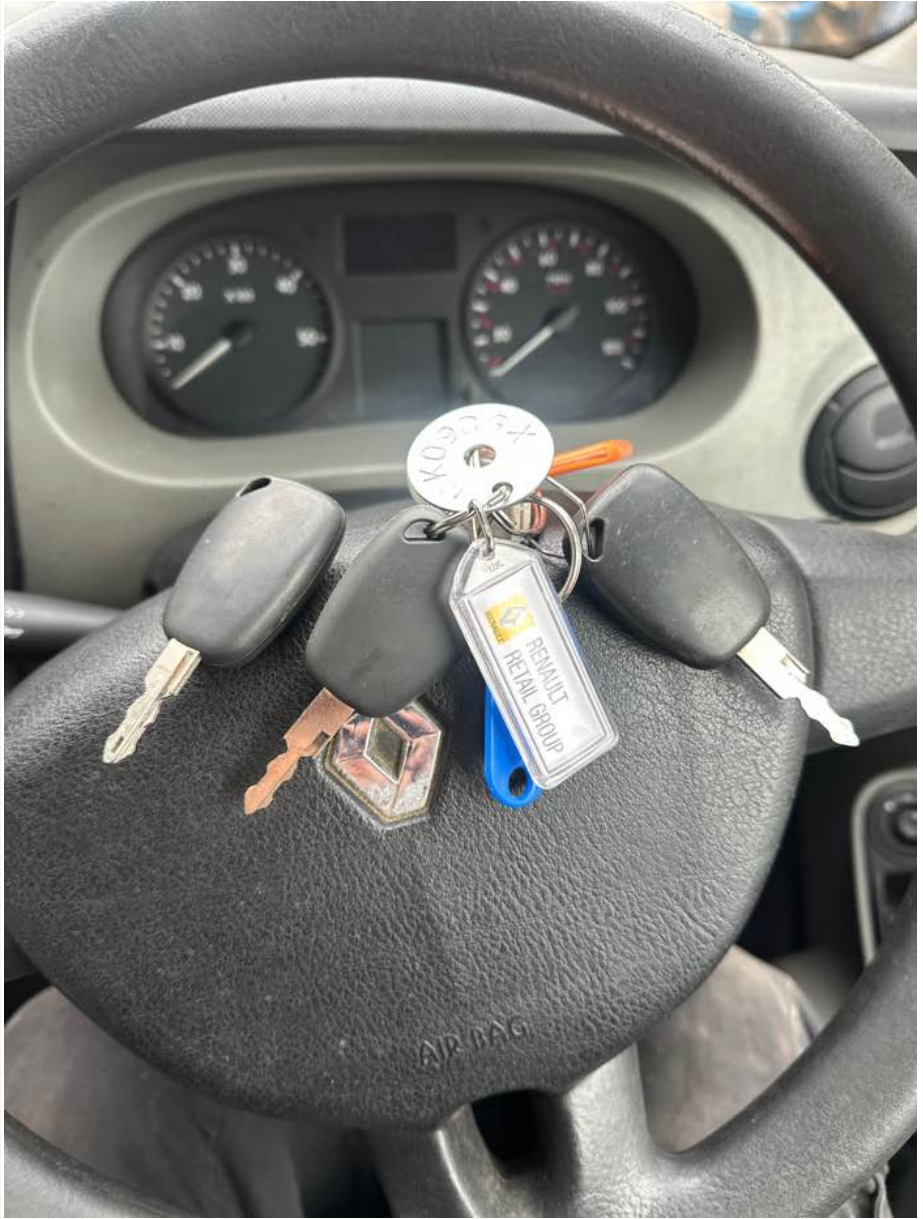
Comment	
	3 keys, very good

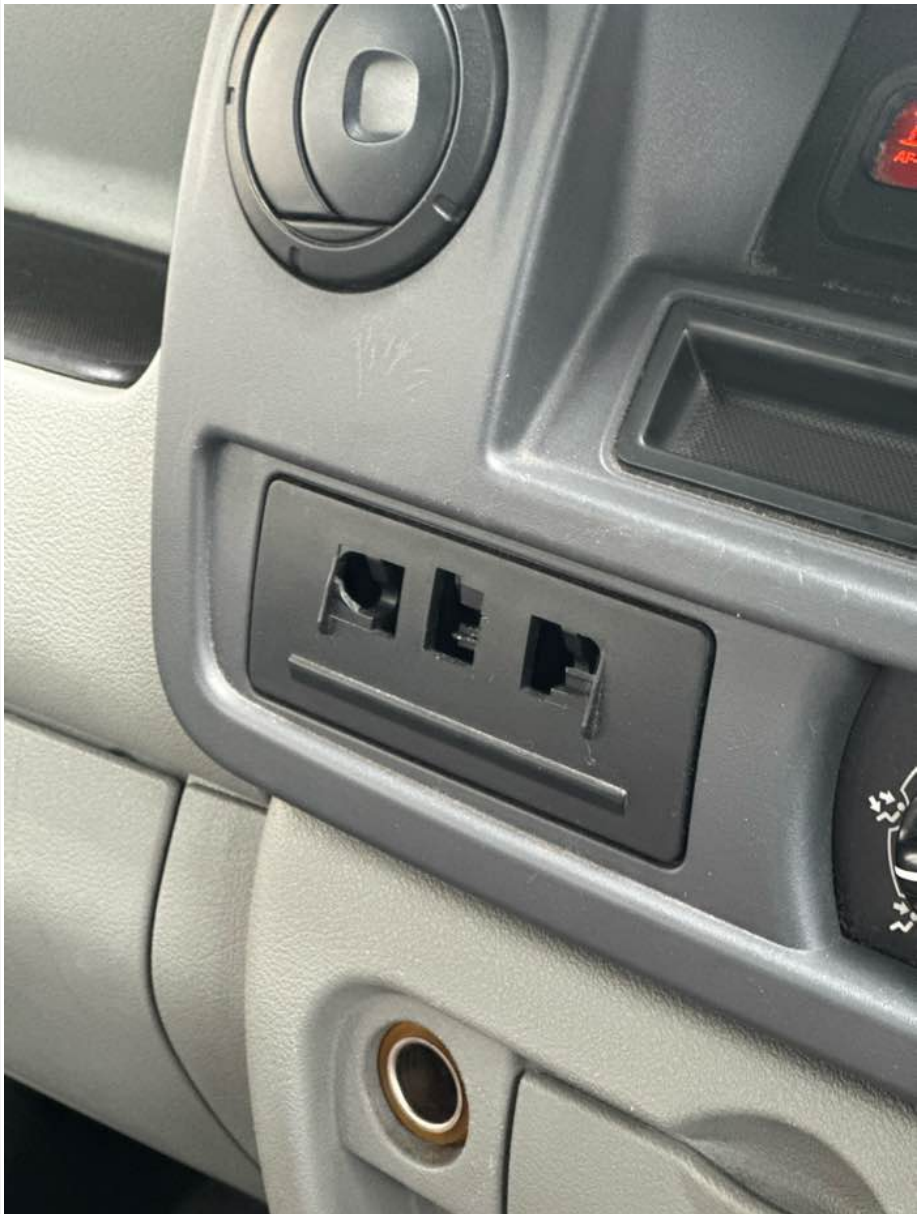
Electric windows present	Yes
Cab windows function check	Driver side function, Passenger side function
Air conditioning present	Yes
Charging socket present (cigarette lighter)	Yes
Function working?	Yes
Radio / Media system fitted?	Yes
Radio / media system check	Functions
Reverse camera present?	No
Reverse camera functioning?	N/A
Show any damage or missing items

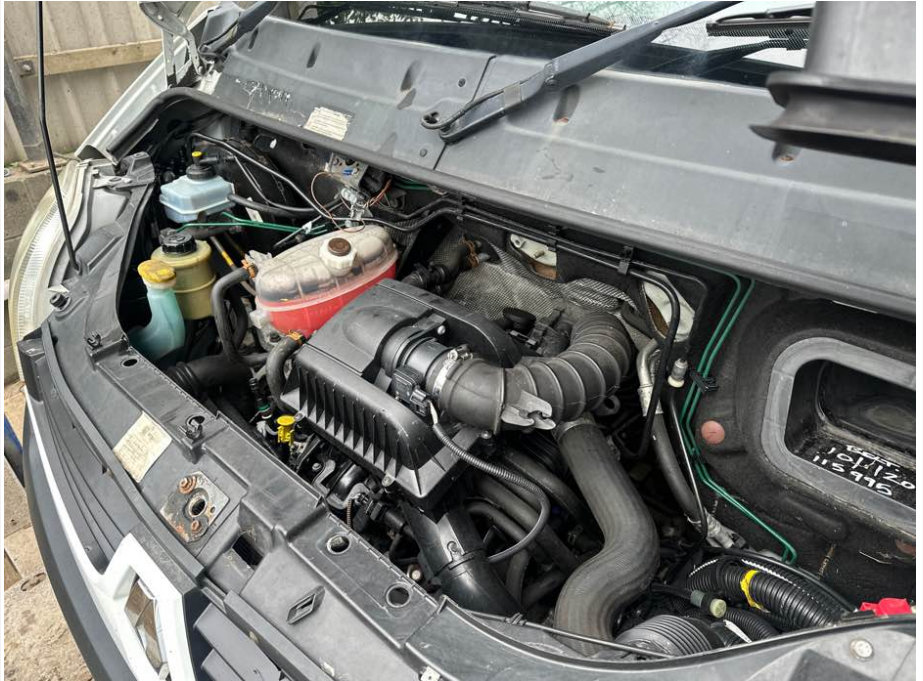
Fuel level	1/2 Full
Oil level	
Oil conditon	Serviced by Basevan
Start up, chassis battery check	Started without jump pack
Start-up from cold	Instant
Exhaust smoke from cold	Normal
Output Voltage of Alternator test	13.6
Chain or Belt driven engine?	Belt
If belt any proof of change?	10/01/2020- 15,995mi
Coolant condition	Clean, Oil present
Coolant level	Full
Anti-freeze temperature check	-17
Washer fluid	Full
Brake fluid	Full
Power steering fluid	Maximum
Dashboard warning light	No warning lights
OBD Scan results	
Engine bay photo

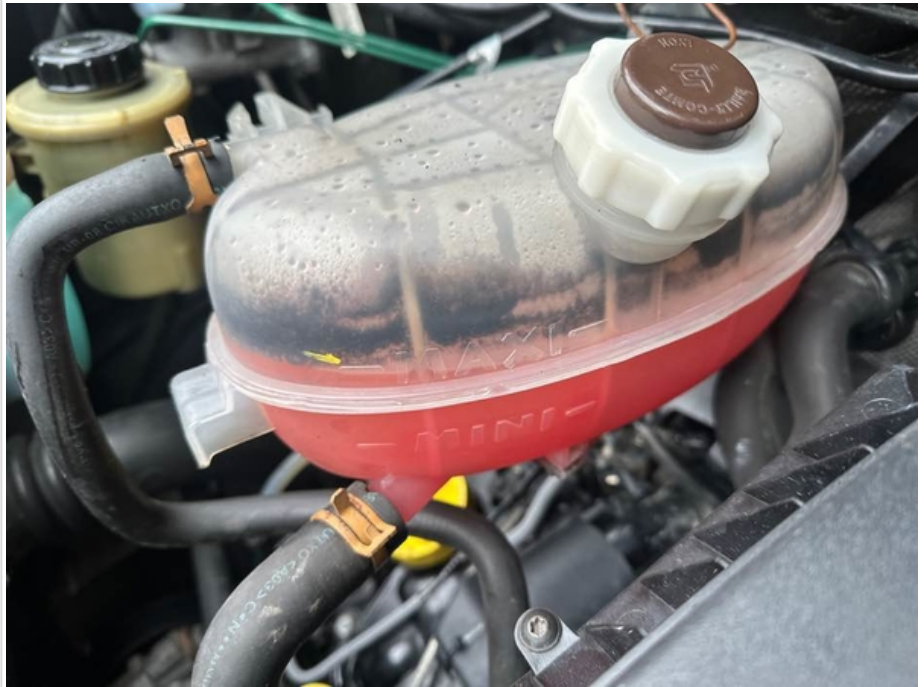
Comment	Oil deposit in expansion tank
---------	-------------------------------
