Basevan.com General Inspection

Vehicle registration	WA06KKD
Vehicle chassis no.	X FC65C0005592470
Miles (if in km, multiply by 0.62)	121,769mi (196403km on clocks)
Make	Iveco
Model	Daily
Transmission	Manual, 6 speed
Factory immobiliser installed	Yes
Speed limiter installed	Yes
Drive configuration	RWD
Gross Vehicle Weight (kg)	6500
Towing capacity	3500kg
Tow bar installed	No

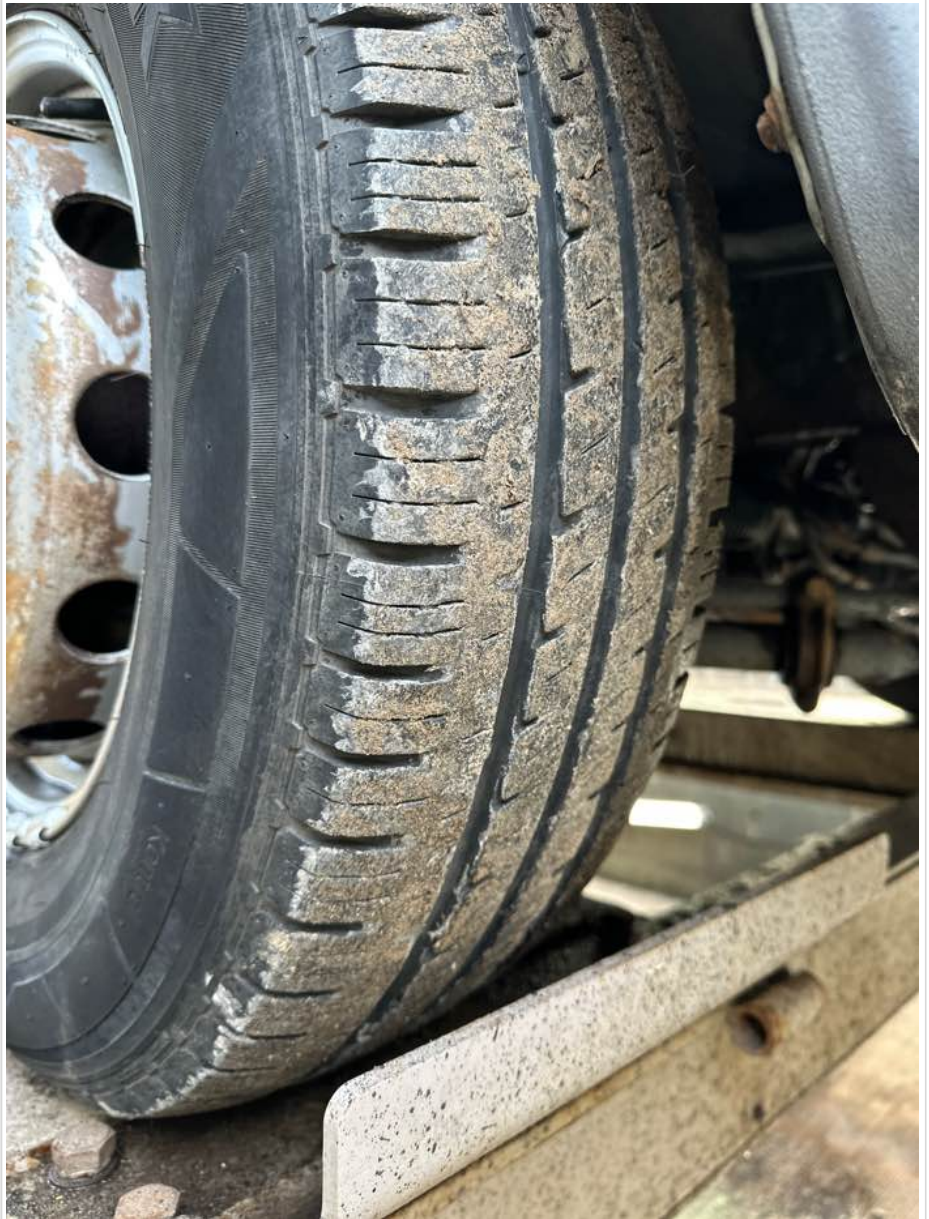
Off side front

Age (month/year) Manufactured	11/18
Make, brand.	Hankook
Tyre size	225/75/R16
Pressure 1	35ps
Pressure 2	50psi
Wearing / Perishing (inner)	none
Wearing / Perishing (outer)	None
tread depth (mm)	6
General comments	good tyre still

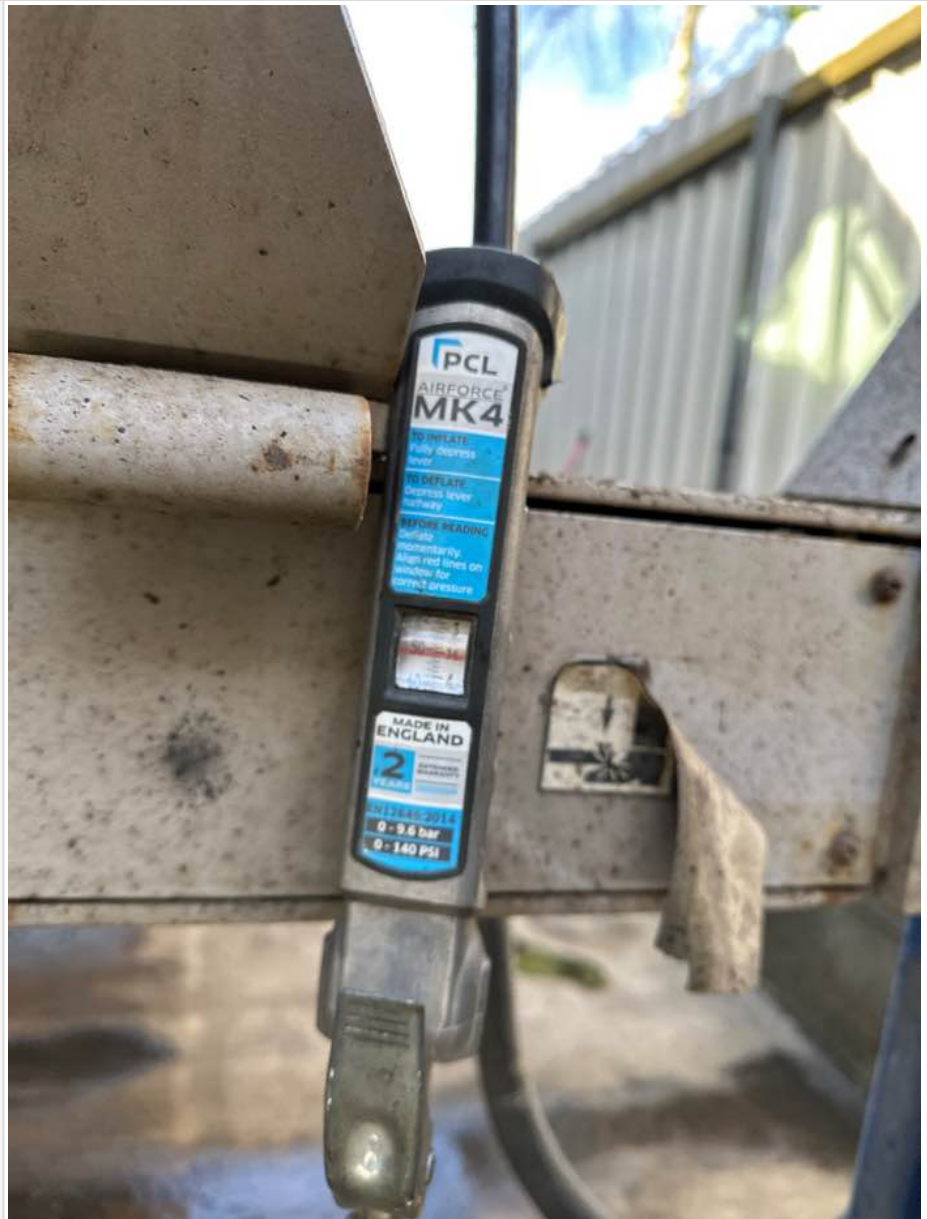
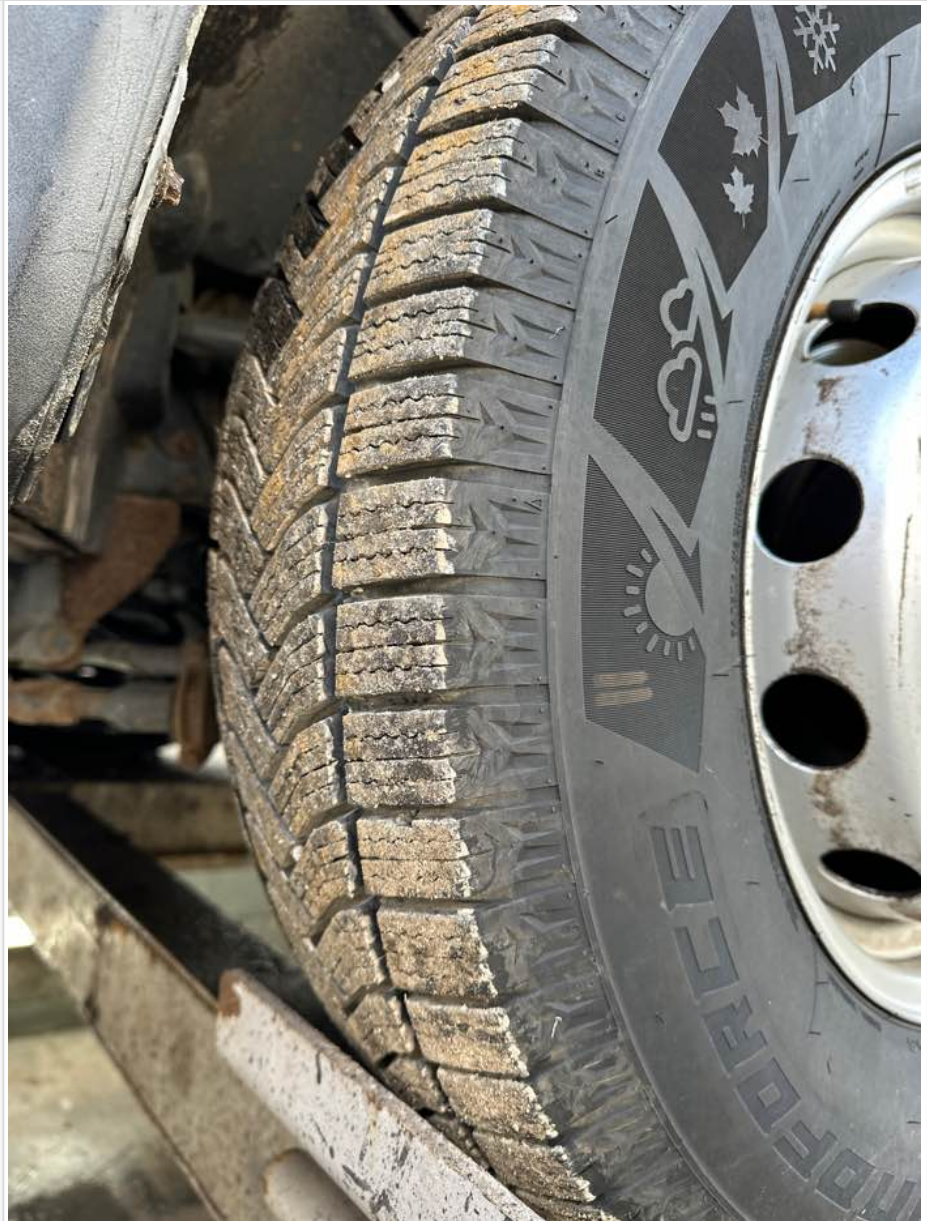
Near side front

Age (month/year) Manufactured	13/24
Make, brand.	Other (comment)
Tyre size	225/75/R16
Pressure 1	50ps
Pressure 2	50ps
Wearing / Perishing (inner)	none
Wearing / Perishing (outer)	None
tread depth (mm)	8
General comments	brand spanker

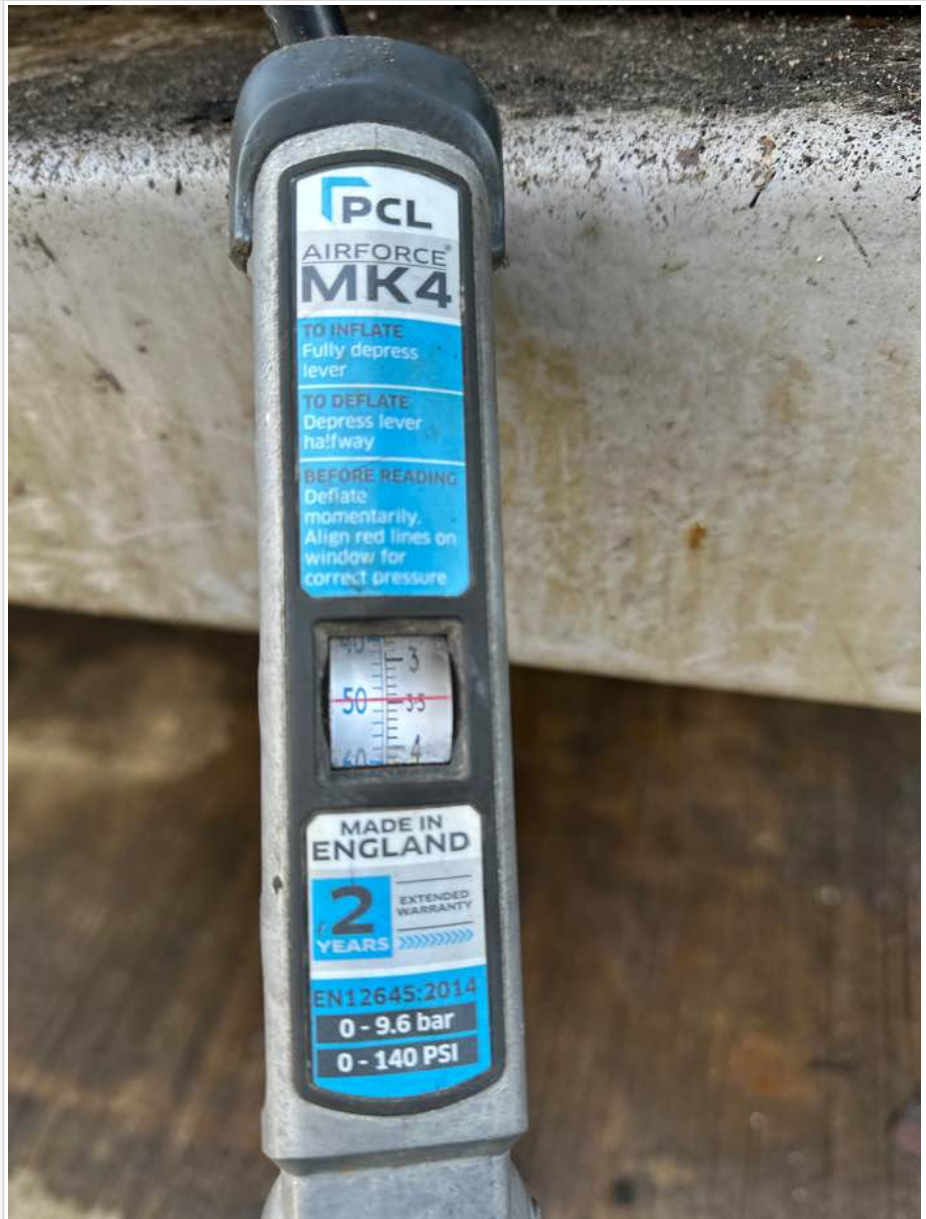
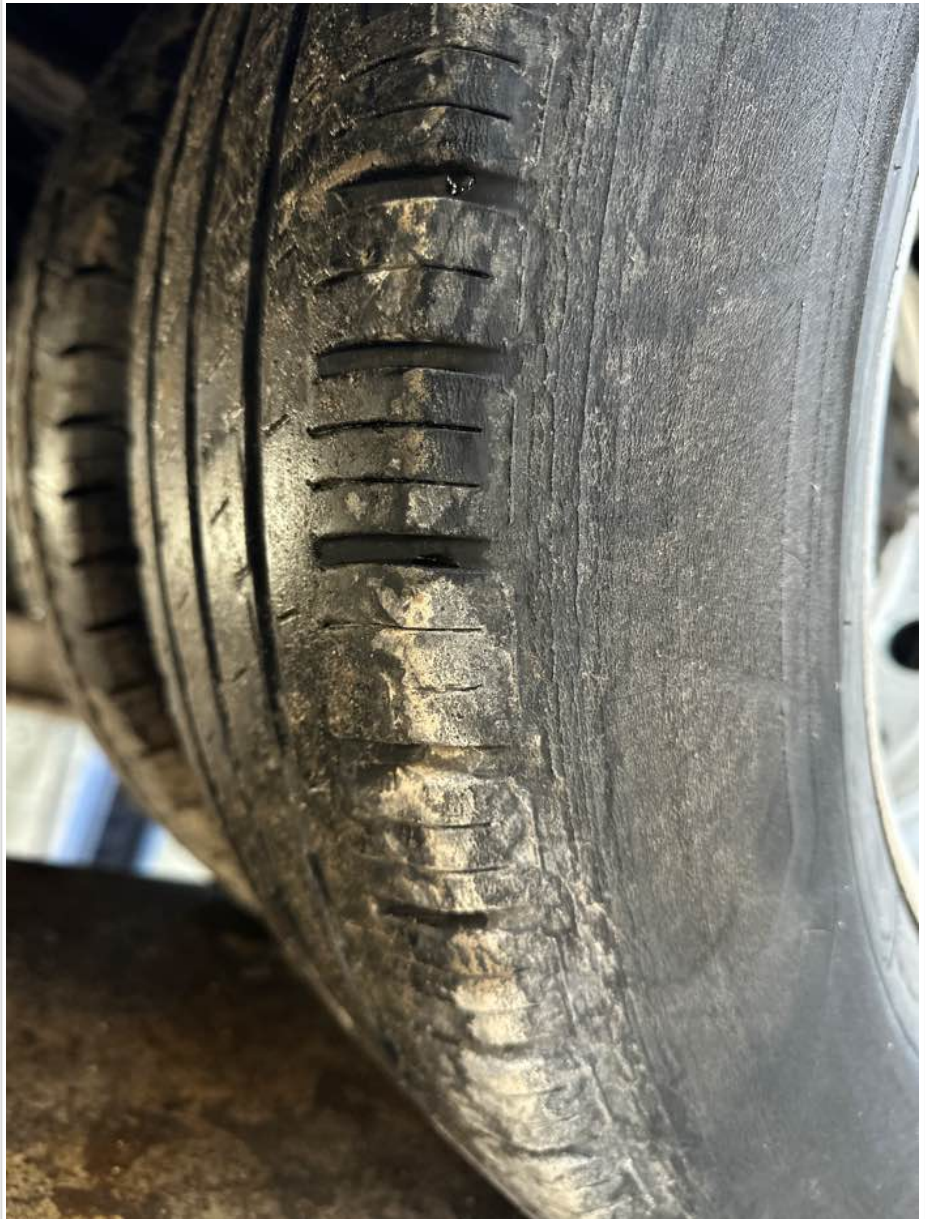
near side rear

Age (month/year) Manufactured	28/17
Make, brand.	Hankook
Tyre size	225/75/R16
Pressure 1	42ps
Pressure 2	50ps
Wearing / Perishing (inner)	none
Wearing / Perishing (outer)	Slight
tread depth (mm)	5
General comments	okay, moderate kerb rash

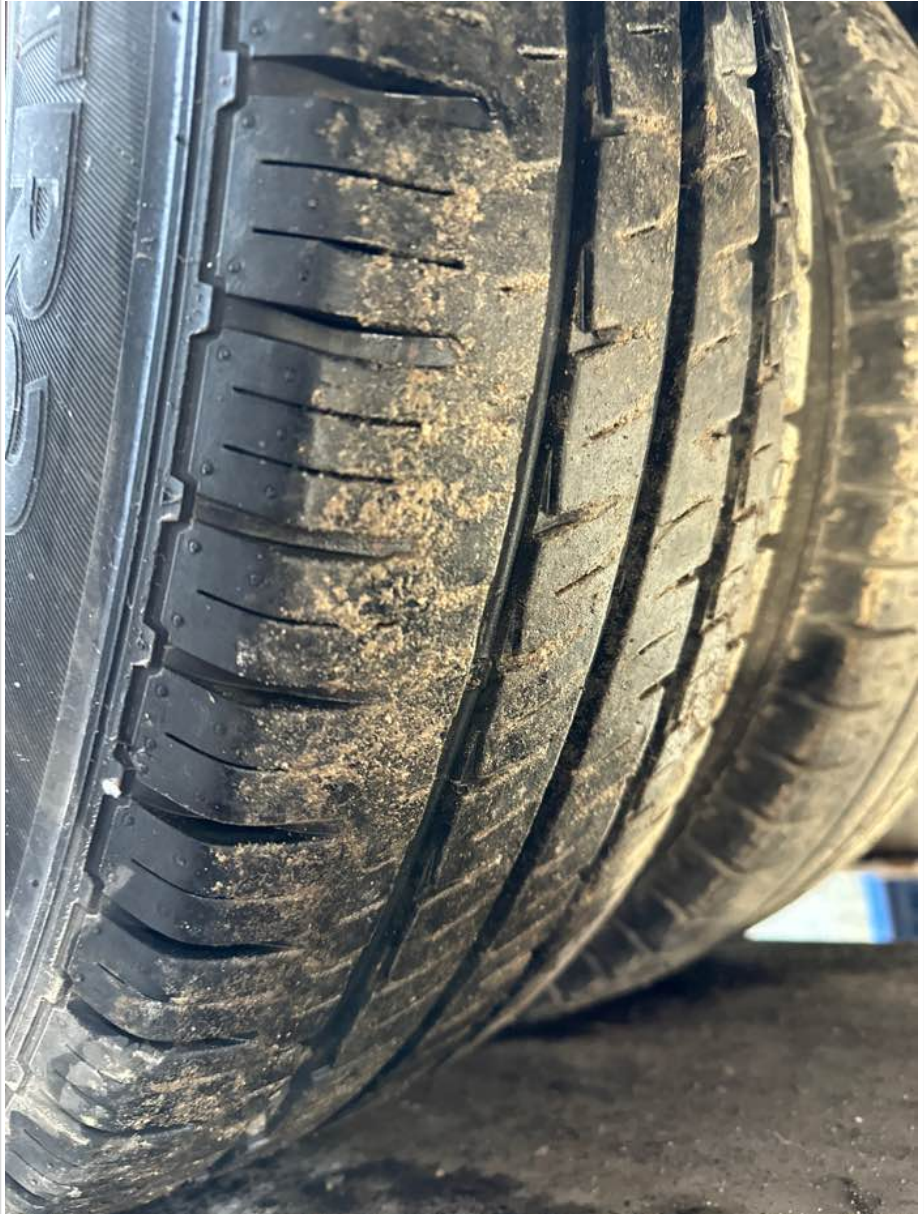
Off side rear

Age (month/year) Manufactured	Cannot be seen
Make, brand.	Hankook
Tyre size	225/75/R16
Pressure 1	
Pressure 2	
Wearing / Perishing (inner)	none
Wearing / Perishing (outer)	None
tread depth (mm)	6

General comments	looks a recent tyre, date stamp on inner, can't be seen with wheel on, valve cap missing
Images of tyre

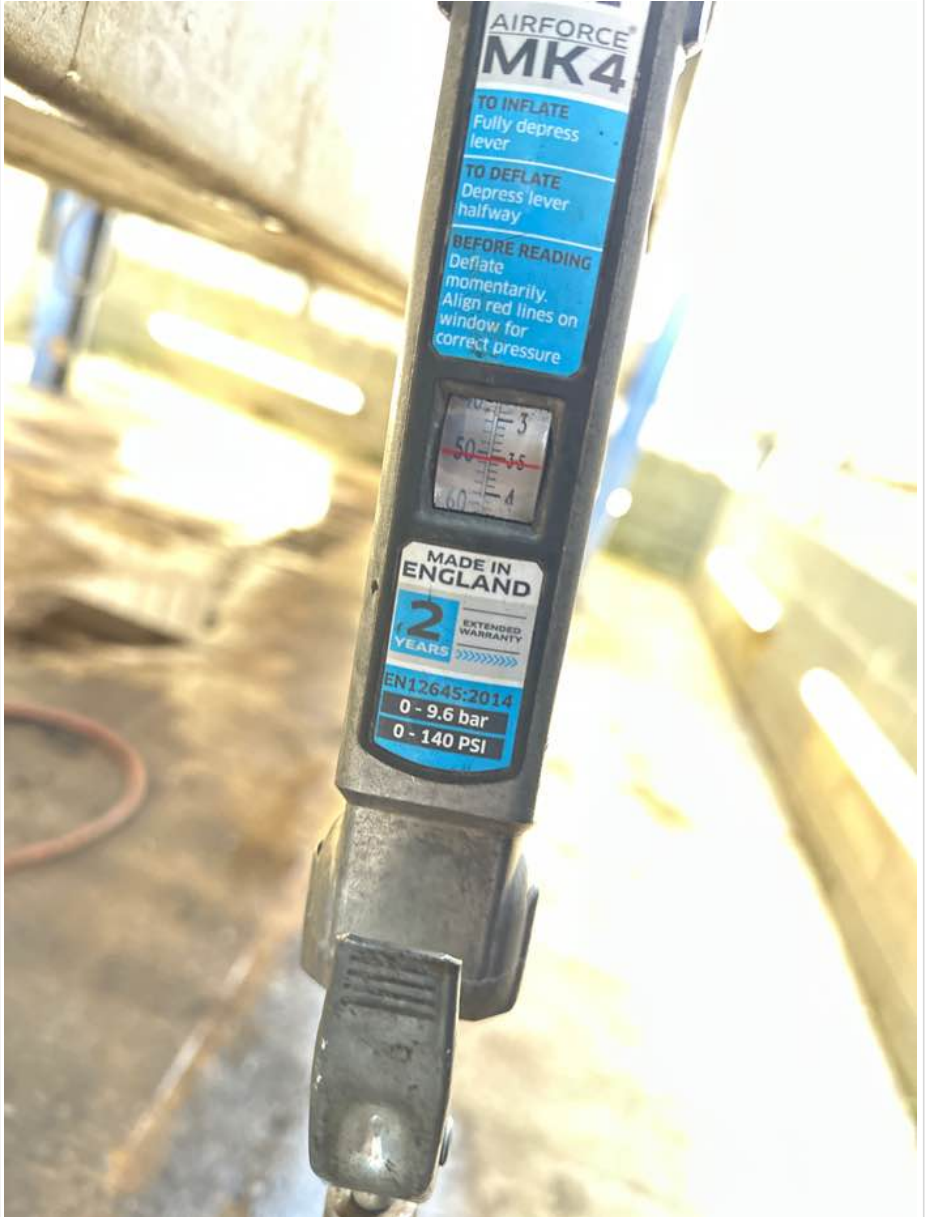
off side Inner (for twin wheel vans)

Is the vehicle a twin wheel axle? (if no don't fill out)	Yes
Age (month/year) Manufactured	10/16
Make, brand.	Michelin
Tyre size	225/75/R16
Pressure 1	48psi
Pressure 2	50psi
Wearing / Perishing (inner)	none
Wearing / Perishing (outer)	None

tread depth (mm)	4
General comments	getting low on tread, NOT MATCHING outer
Images of tyre

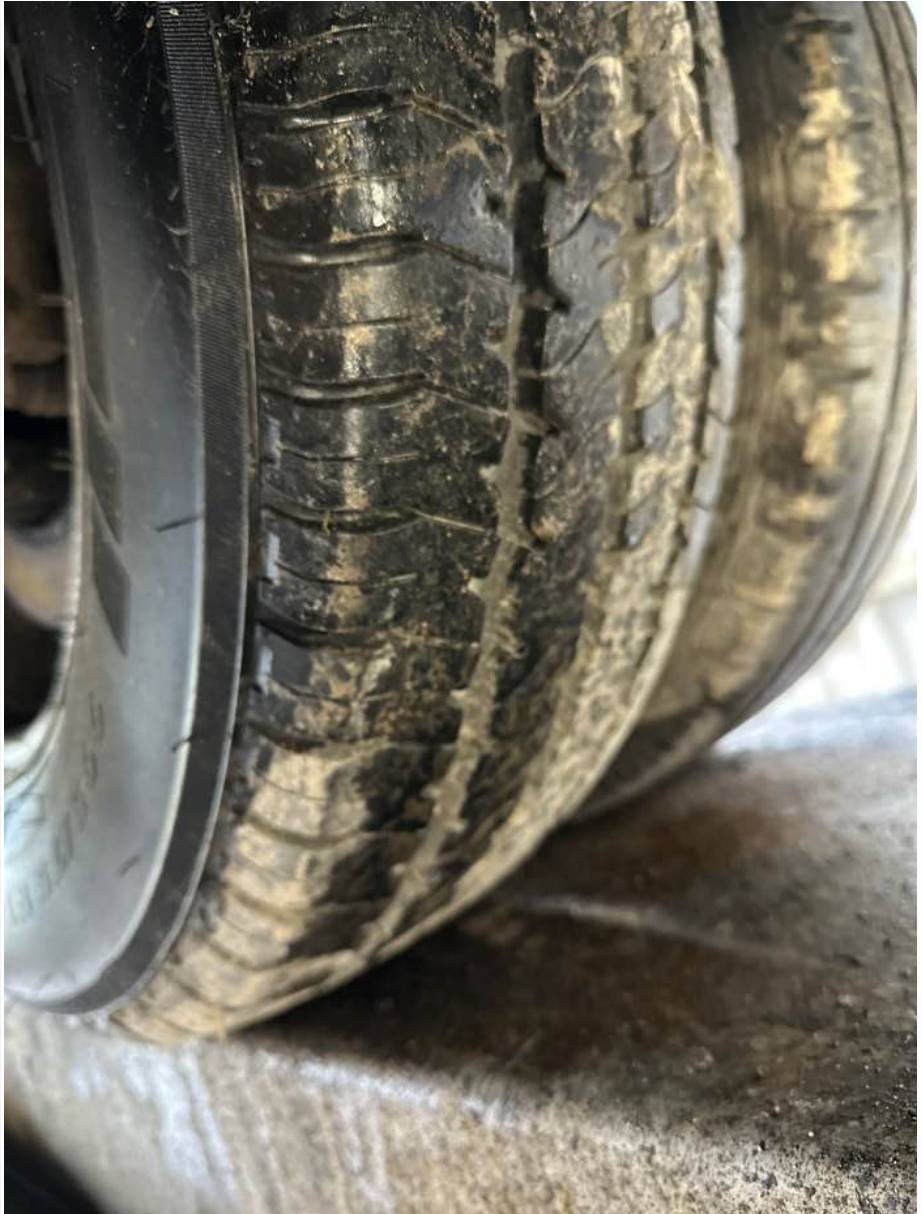
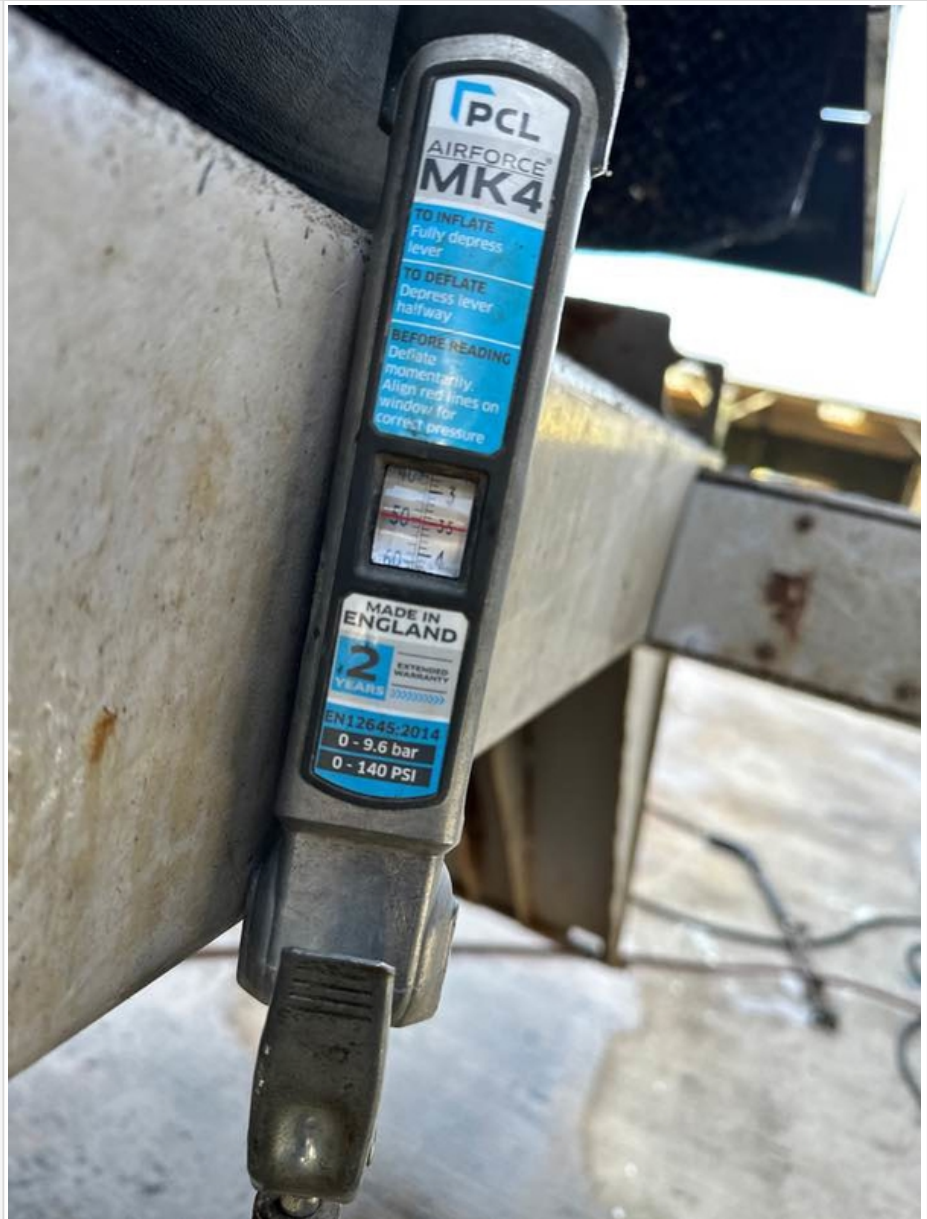
near side Inner (for twin wheel vans)

Is the vehicle a twin wheel axle? (if no don't fill out)	Yes
Age (month/year) Manufactured	10/20
Make, brand.	GT Radial
Tyre size	225/75/R16
Pressure 1	39ps
Pressure 2	50ps

Wearing / Perishing (inner)	none
Wearing / Perishing (outer)	None
tread depth (mm)	8
General comments	nice tyre, however does NOT match near side outer
Images of tyre

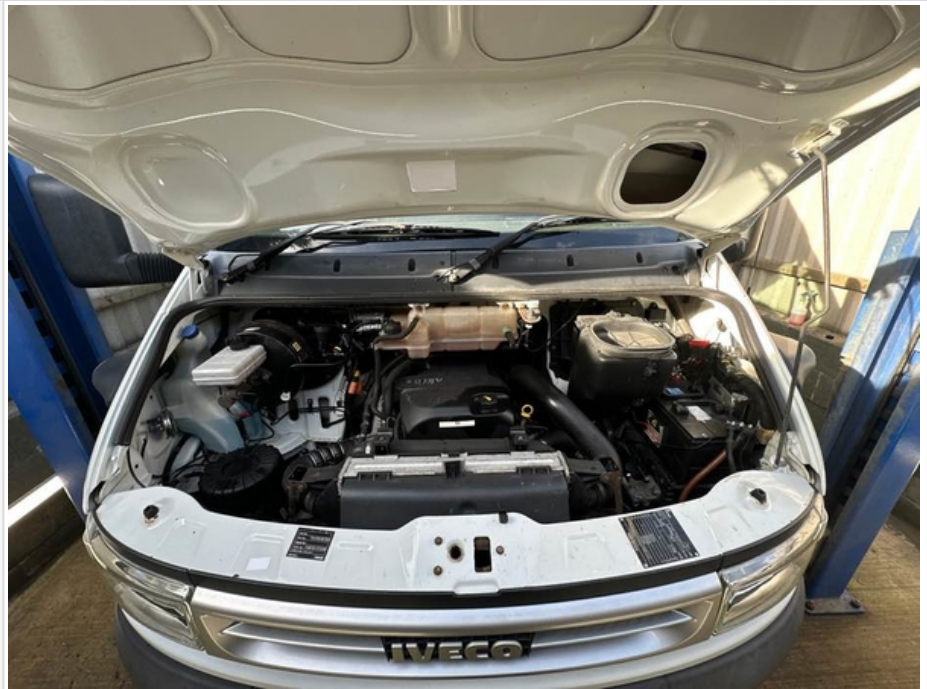
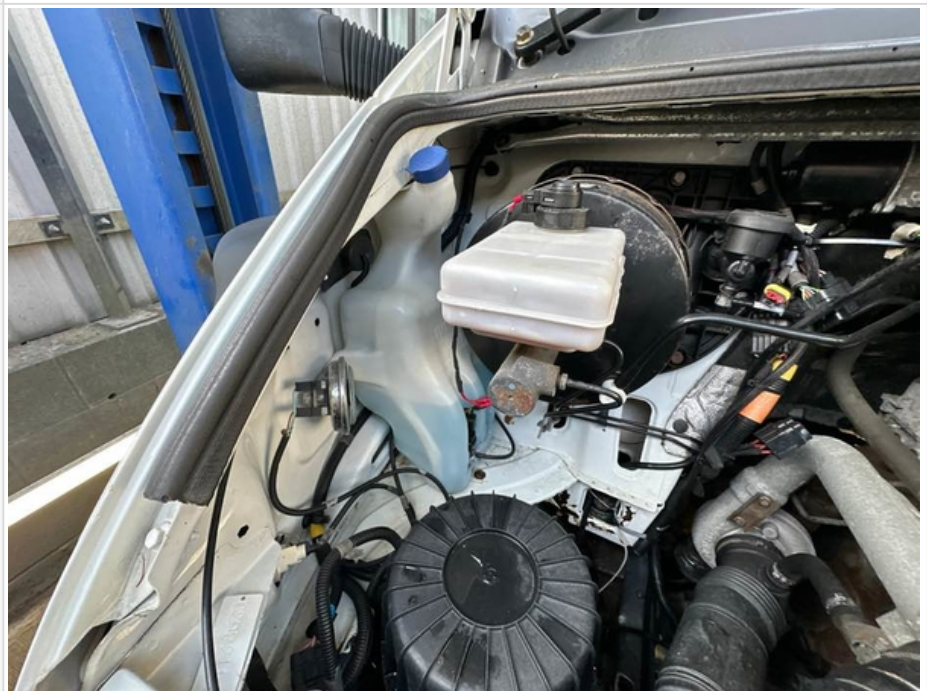
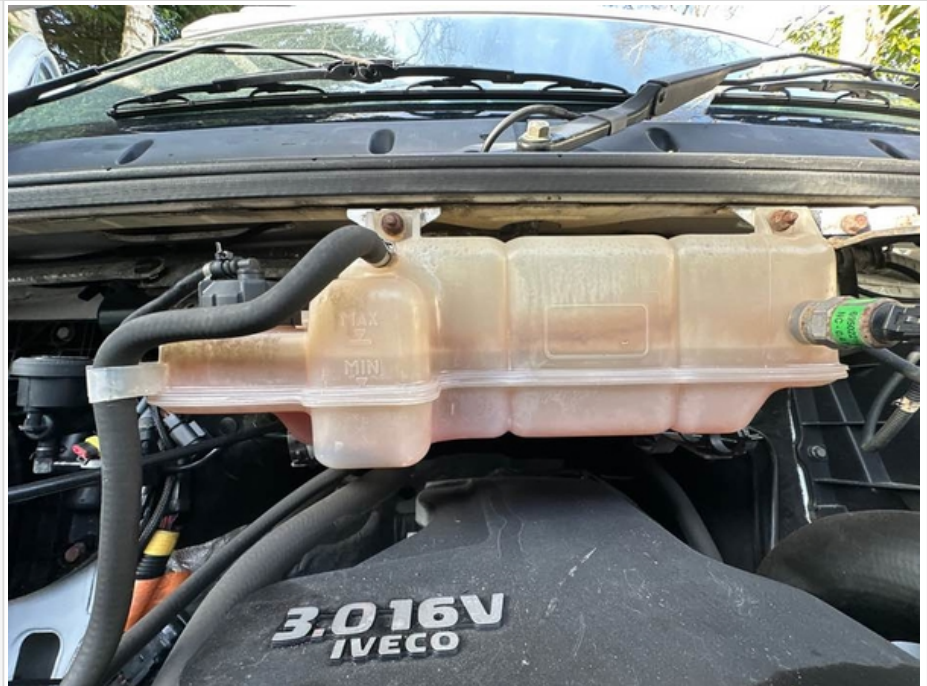
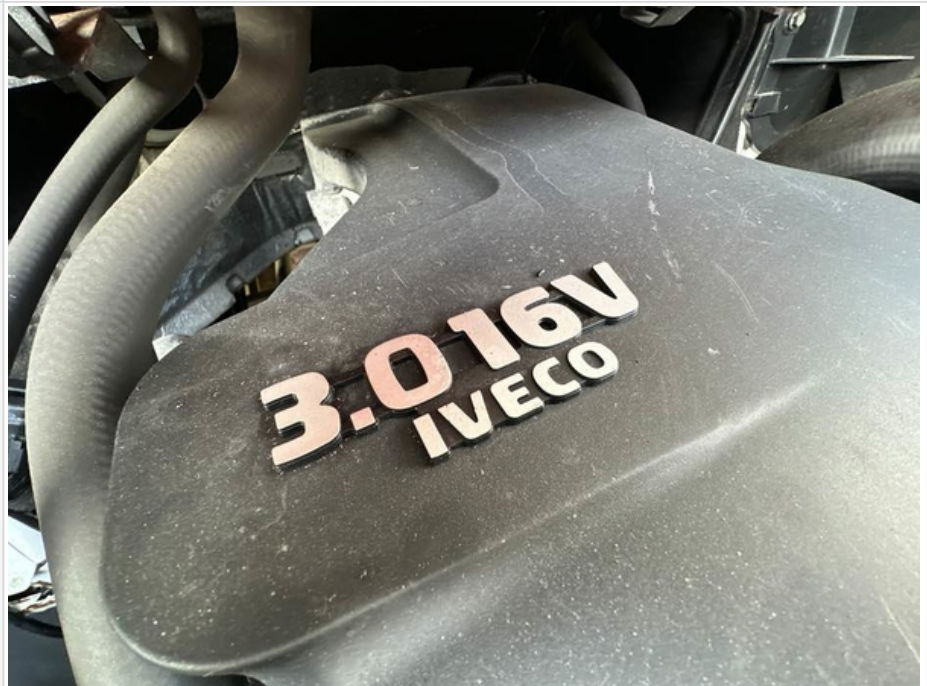
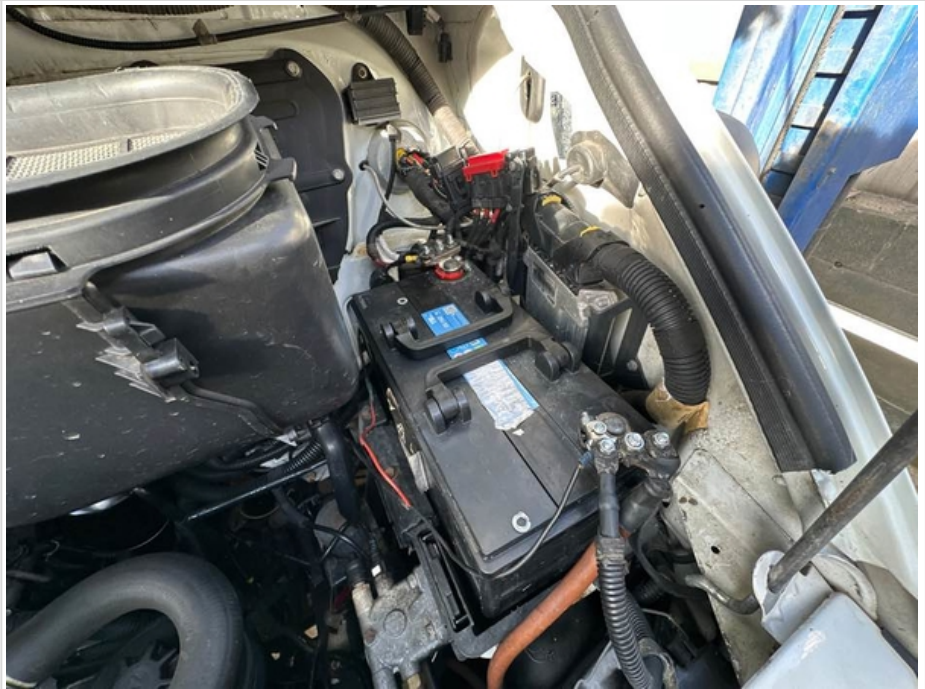
Engine bay photo

Fuel level	1/2 Full
Oil level	Full
Oil conditon	Clean
Start up, chassis battery check	Started, but required boost pack, Chassis battery requires charging
Start-up from cold	2 seconds
Exhaust smoke from cold	Normal
Output Voltage of Alternator test	13.6
Chain or Belt driven engine?	Chain
If belt any proof of change?	n/a
Coolant condition	Clean
Coolant level	Full
Anti-freeze temperature check	-16
Washer fluid	Full
Brake fluid	Full
Power steering fluid	Maximum
Dashboard warning light	No warning lights
OBD Scan results

mechanically good, battery terminals replaced as worn to point of no contact
