Basevan.com General Inspection

| Vehicle registration | LO14VGM |
| Make | peugeot |
| Model | boxer |

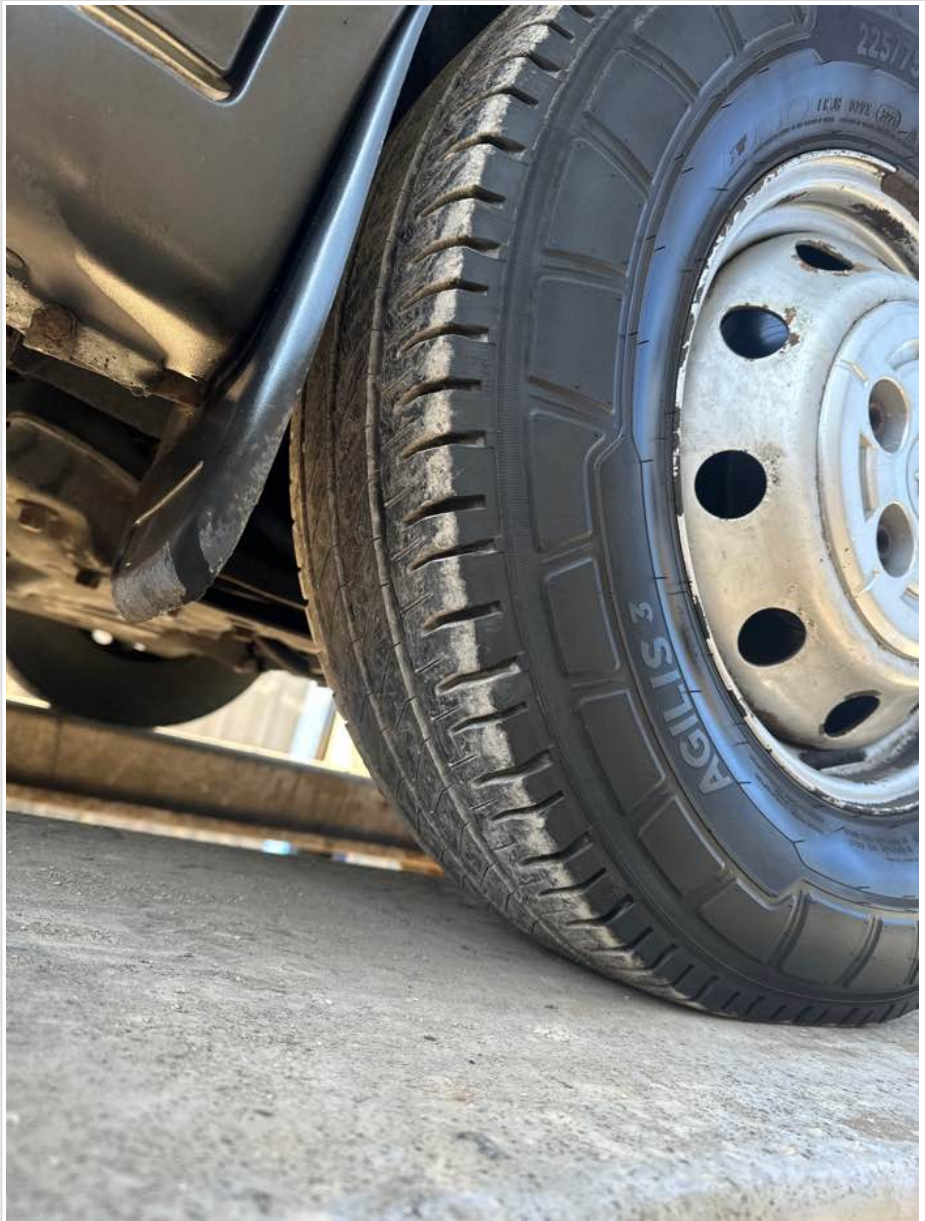
Off side front

| Wearing / Perishing (inner) | none |
| Wearing / Perishing (outer) | None |
| tread depth (mm) | 7 |
| General comments | great tyre |

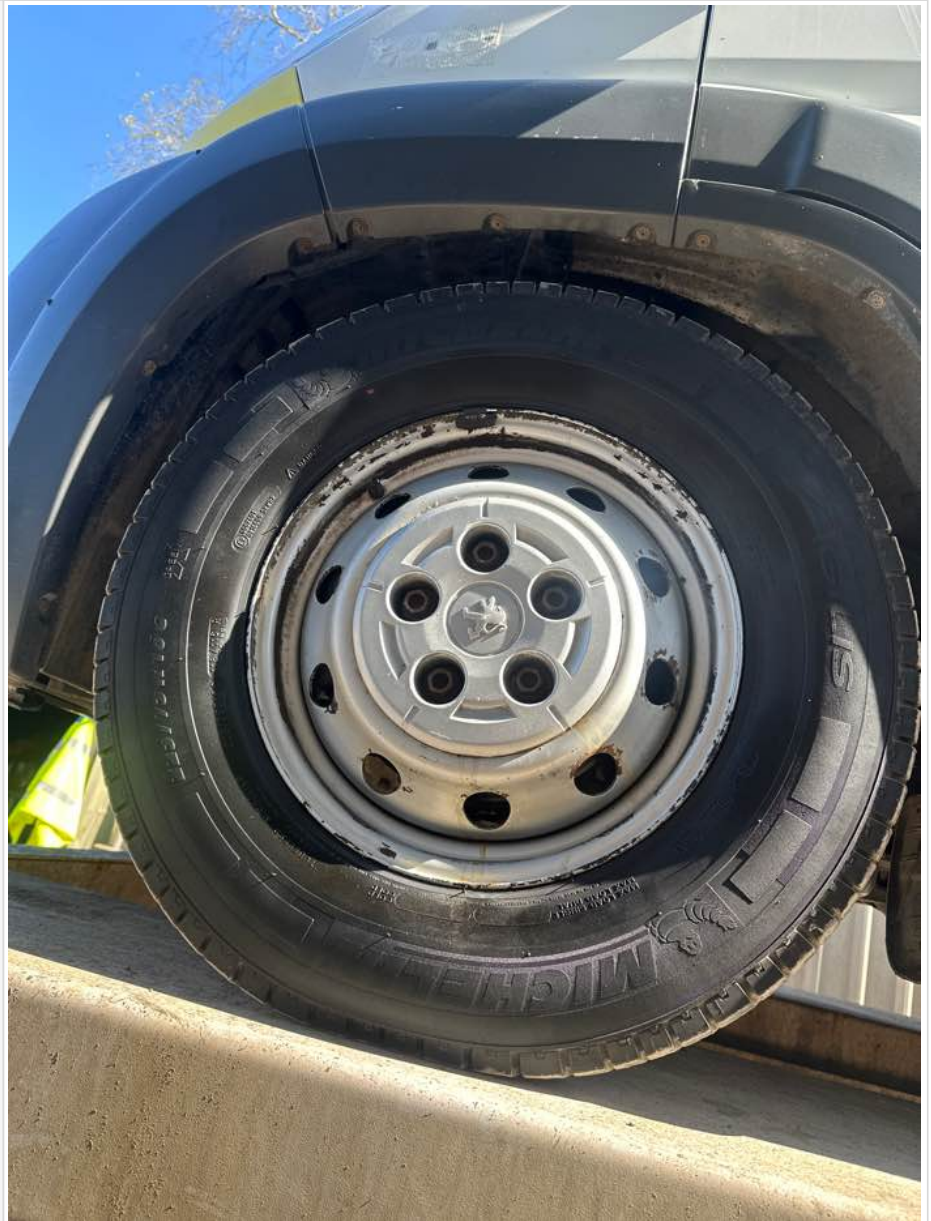
Near side front

| Wearing / Perishing (inner) | none |
| Wearing / Perishing (outer) | None |
| tread depth (mm) | 6 |
| General comments | good tyre but older than OS |

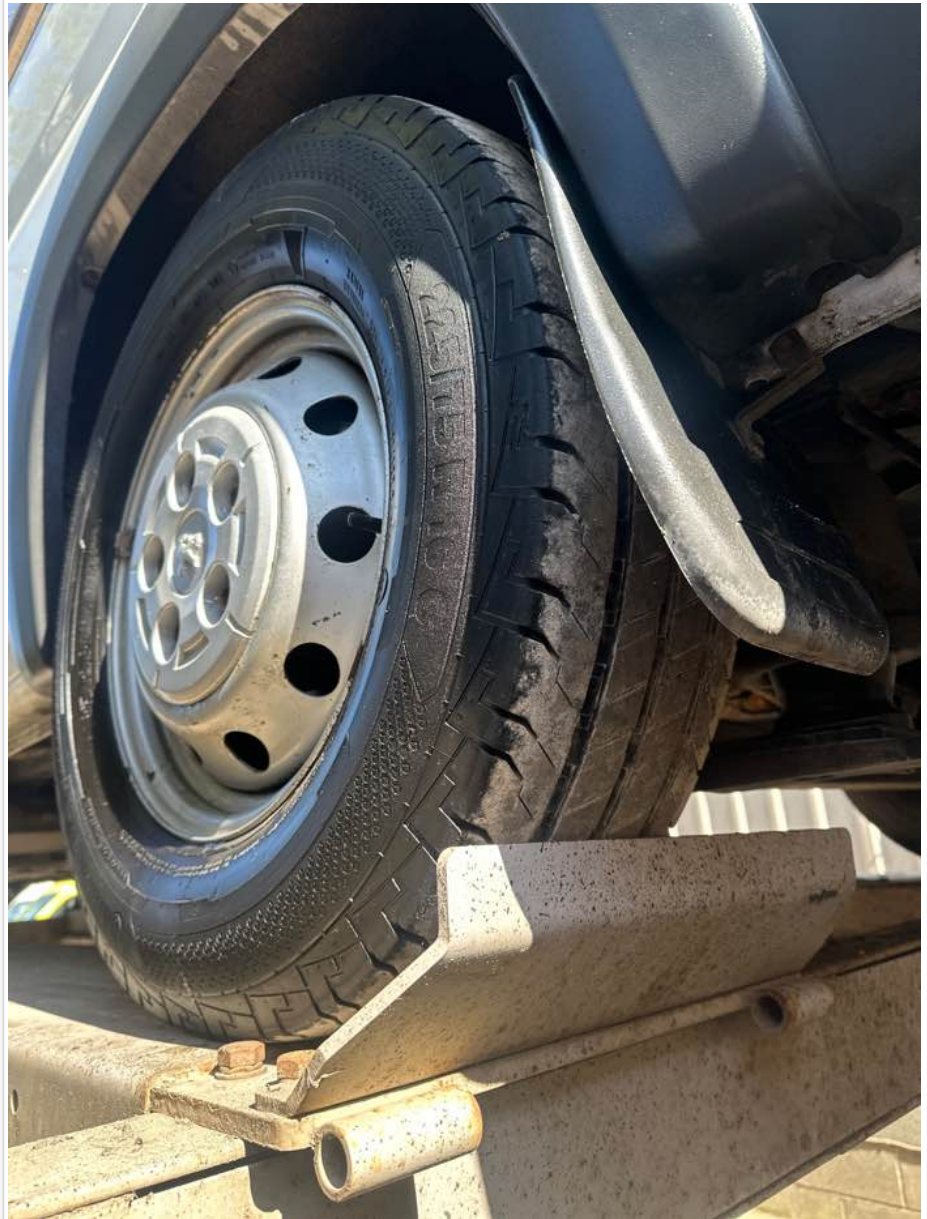
near side rear

| Wearing / Perishing (inner) | none |
| Wearing / Perishing (outer) | None |
| tread depth (mm) | 6 |
| General comments | good tyre, nice tread |

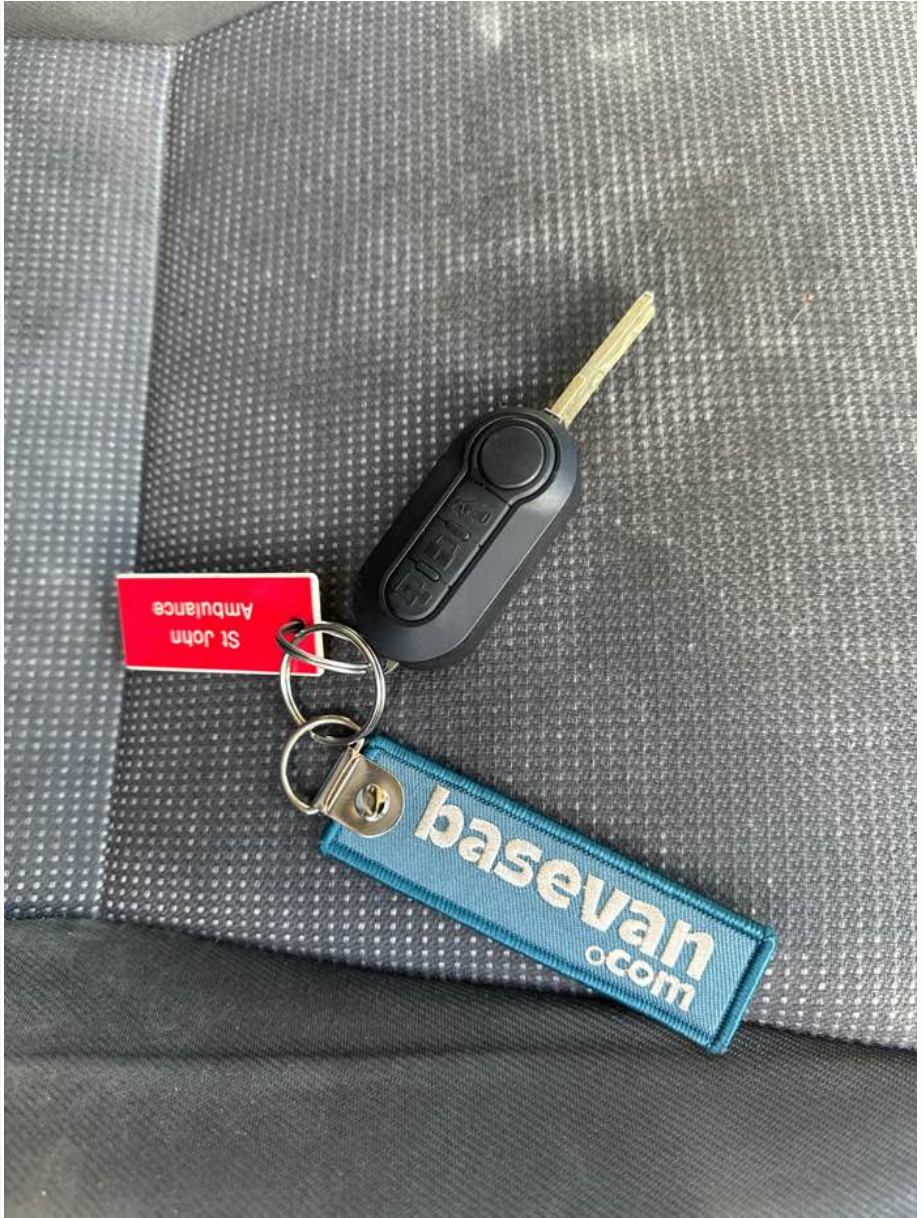
| Do all the doors lock from central locking function? | Some |

| Select the following doors that lock. | O/S Front |
| Method of locking | Key |
| In conclusion can all the doors be locked in some way and thus the vehicle can be left unattended at night safely? | No |
| | Drivers door locks off key - INSPECT CENTRAL LOCKING |
