Basevan.com General Inspection

Vehicle registration	CU11FWS
Vehicle chassis no.	VF1MAF4DE44739505
Miles (if in km, multiply by 0.62)	194281
Make	Renault
Model	Master
Transmission	Manual, 6 speed
Factory immobiliser installed	Yes
Speed limiter installed	Yes
Drive configuration	FWD
Gross Vehicle Weight (kg)	3500
Towing capacity	2500
Tow bar installed	No

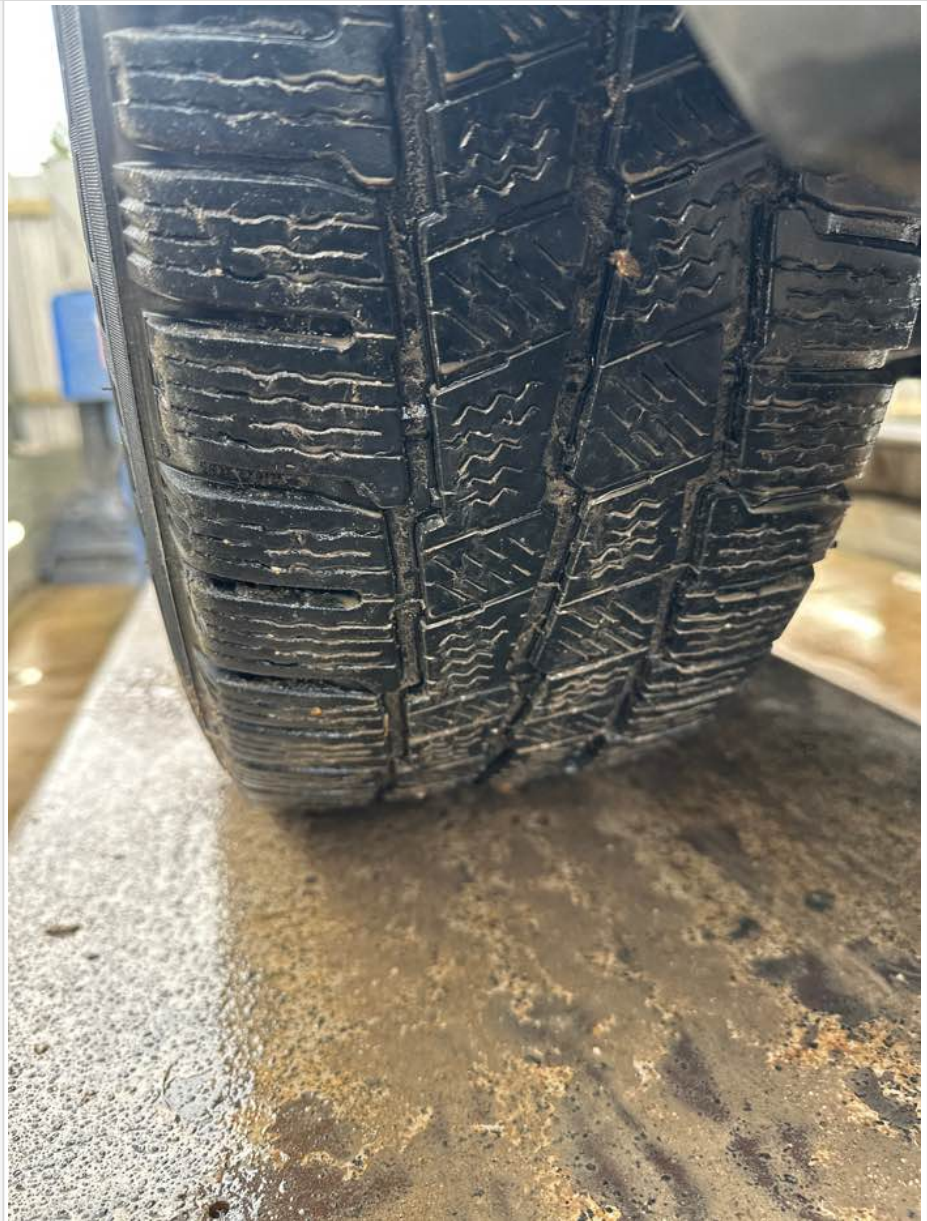
Off side front

Age (month/year) Manufactured	17/22
Make, brand.	Michelin
Tyre size	225/65/R16
Pressure 1	62
Pressure 2	
Wearing / Perishing (inner)	Slight
Wearing / Perishing (outer)	Slight
tread depth (mm)	6
General comments

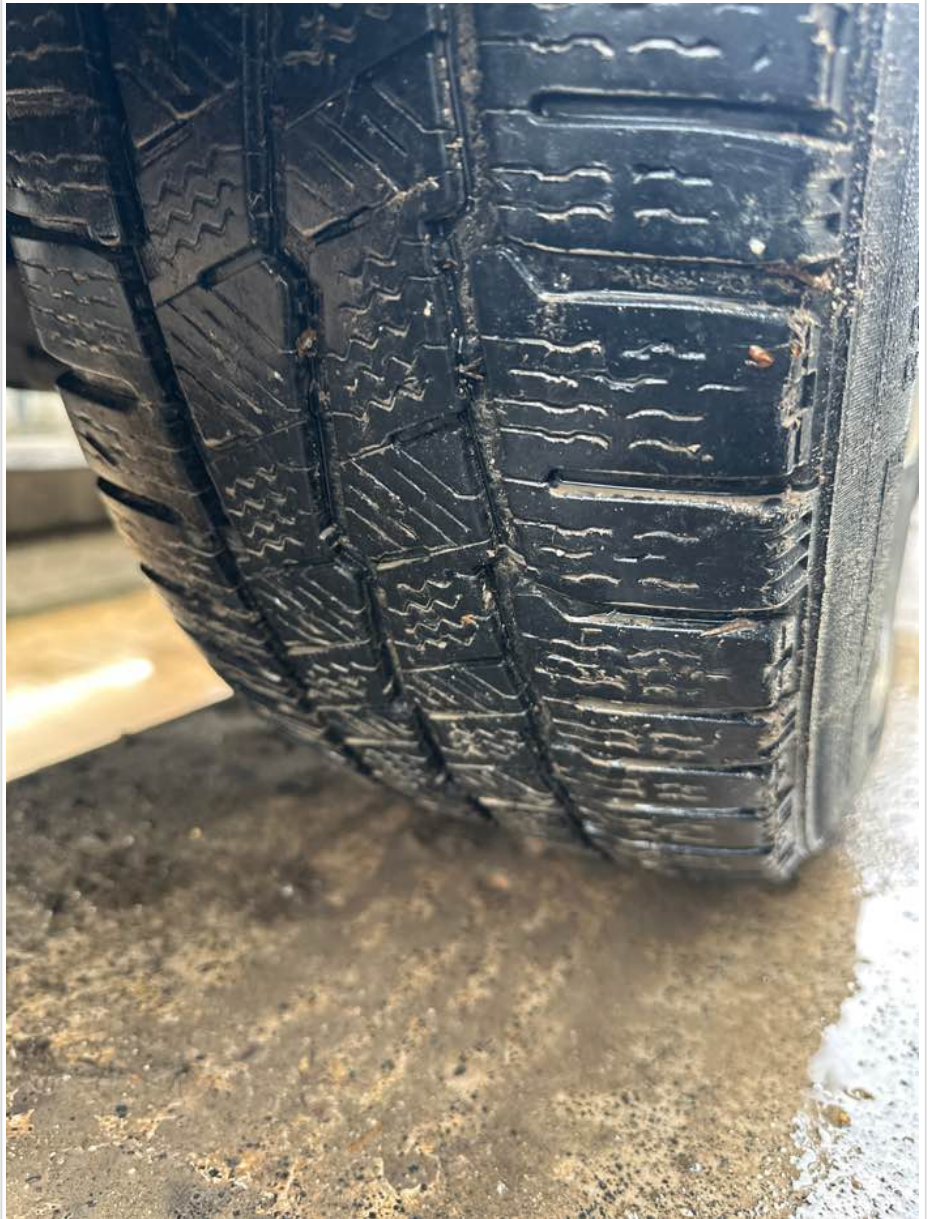
Near side front

Age (month/year) Manufactured	21/20
Make, brand.	Michelin
Tyre size	225/65/R16
Pressure 1	65
Pressure 2	
Wearing / Perishing (inner)	Slight
Wearing / Perishing (outer)	Slight
tread depth (mm)	6
General comments

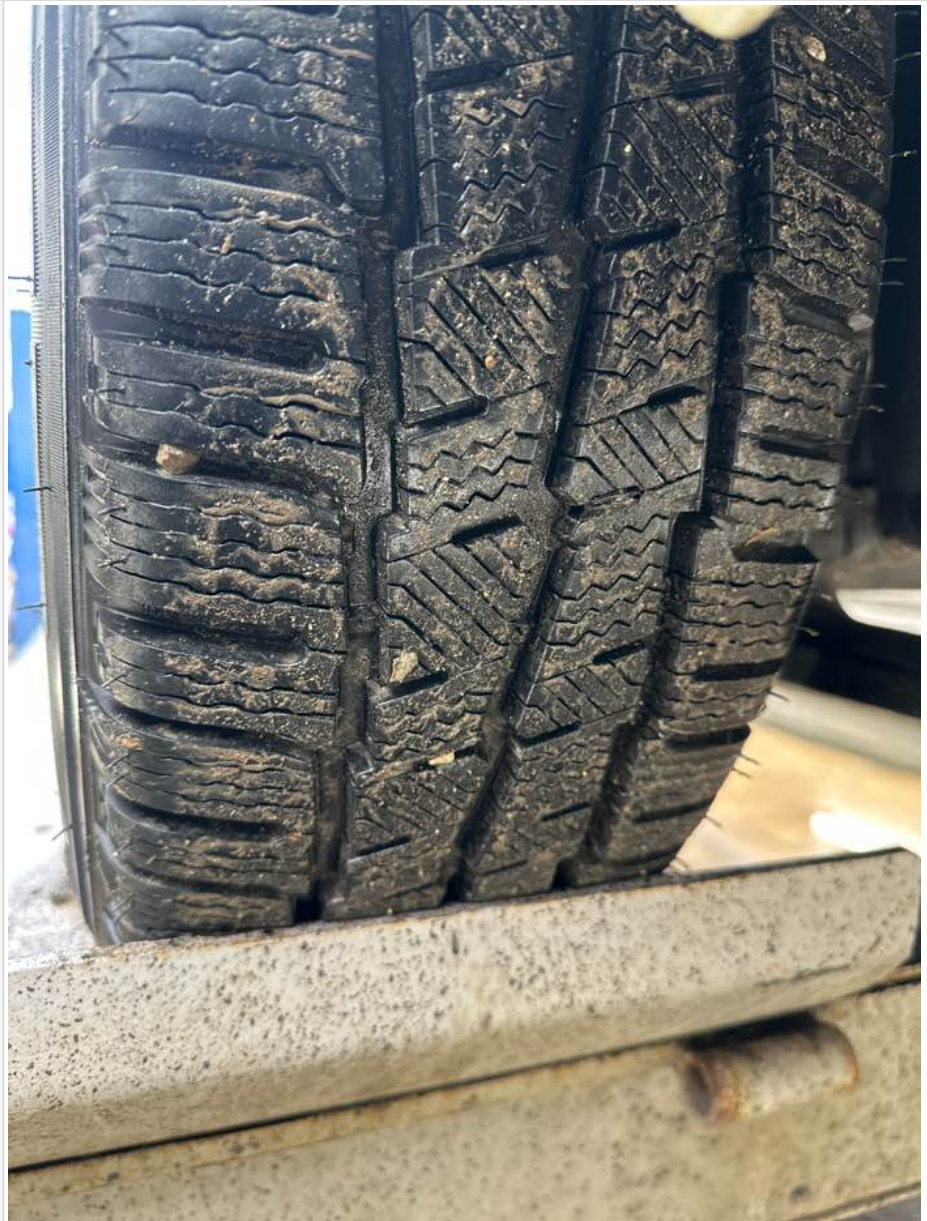
near side rear

Age (month/year) Manufactured	04/24
Make, brand.	Michelin
Tyre size	225/65/R16
Pressure 1	60
Pressure 2	
Wearing / Perishing (inner)	none
Wearing / Perishing (outer)	None
tread depth (mm)	9
General comments

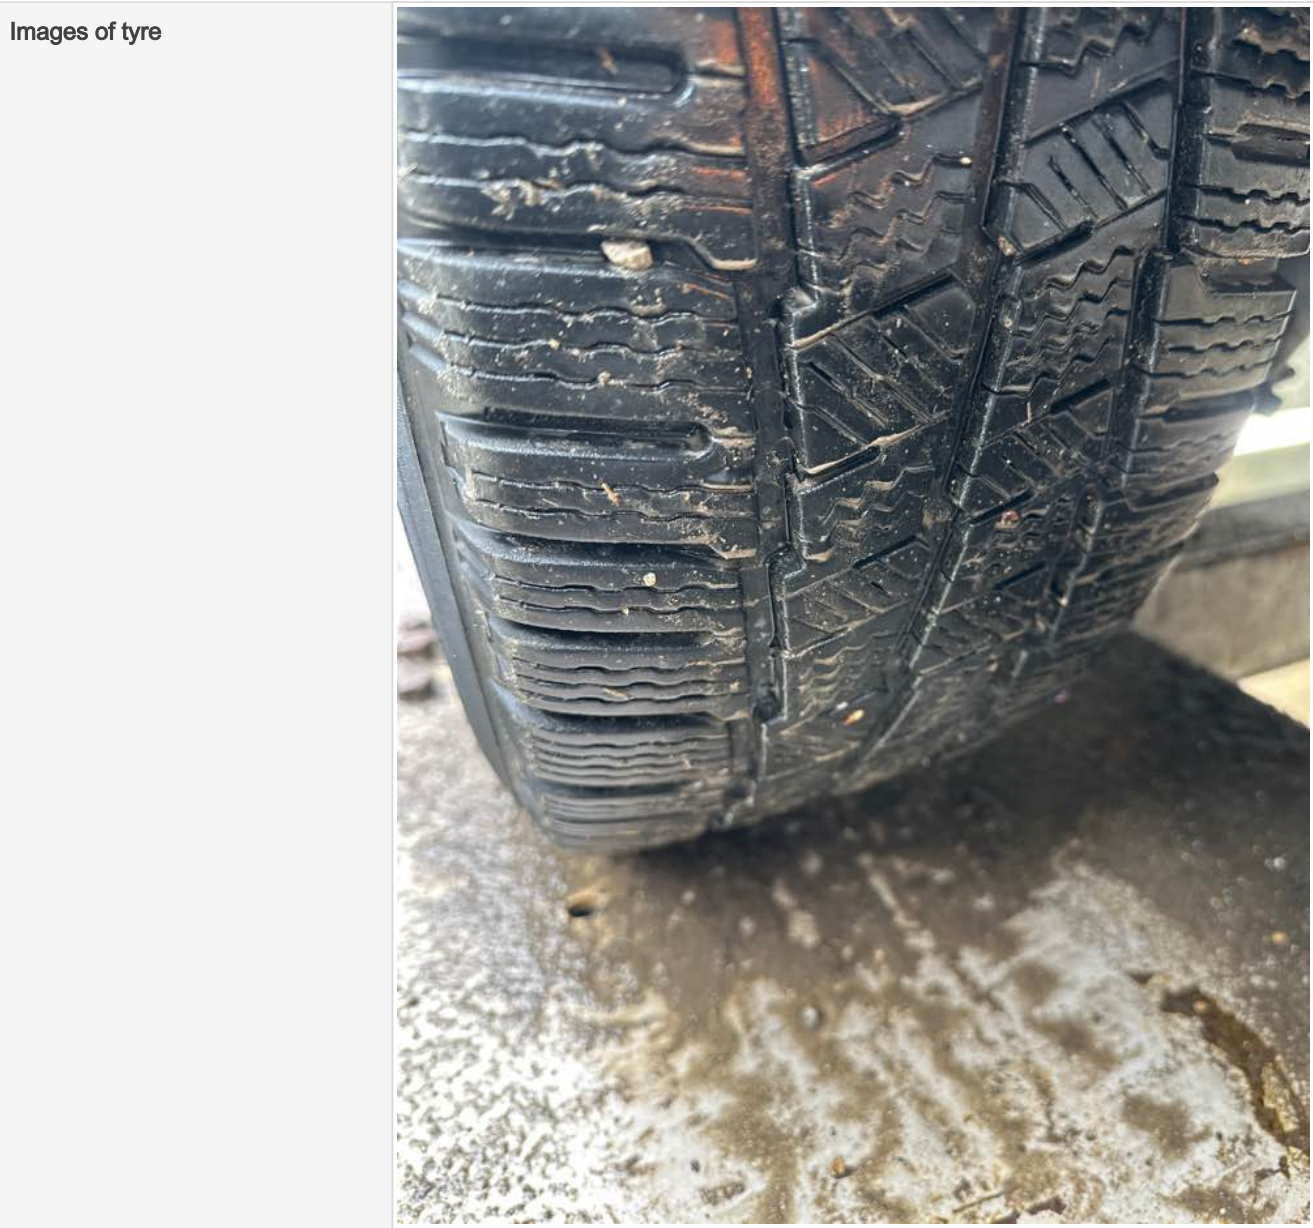
Off side rear

Age (month/year) Manufactured	33/22
Make, brand.	Michelin
Tyre size	225/65/R16
Pressure 1	60
Pressure 2	
Wearing / Perishing (inner)	Slight
Wearing / Perishing (outer)	Slight
tread depth (mm)	7
General comments

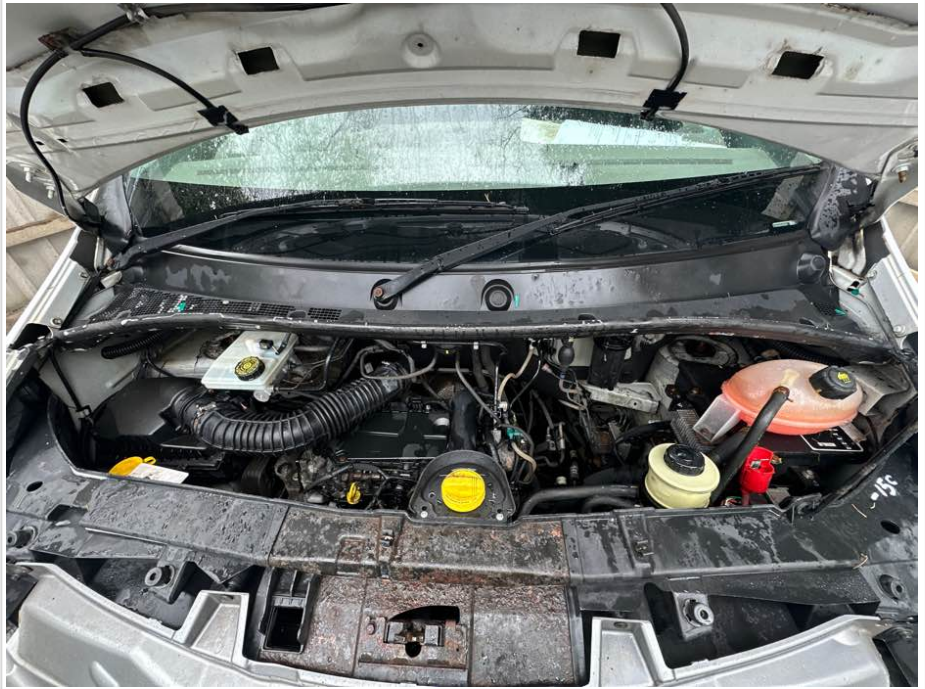
Engine bay photo

Fuel level	1/2 Full
Oil level	Full
Oil conditon	Clean
Start up, chassis battery check	Started without jump pack
Start-up from cold	2 seconds
Exhaust smoke from cold	Normal
Output Voltage of Alternator test	14.1
Chain or Belt driven engine?	Chain
If belt any proof of change?	N/A
Coolant condition	Clean
Coolant level	Full
Anti-freeze temperature check	-15
Washer fluid	Medium
Brake fluid	Full
Power steering fluid	Maximum
Dashboard warning light	No warning lights
OBD Scan results
