## Basevan.com General Inspection

Vehicle registration	YJ14HSD
Vehicle chassis no.	VF1MAF4SE50062278
Miles (if in km, multiply by 0.62)	51313
Make	Renault
Model	Master
Transmission	Manual, 6 speed
Factory immobiliser installed	Yes
Speed limiter installed	N/A
Drive configuration	FWD
Gross Vehicle Weight (kg)	3500
Towing capacity	2500
Tow bar installed	No

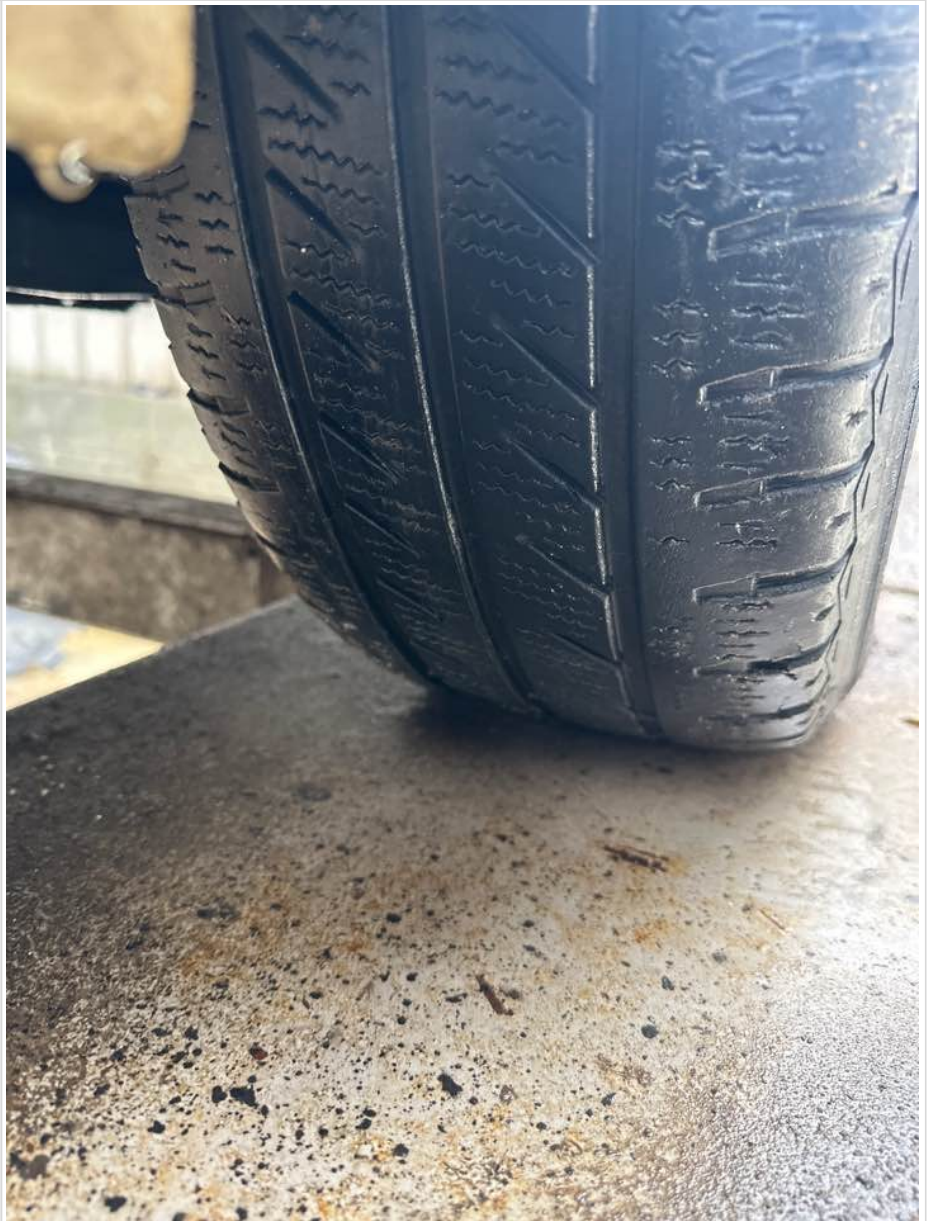
Images of tyre

Age (month/year) Manufactured	47/20
Make, brand.	Good Year
Tyre size	225/65/R16
Pressure 1	30
Pressure 2	
Wearing / Perishing (inner)	Medium
Wearing / Perishing (outer)	Medium
tread depth (mm)	5
General comments

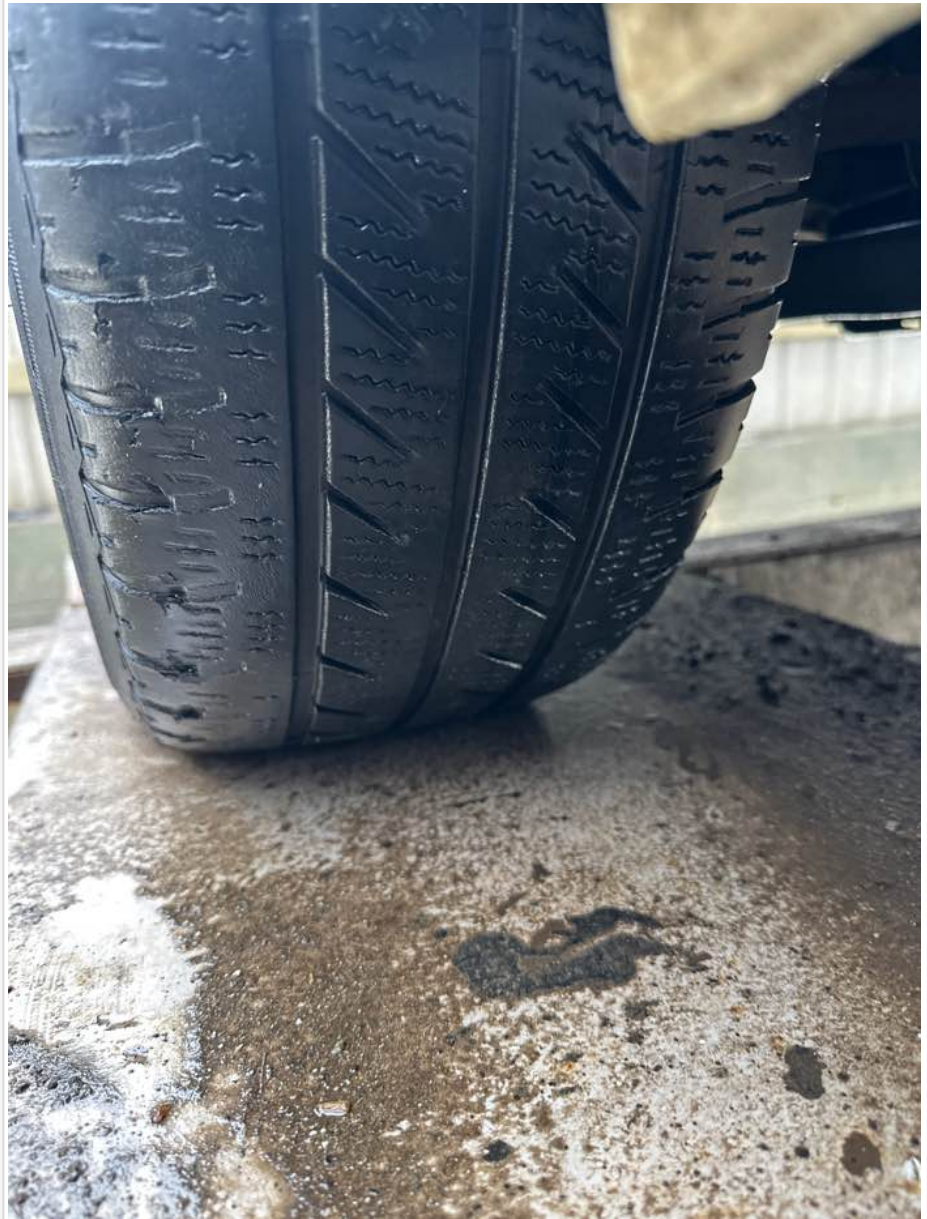
Images of tyre

Age (month/year) Manufactured	42/20
Make, brand.	Good Year
Tyre size	225/65/R16
Pressure 1	30
Pressure 2	
Wearing / Perishing (inner)	Medium
Wearing / Perishing (outer)	Medium
tread depth (mm)	5
General comments

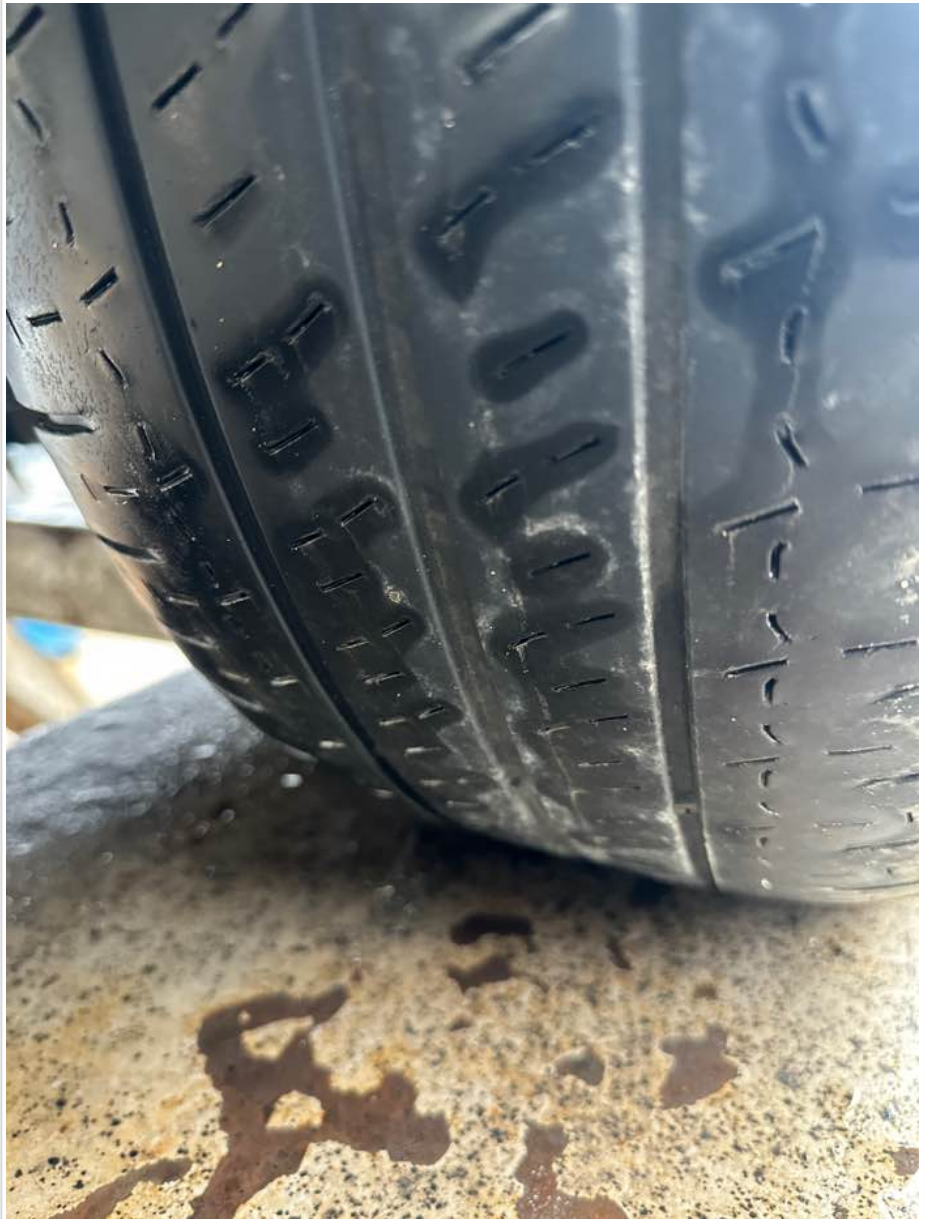
Images of tyre

Age (month/year) Manufactured	42/13
Make, brand.	Michelin
Tyre size	225/65/R16
Pressure 1	46
Pressure 2	
Wearing / Perishing (inner)	Replace soon
Wearing / Perishing (outer)	Replace soon
tread depth (mm)	3
General comments

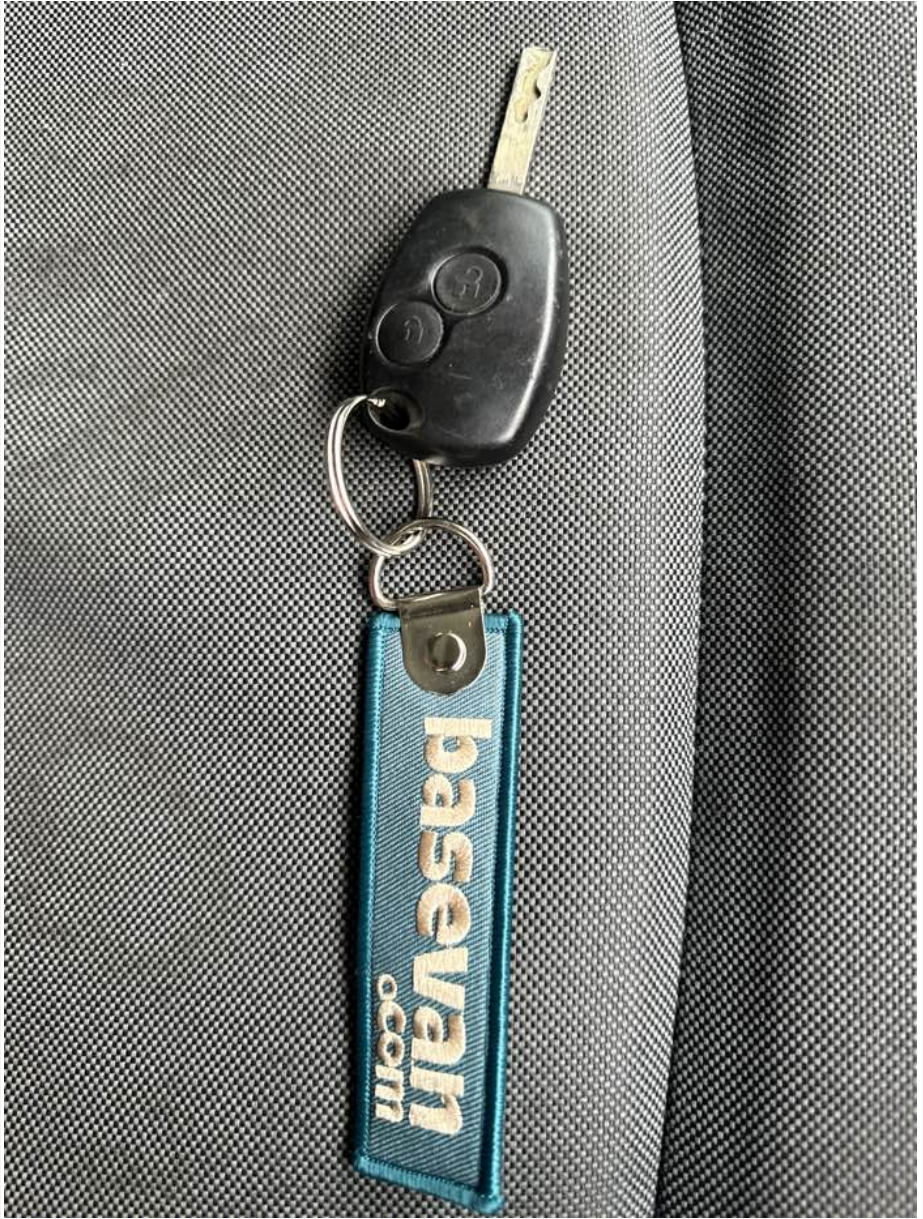
Select the following doors that lock.	N/S Front, O/S Front, N/S SL, N/S Rear, O/S Rear
Method of locking	Fob
In conclusion can all the doors be locked in some way and thus the vehicle can be left unattended at night safely?	Yes
How many keys present at time of inspection?

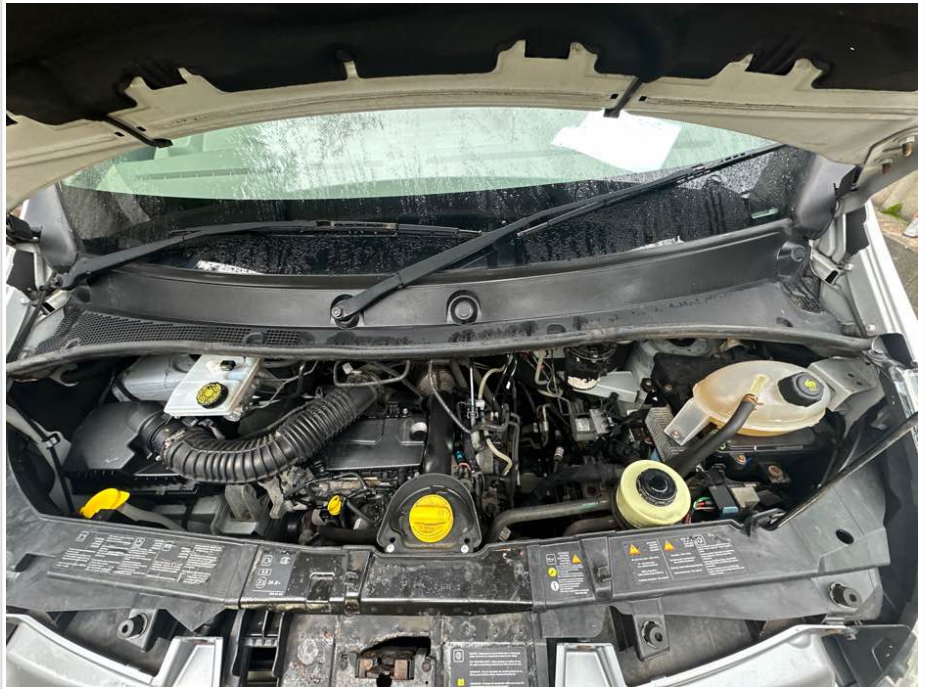
Engine bay photo

Fuel level	1/2 Full
Oil level	Medium
Oil conditon	Service due soon
Start up, chassis battery check	Started without jump pack
Start-up from cold	2 seconds
Exhaust smoke from cold	Normal
Output Voltage of Alternator test	14.1
Chain or Belt driven engine?	Chain
If belt any proof of change?	N/A
Coolant condition	Clean
Coolant level	Medium
Anti-freeze temperature check	-17
Washer fluid	Medium
Brake fluid	Full
Power steering fluid	Miniumum
Dashboard warning light	No warning lights
OBD Scan results
