Basevan.com General Inspection

Vehicle registration	LG57KMV
Vehicle chassis no.	VN1F9C1H637523301
Miles (if in km, multiply by 0.62)	50,893
Make	Vauxhall
Model	Movano
Transmission	Manual, 6 speed
Factory immobiliser installed	Yes
Speed limiter installed	Yes
Drive configuration	FWD
Gross Vehicle Weight (kg)	3500
Towing capacity	2500
Tow bar installed	No

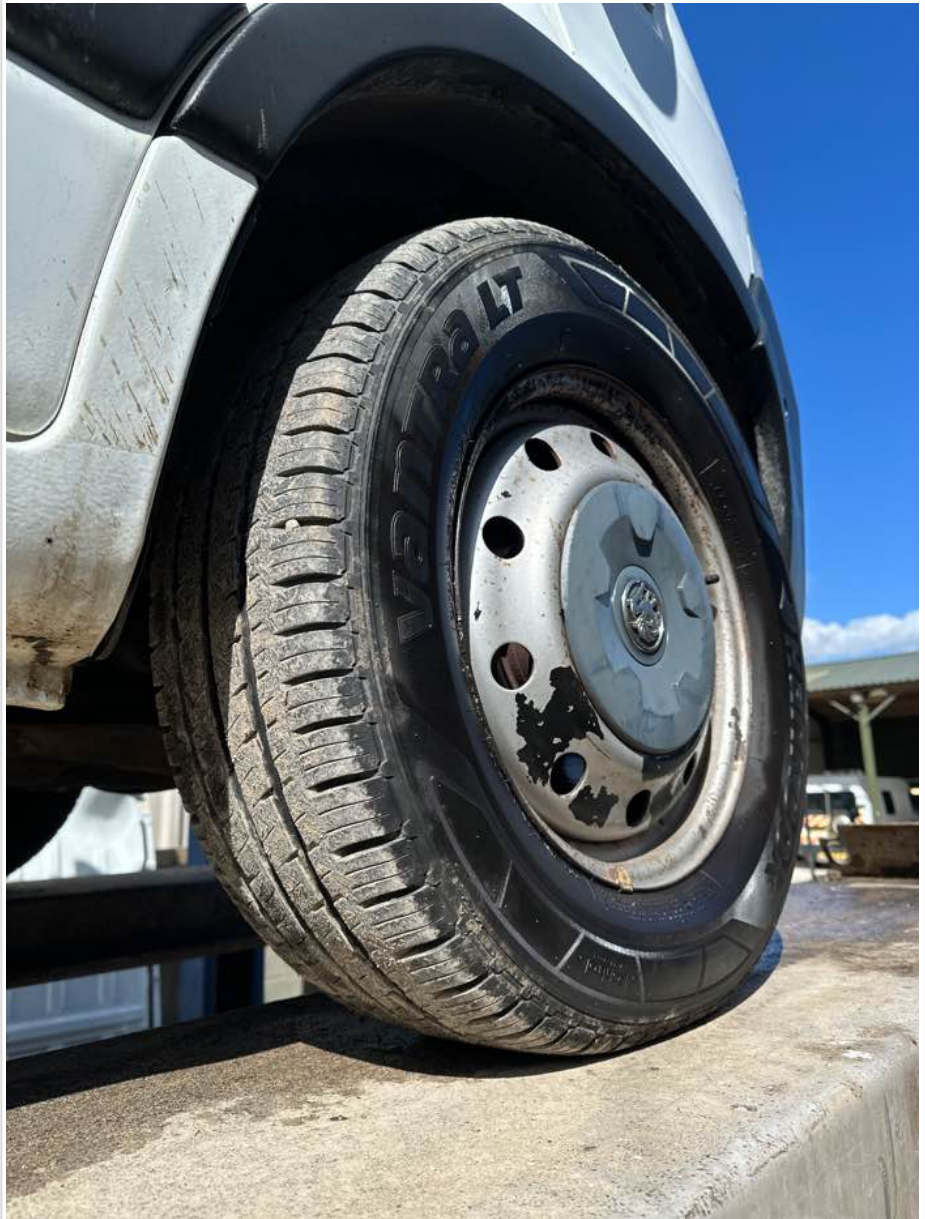
Off side front

Age (month/year) Manufactured	49/20
Make, brand.	Hankook
Tyre size	225/65/R16
Pressure 1	
Pressure 2	
Wearing / Perishing (inner)	none
Wearing / Perishing (outer)	None
tread depth (mm)	7
General comments	virtually brand new

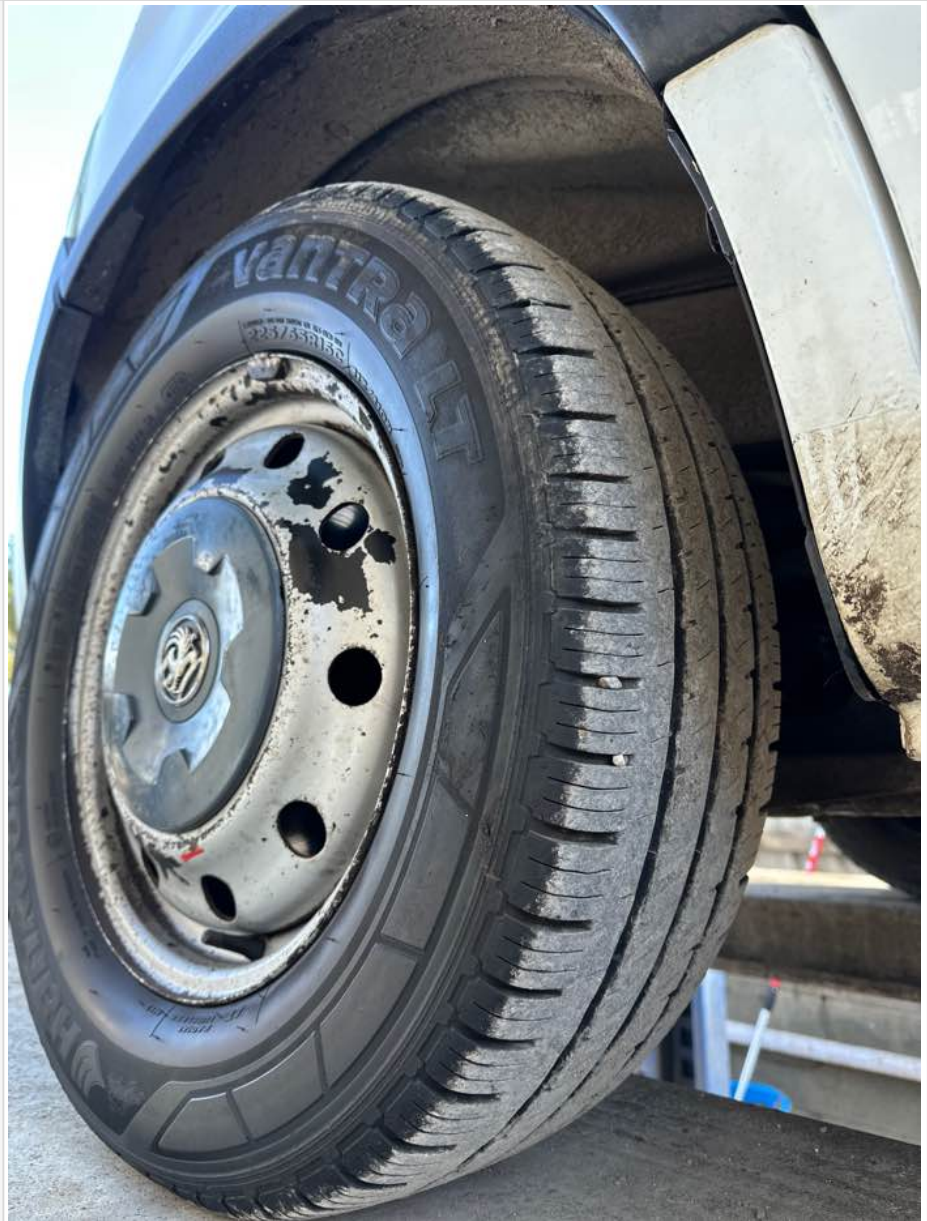
Near side front

Age (month/year) Manufactured	49/20
Make, brand.	Hankook
Tyre size	225/65/R16
Pressure 1	
Pressure 2	
Wearing / Perishing (inner)	none
Wearing / Perishing (outer)	None
tread depth (mm)	7
General comments	matches offside

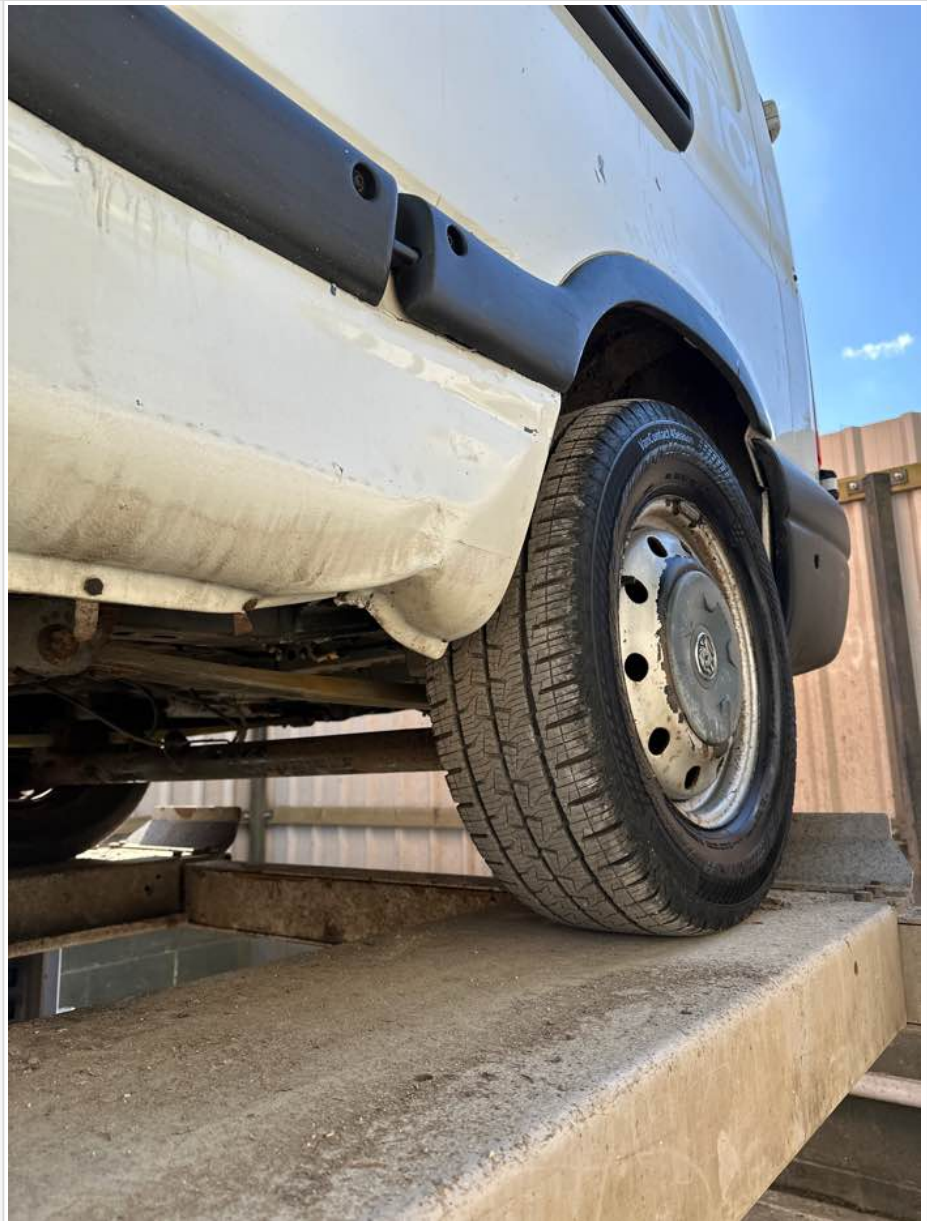
near side rear

Age (month/year) Manufactured	51/22
Make, brand.	Continental
Tyre size	235/65/R16
Pressure 1	
Pressure 2	
Wearing / Perishing (inner)	none
Wearing / Perishing (outer)	None
tread depth (mm)	8
General comments	possible reason for recent tyre pictured below + Irregular size

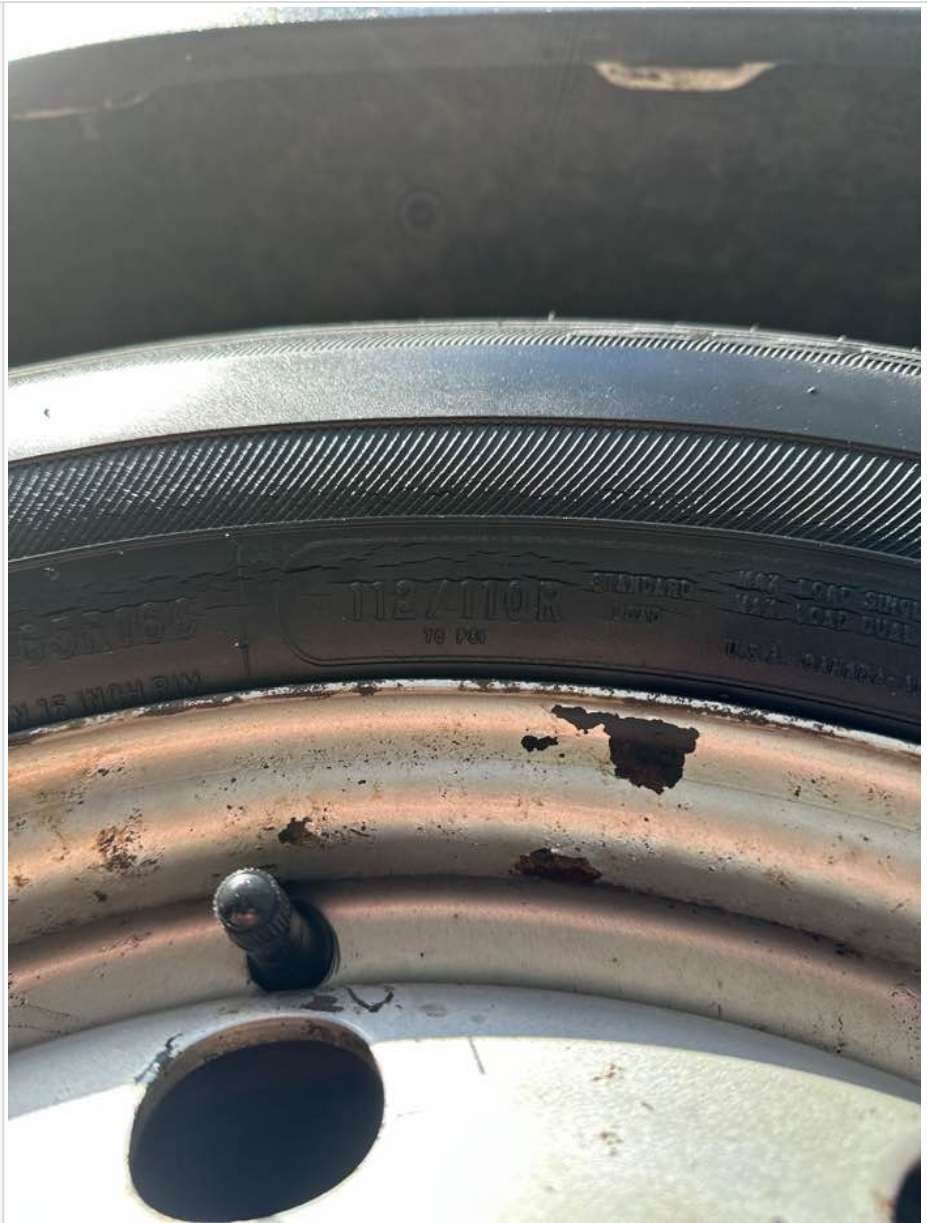
Off side rear

Age (month/year) Manufactured	39/16
Make, brand.	Cooper
Tyre size	225/65/R16
Pressure 1	
Pressure 2	
Wearing / Perishing (inner)	Dangerous, replace
Wearing / Perishing (outer)	Dangerous, Replace
tread depth (mm)	7
General comments	Perishing BAD

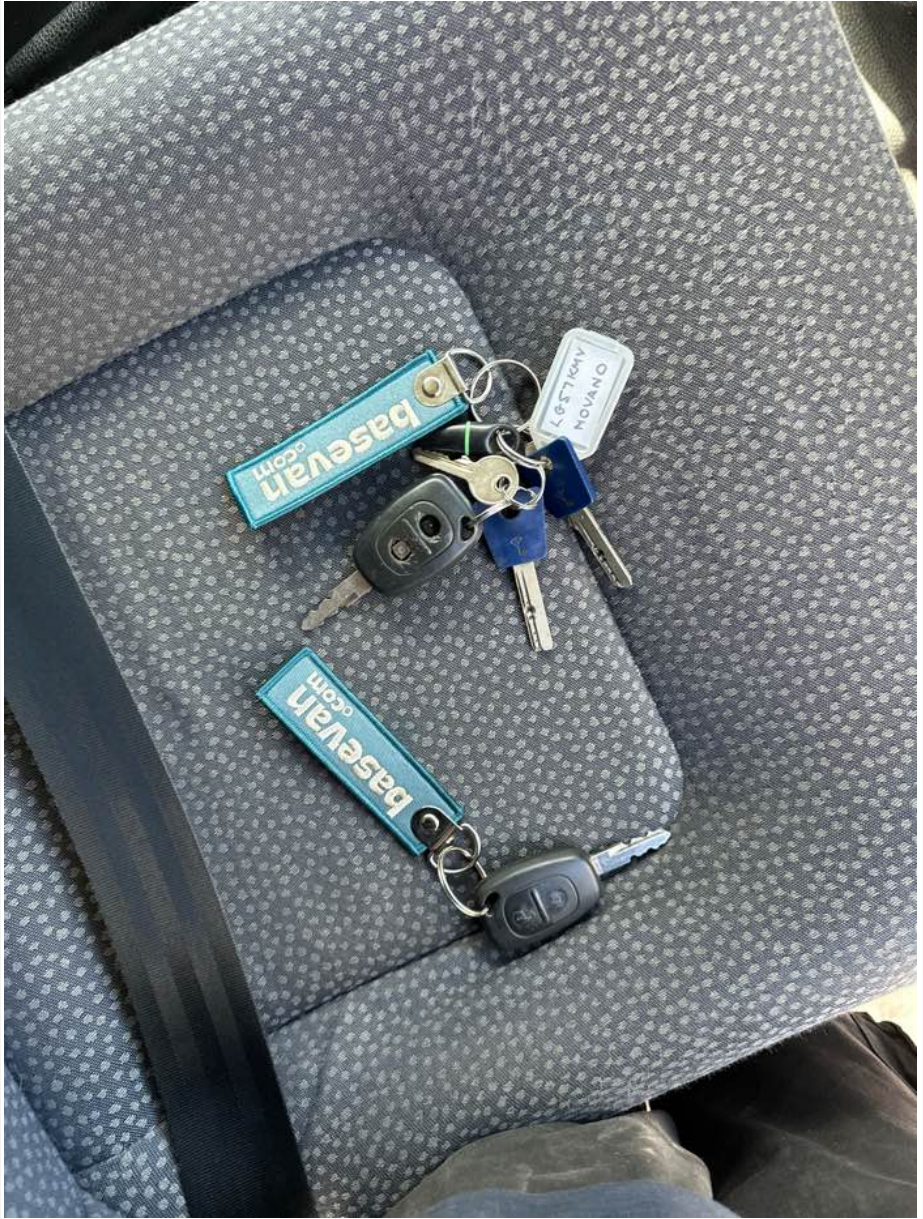
Select the following doors that lock.	N/S Front, O/S Front, N/S SL, N/S Rear, O/S Rear
Method of locking	Key, Fob
In conclusion can all the doors be locked in some way and thus the vehicle can be left unattended at night safely?	Yes
How many keys present at time of inspection?

Comment	
	Rear doors lock only on deadlock / key

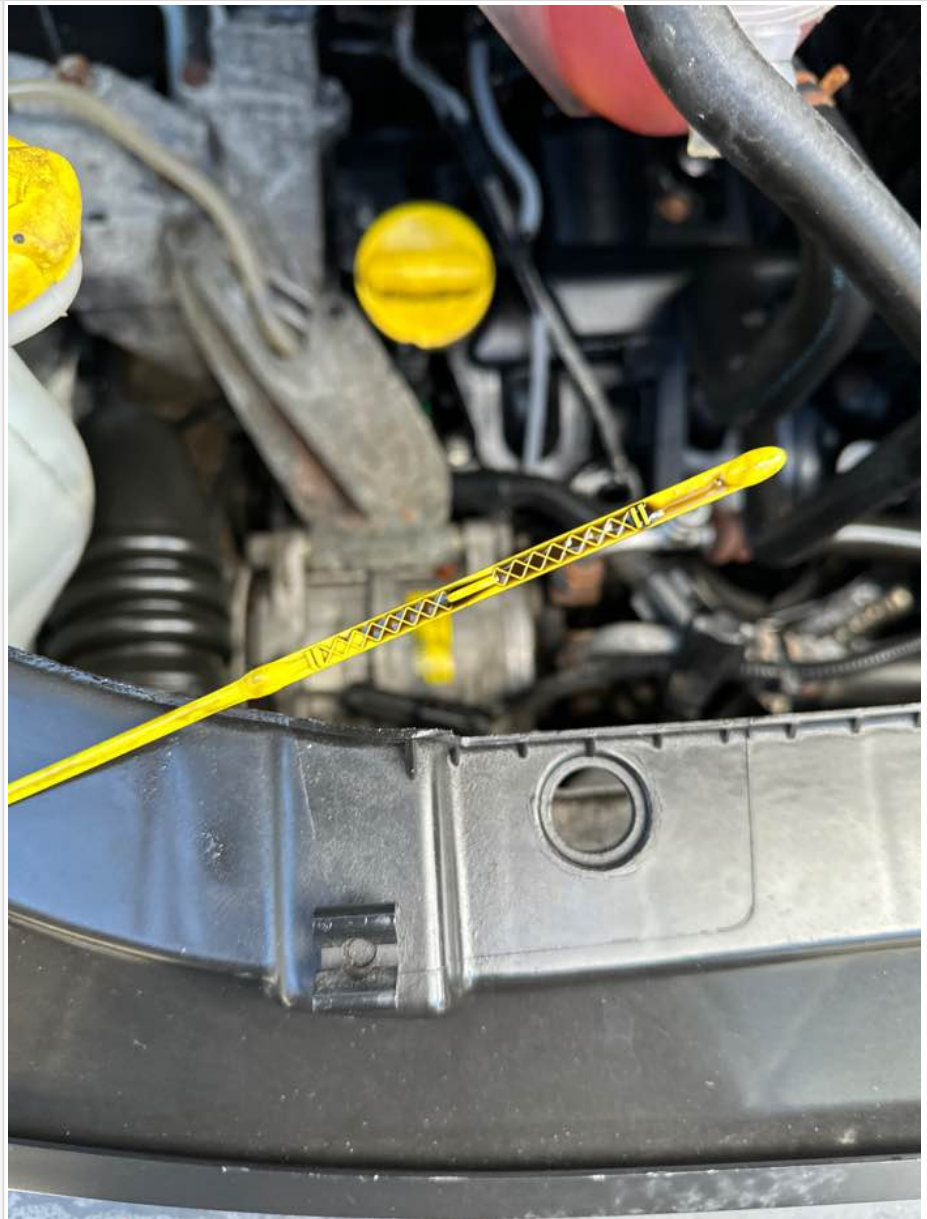
Engine bay photo

Fuel level	1/2 Full
Oil level	Full
Oil conditon	Clean
Start up, chassis battery check	Started without jump pack
Start-up from cold	Instant
Exhaust smoke from cold	Normal
Output Voltage of Alternator test	13.9
Chain or Belt driven engine?	Belt
If belt any proof of change?	No
Coolant condition	Clean
Coolant level	Full
Anti-freeze temperature check	-16
Washer fluid	Medium
Brake fluid	Full
Power steering fluid	Maximum
Dashboard warning light	No warning lights
OBD Scan results

sweet mechanically
