Basevan.com General Inspection

Vehicle registration	OY63LYF
Vehicle chassis no.	WOLMTF8FKCB042785
Miles (if in km, multiply by 0.62)	56,195
Make	Vauxhall
Model	Movano
Transmission	Manual, 6 speed
Factory immobiliser installed	Yes
Speed limiter installed	No
Drive configuration	RWD
Gross Vehicle Weight (kg)	4500
Towing capacity	3000kg
Tow bar installed	No

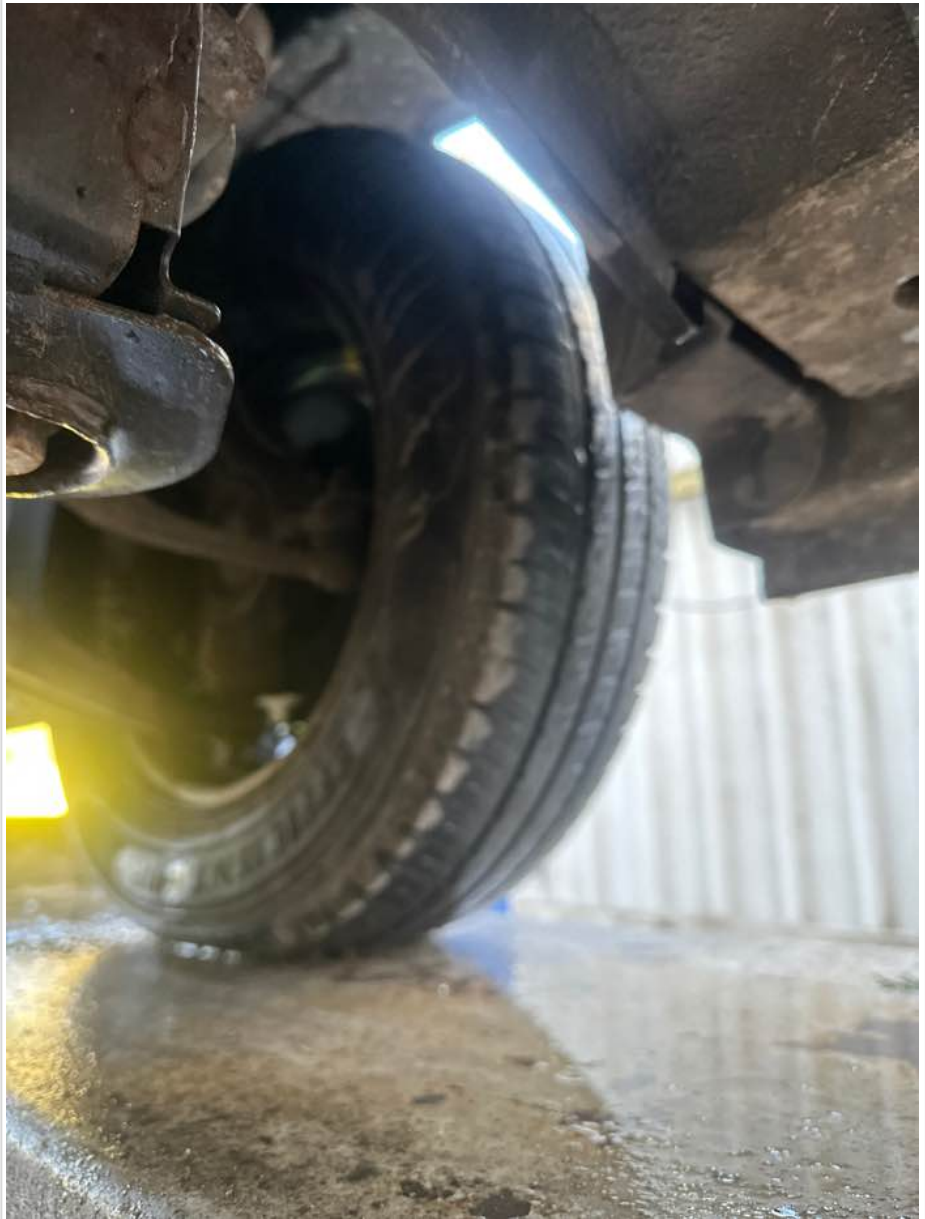
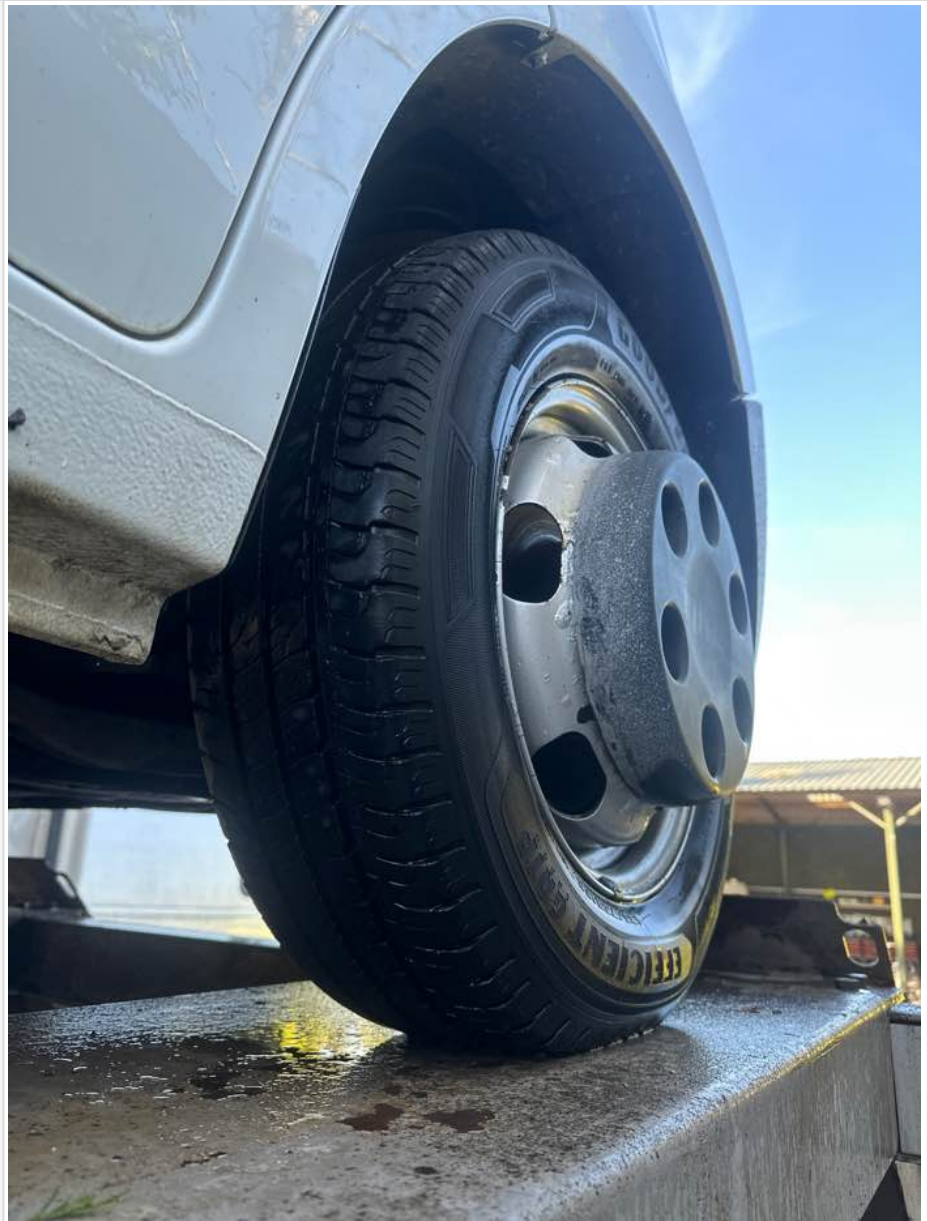
Off side front

Age (month/year) Manufactured	40/19
Make, brand.	Good Year
Tyre size	195/75/R16
Pressure 1	
Pressure 2	60
Wearing / Perishing (inner)	none
Wearing / Perishing (outer)	None
tread depth (mm)	7
General comments	very good tyre, top of range

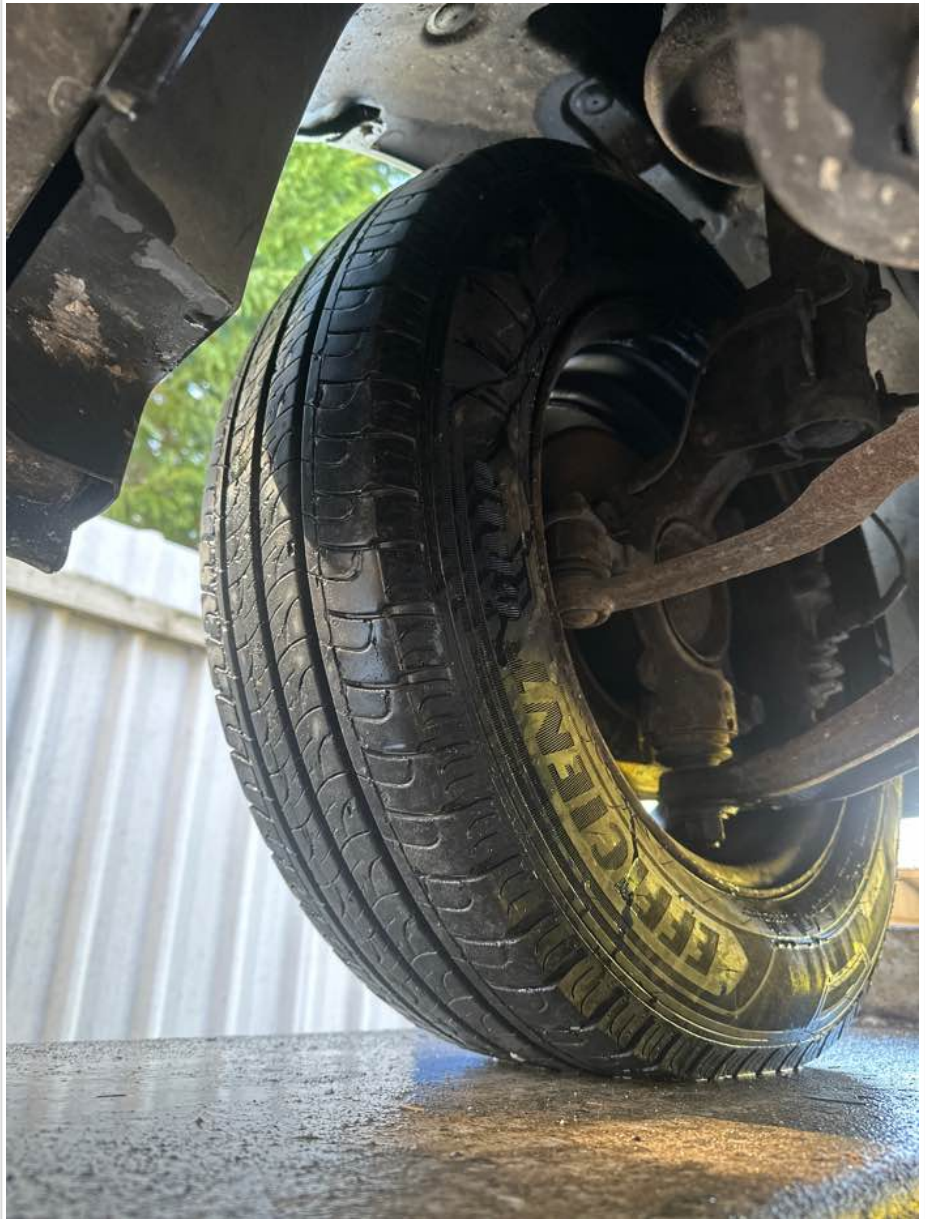
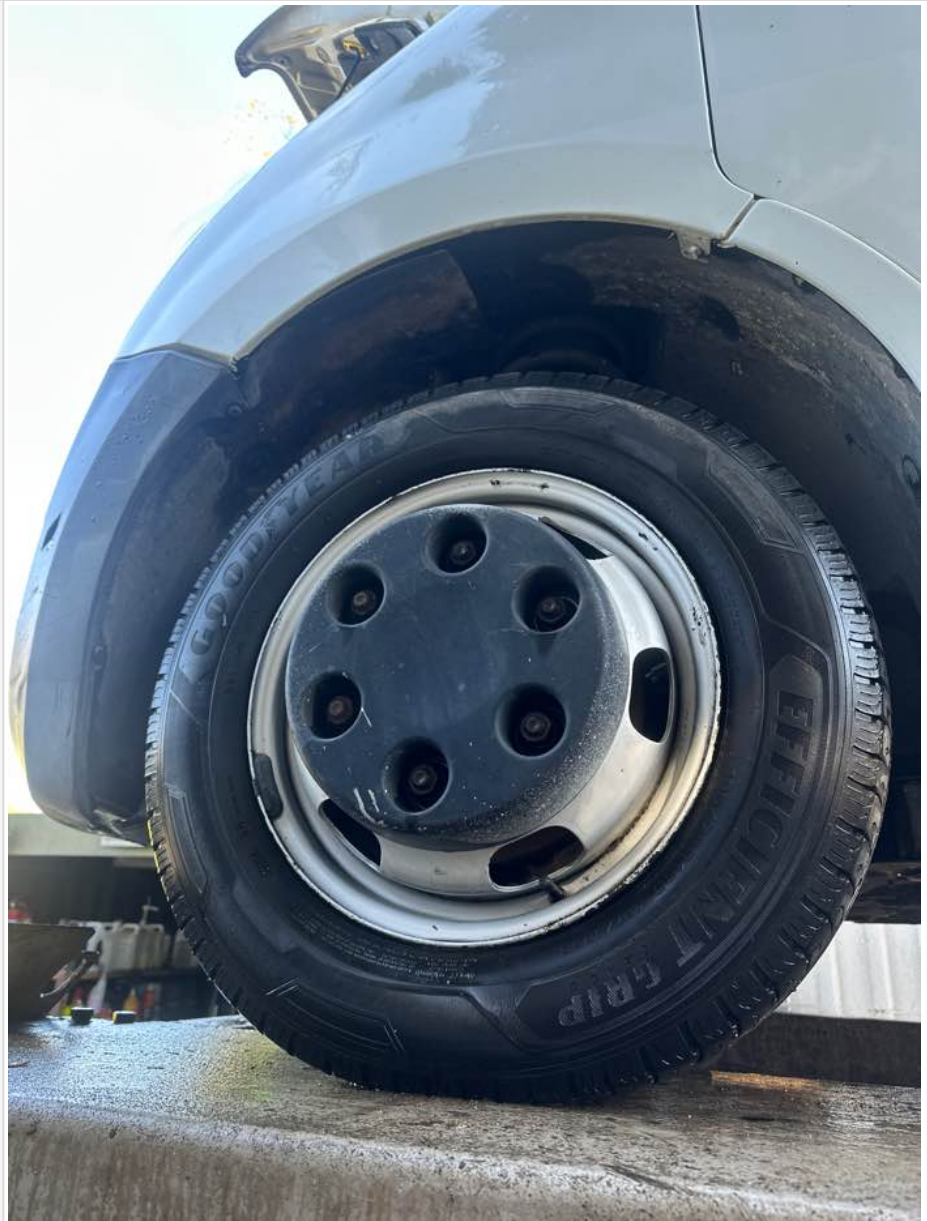
Near side front

Age (month/year) Manufactured	35/21
Make, brand.	Good Year
Tyre size	195/75/R16
Pressure 1	
Pressure 2	60
Wearing / Perishing (inner)	none
Wearing / Perishing (outer)	None
tread depth (mm)	7
General comments	good tyre, top of range

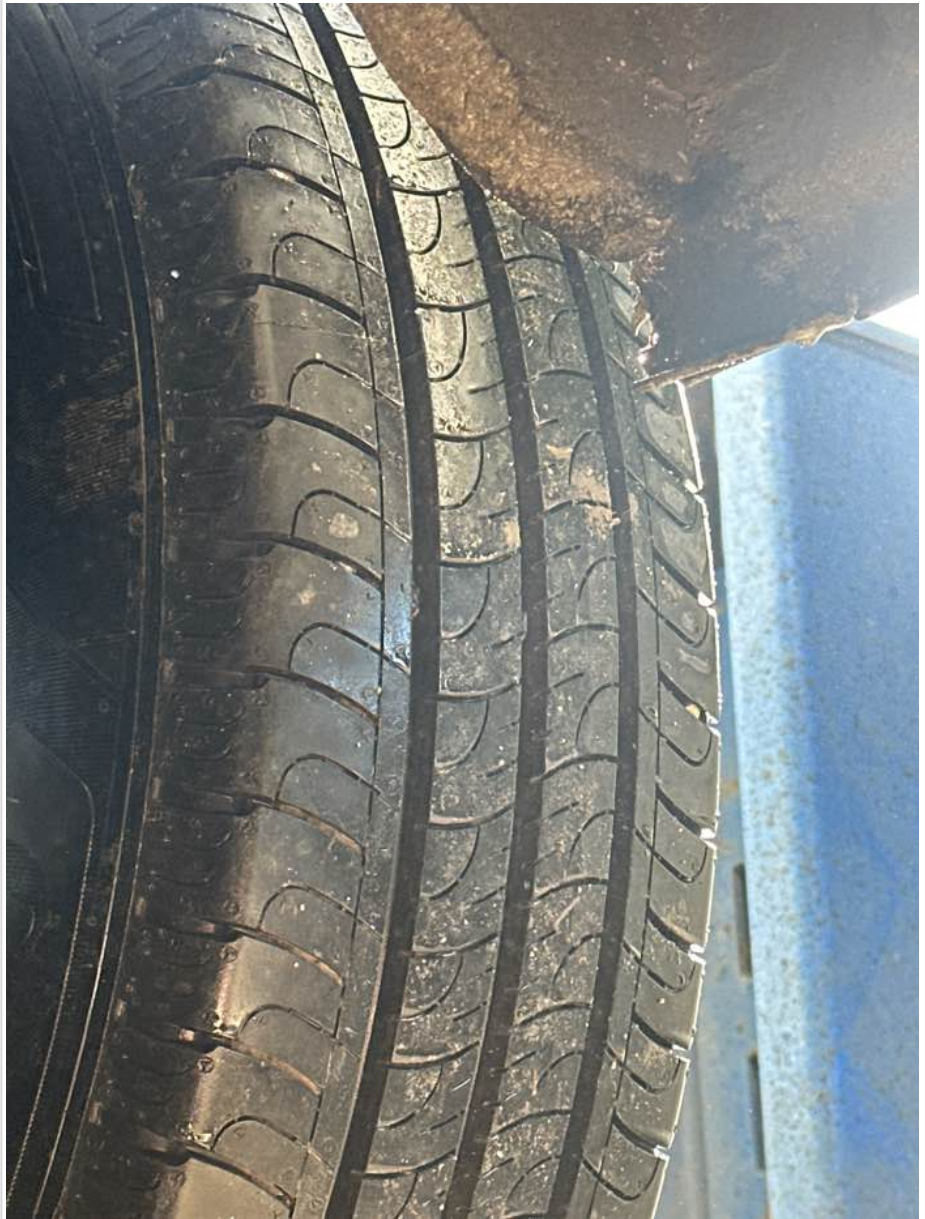
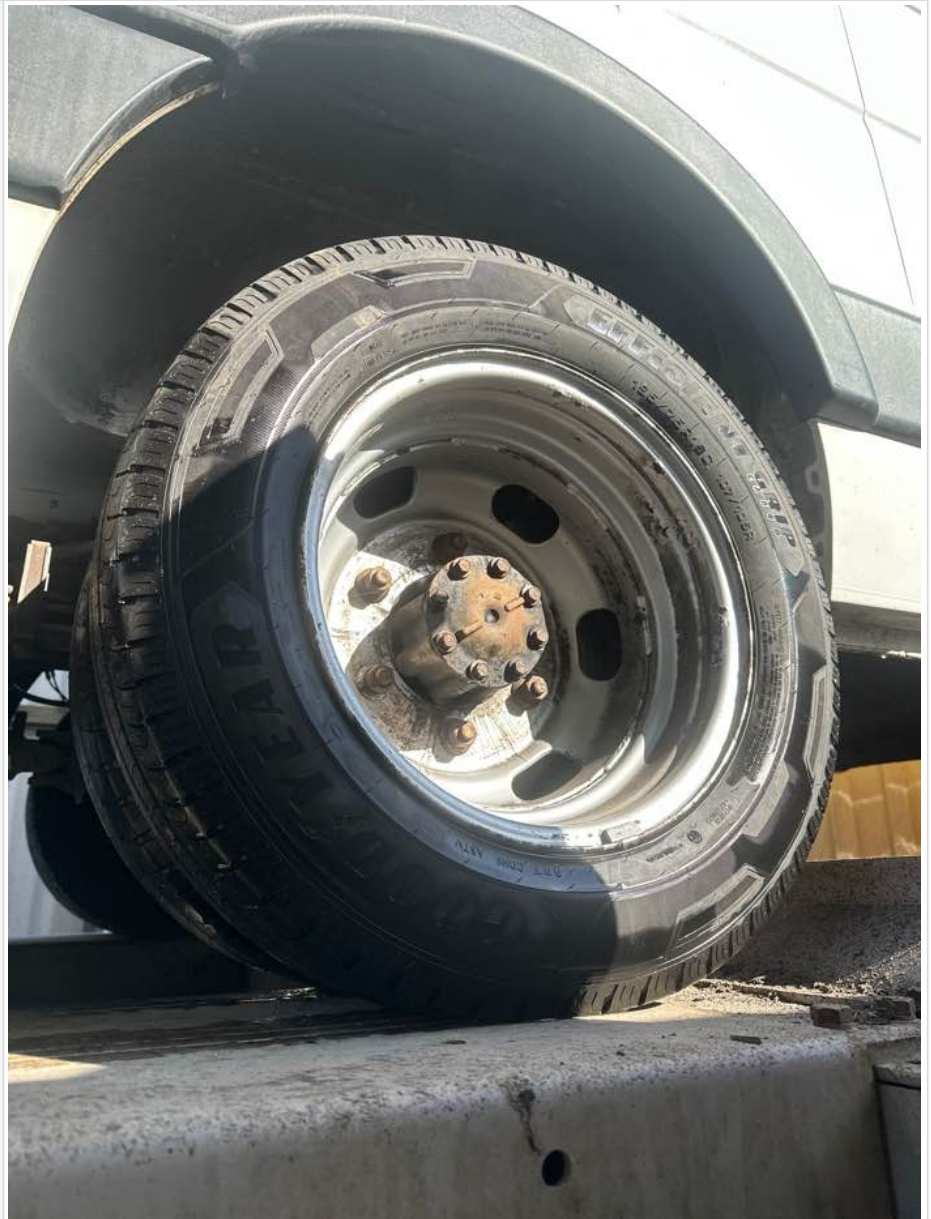
near side rear

Age (month/year) Manufactured	28/20 (educated guess)
Make, brand.	Good Year
Tyre size	195/75/R16
Pressure 1	
Pressure 2	60
Wearing / Perishing (inner)	none
Wearing / Perishing (outer)	None
tread depth (mm)	8
General comments	virtually brand new!

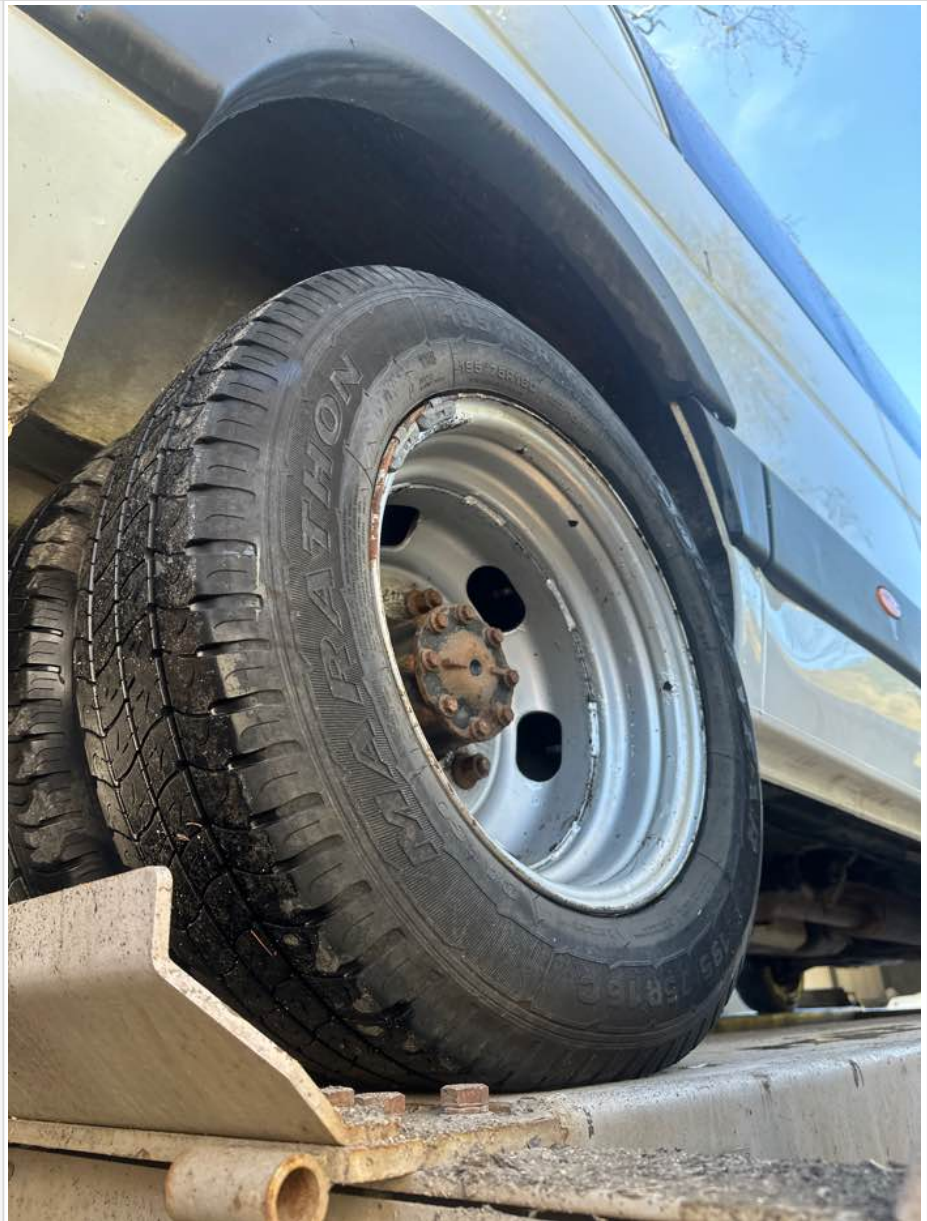
Off side rear

Age (month/year) Manufactured	28/20 (educated guess)
Make, brand.	Michelin
Tyre size	195/75/R16
Pressure 1	
Pressure 2	60
Wearing / Perishing (inner)	none
Wearing / Perishing (outer)	None
tread depth (mm)	7
General comments	mint

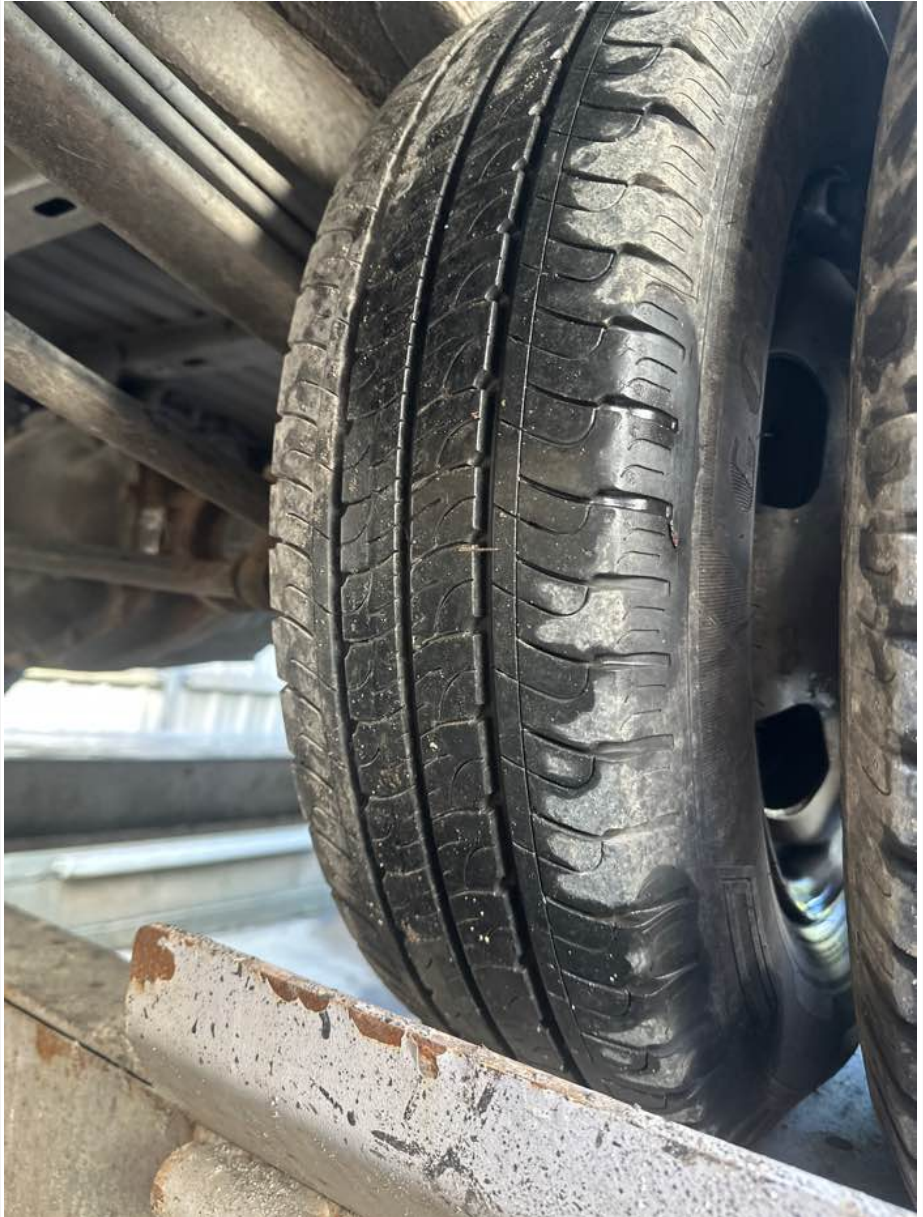
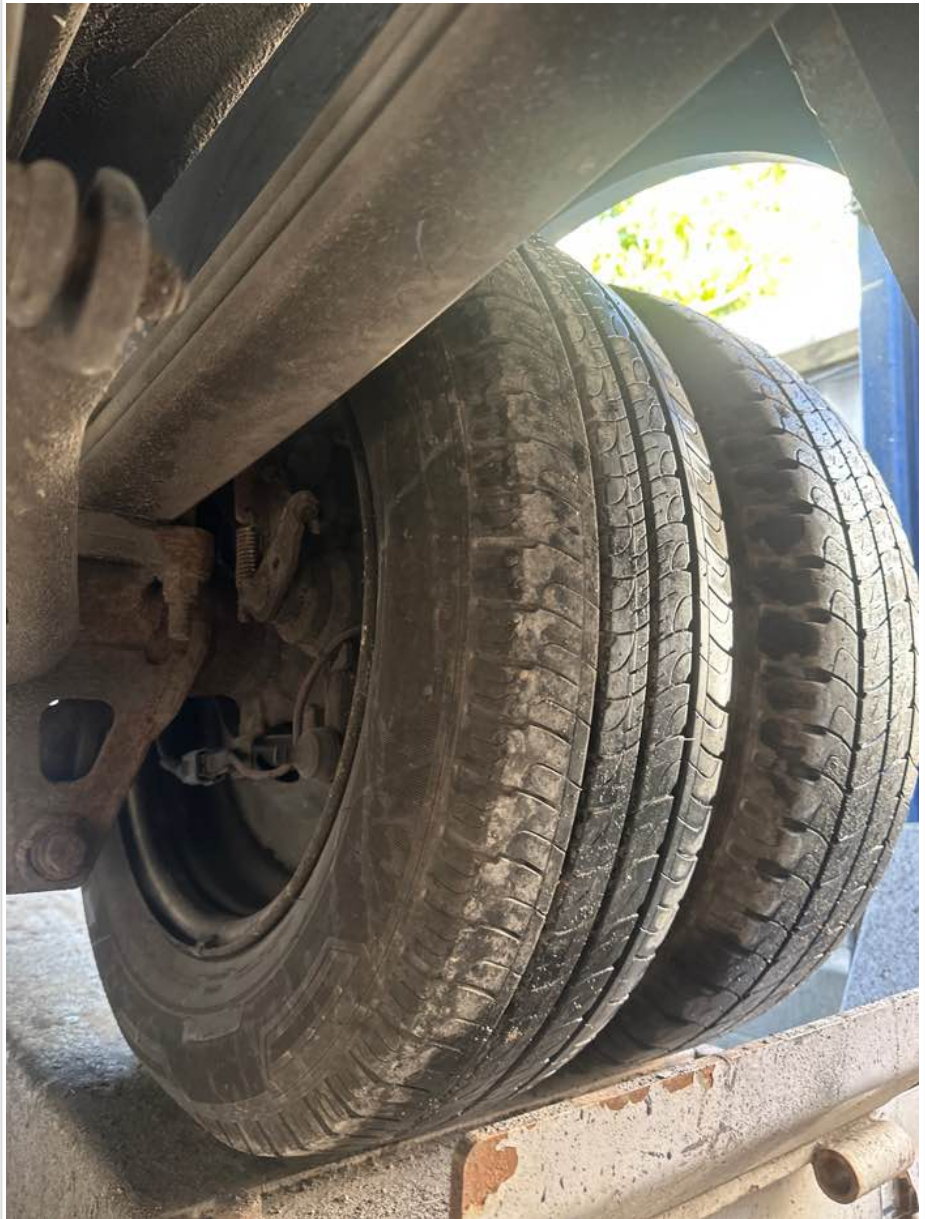
off side Inner (for twin wheel vans)

Is the vehicle a twin wheel axle? (if no don't fill out)	Yes
Age (month/year) Manufactured	28/20
Make, brand.	Good Year
Tyre size	195/75/R16
Pressure 1	
Pressure 2	60
Wearing / Perishing (inner)	none
Wearing / Perishing (outer)	None

tread depth (mm)	7
General comments	good good tyre
Images of tyre

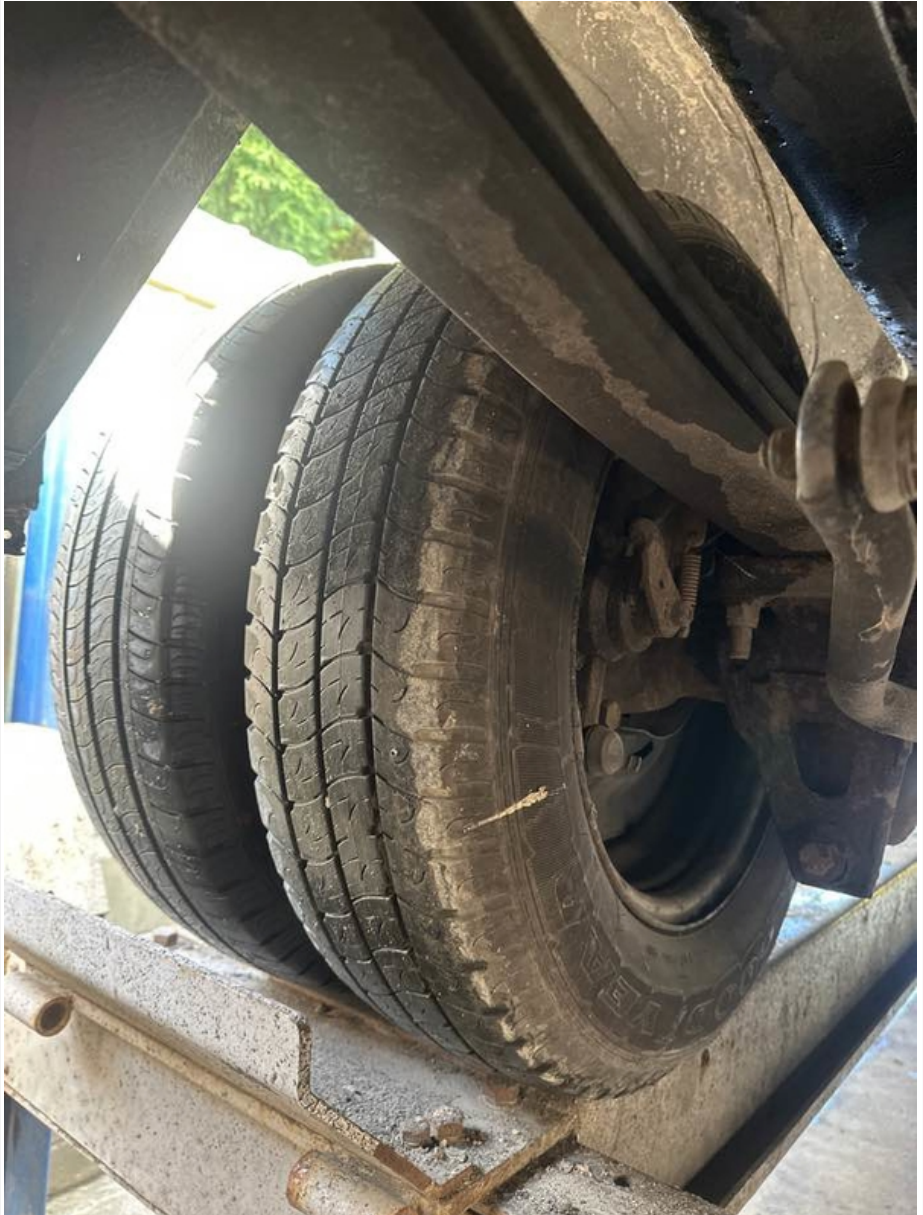
near side Inner (for twin wheel vans)

Is the vehicle a twin wheel axle? (if no don't fill out)	Yes
Age (month/year) Manufactured	28/20
Make, brand.	Good Year
Tyre size	195/75/R16
Pressure 1	
Pressure 2	60
Wearing / Perishing (inner)	none
Wearing / Perishing (outer)	None

tread depth (mm)	7
General comments	good tyre
Images of tyre

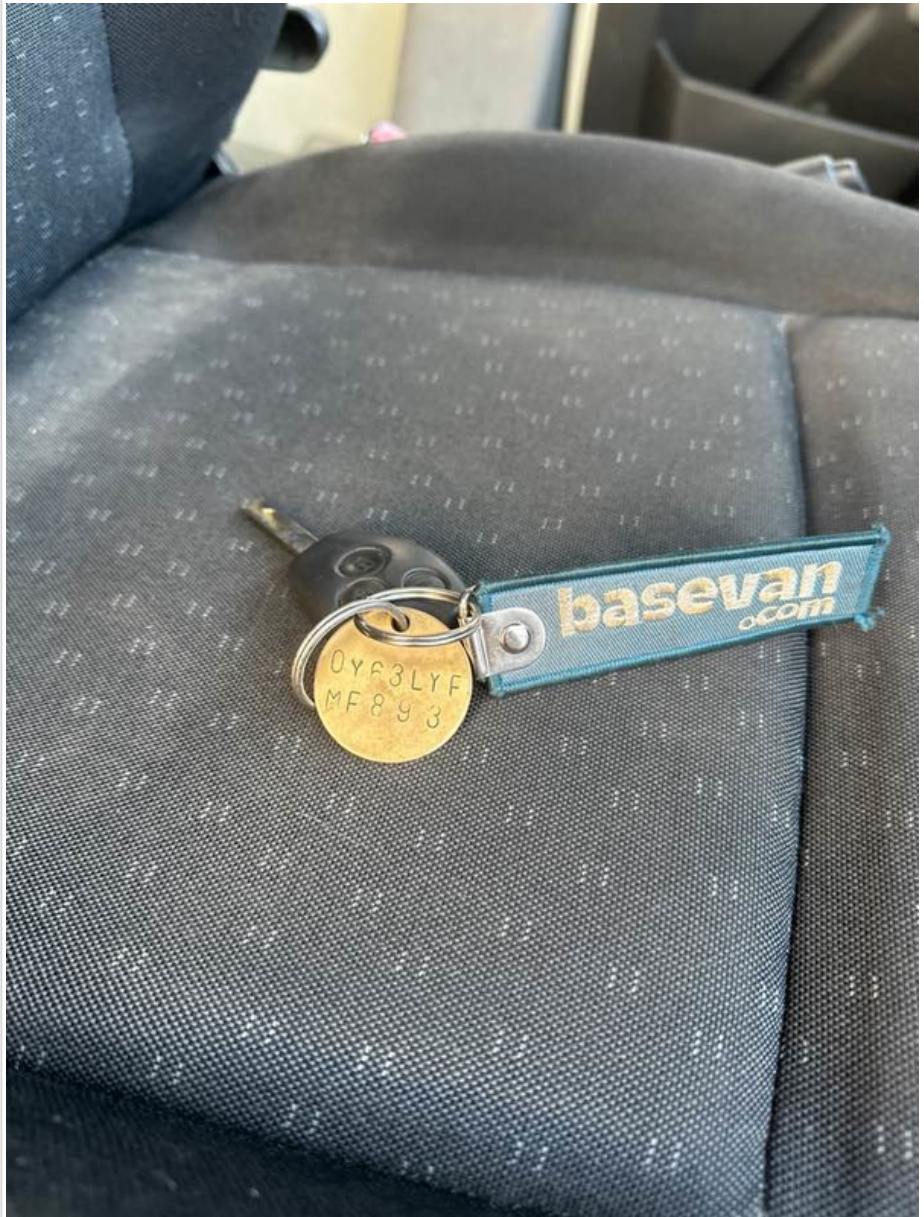
How many keys present at time of inspection?

functions as should, 1key

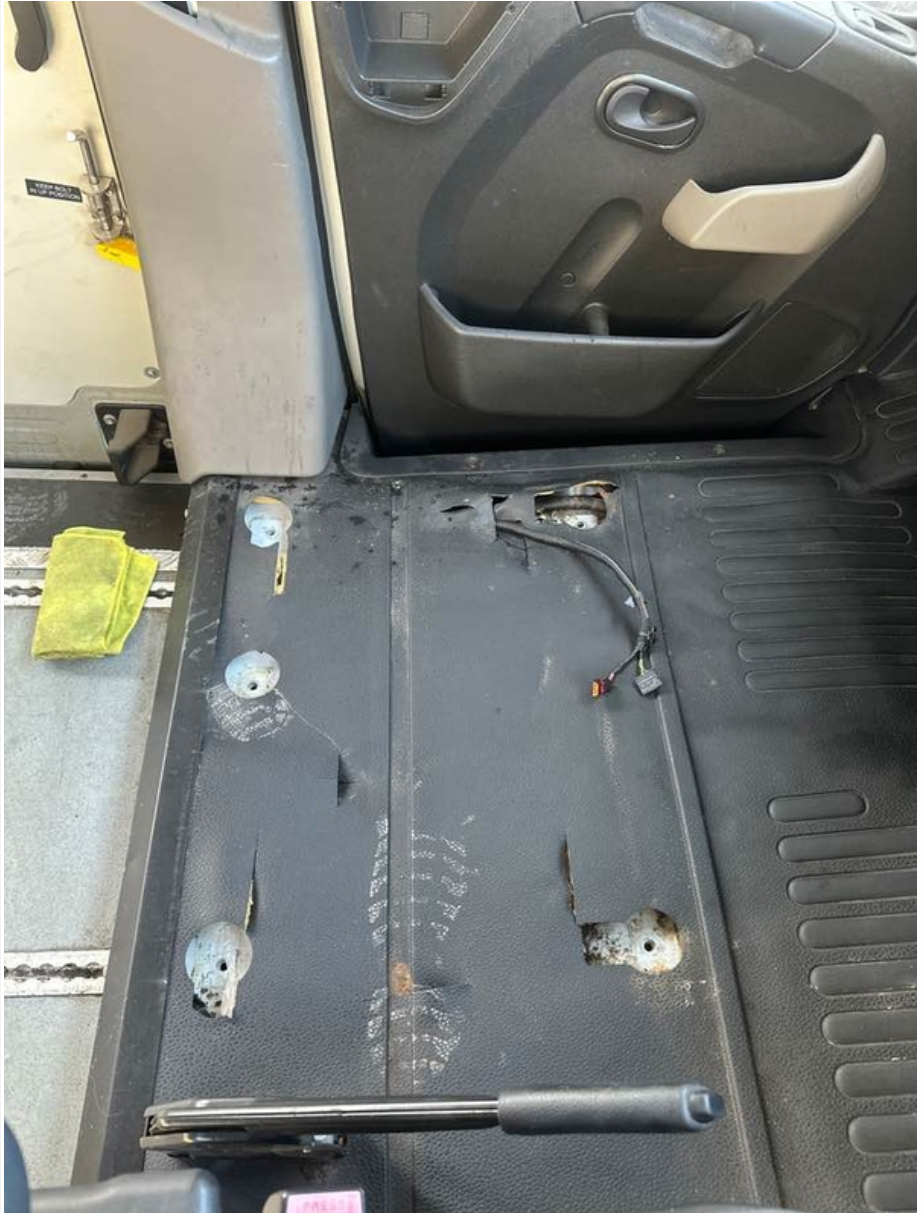
Function working?	Yes
Radio / Media system fitted?	Yes
Radio / media system check	Functions
Reverse camera present?	No
Reverse camera functioning?	N/A
Show any damage or missing items
