## Basevan.com General Inspection

Vehicle registration	CN06CKG
Vehicle chassis no.	WDB90366224948450
Miles (if in km, multiply by 0.62)	102,548
Make	Mercedes Benz
Model	Sprinter
Transmission	Automatic
Factory immobiliser installed	Yes
Speed limiter installed	No
Drive configuration	RWD
Gross Vehicle Weight (kg)	3500
Towing capacity	2800kg
Tow bar installed	No

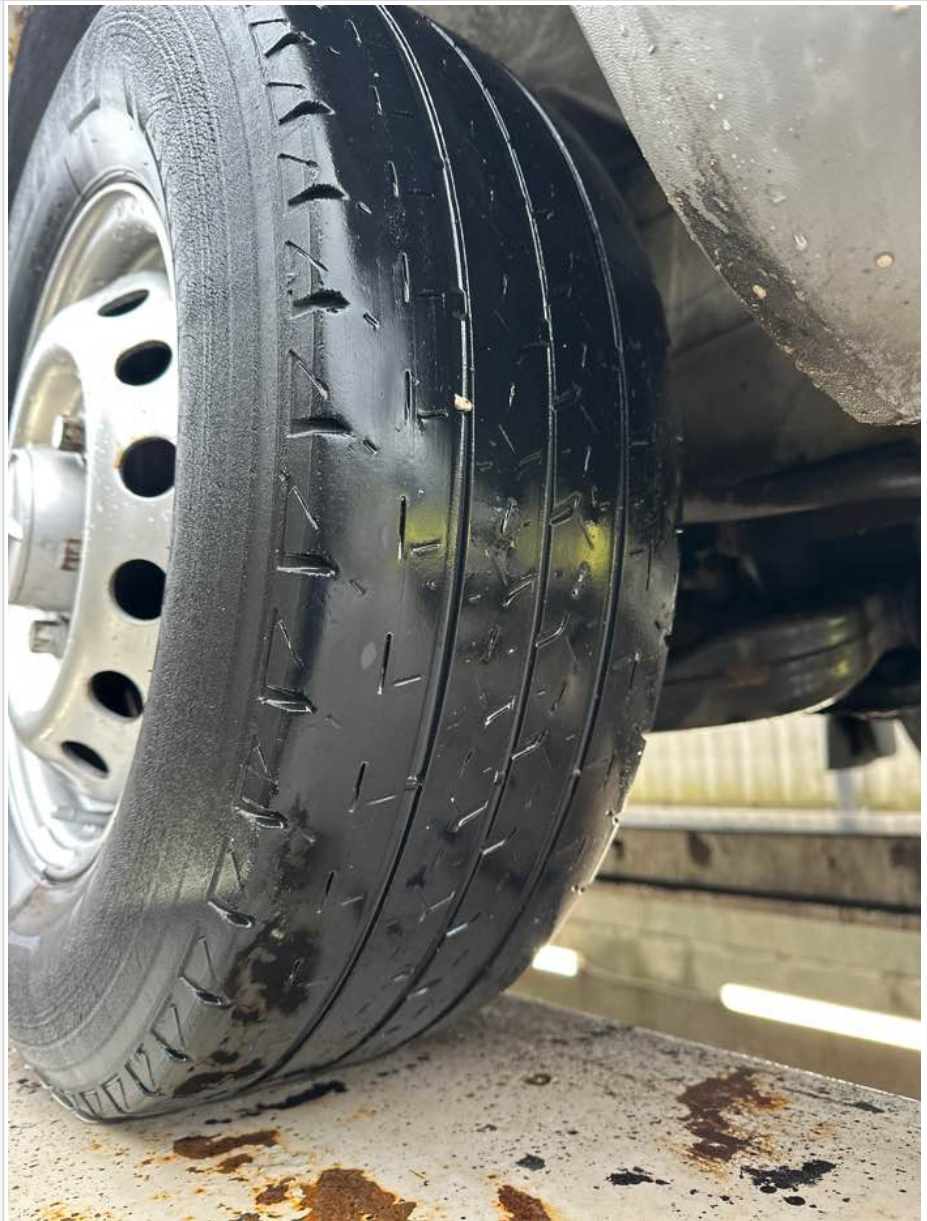
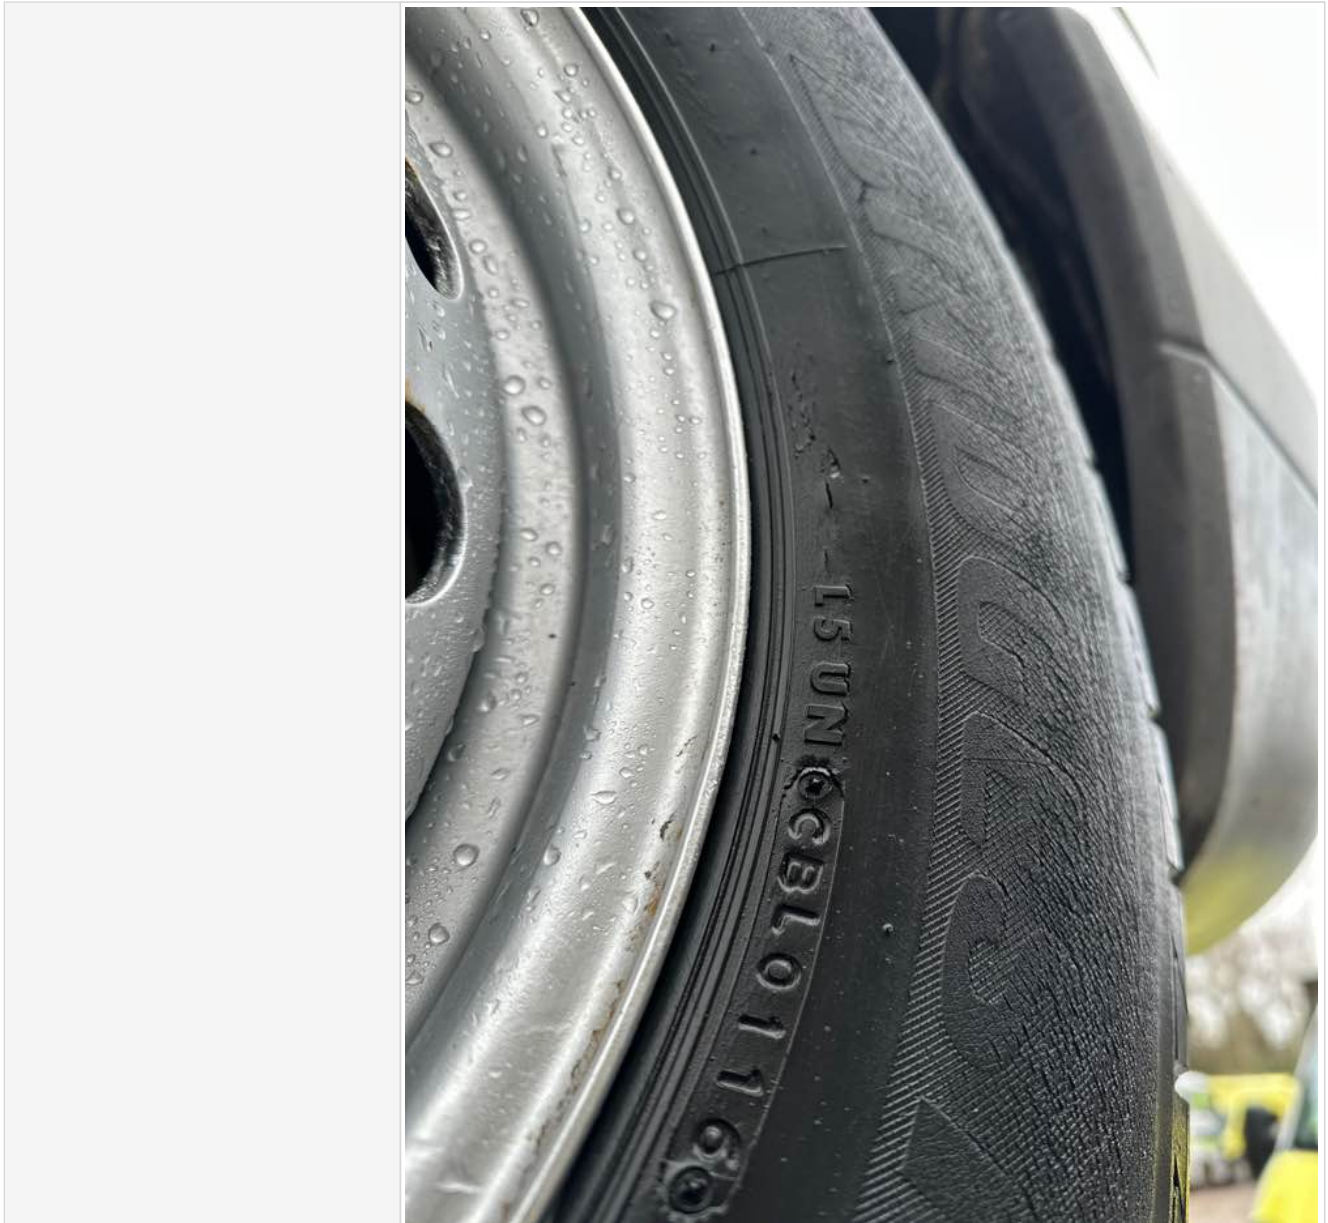
### Off side front

Age (month/year) Manufactured	01/16
Make, brand.	Other (comment)
Tyre size	Not here (see comment)
Pressure 1	
Pressure 2	
Wearing / Perishing (inner)	Replace soon
Wearing / Perishing (outer)	Replace soon
tread depth (mm)	3
General comments	tyre close to its final day

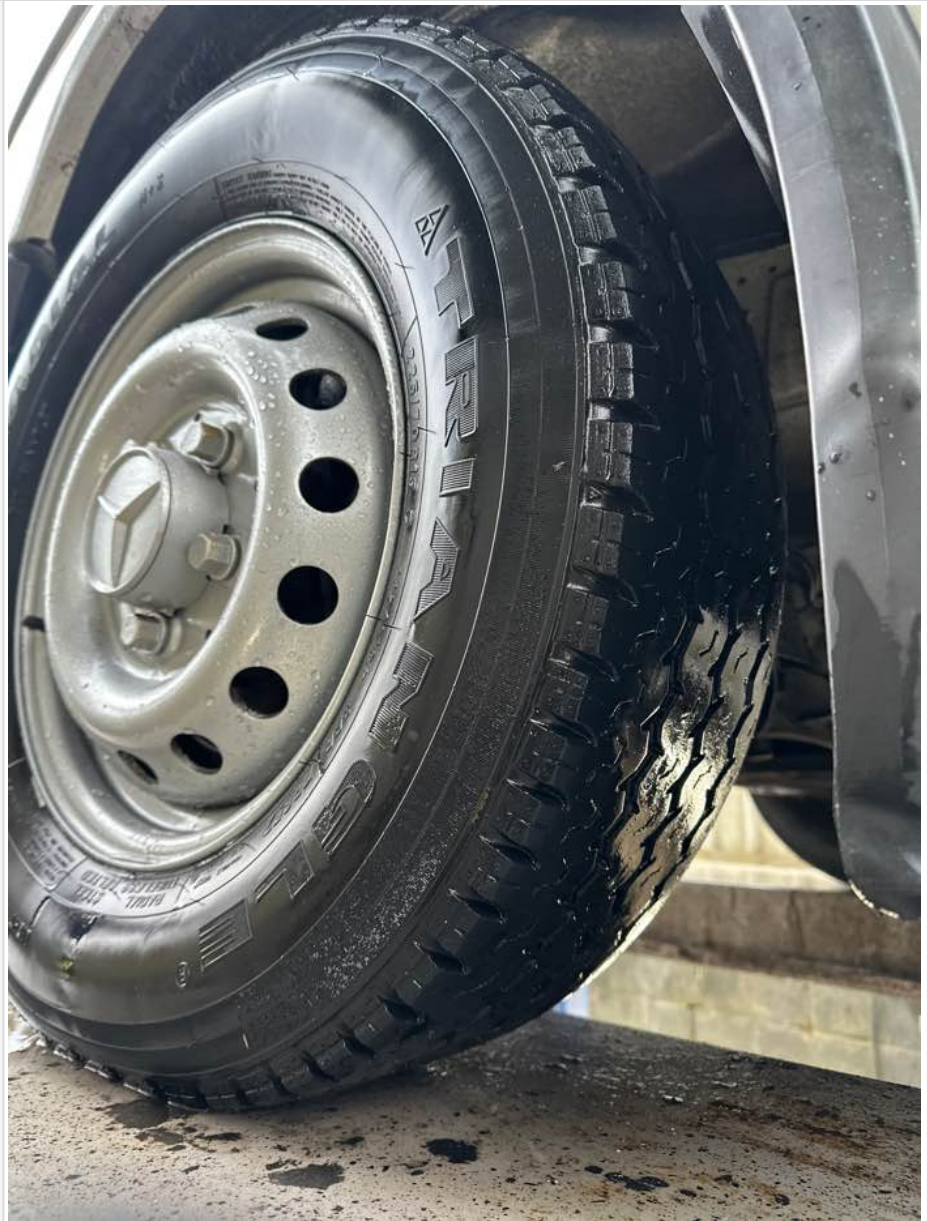
### Near side front

Age (month/year) Manufactured	20:22
Make, brand.	Budget
Tyre size	Not here (see comment)
Pressure 1	
Pressure 2	
Wearing / Perishing (inner)	none
Wearing / Perishing (outer)	None
tread depth (mm)	6
General comments	sturdy tyre

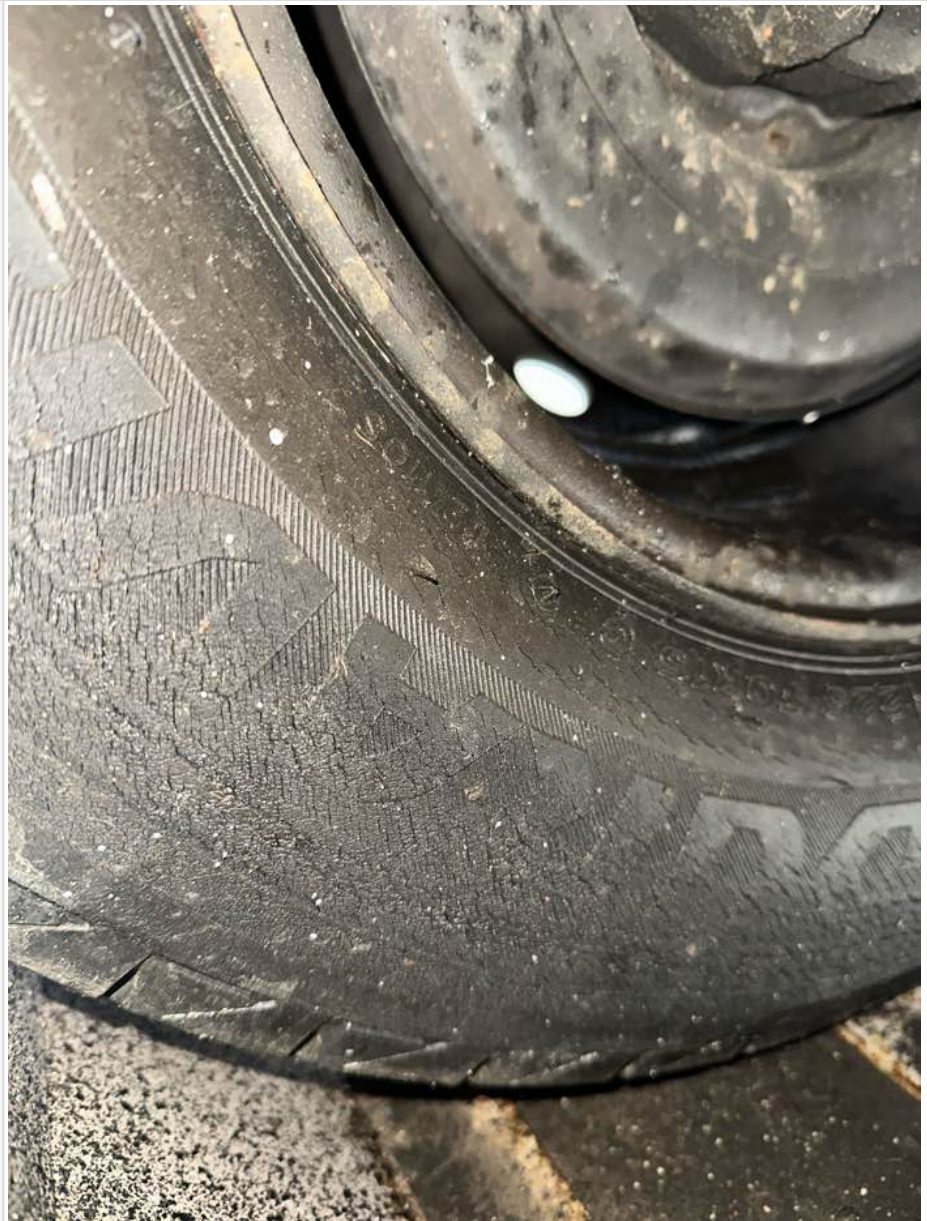
### near side rear

Age (month/year) Manufactured	17/19
Make, brand.	Other (comment)
Tyre size	Not here (see comment)
Pressure 1	
Pressure 2	
Wearing / Perishing (inner)	Replace soon
Wearing / Perishing (outer)	None
tread depth (mm)	8
General comments	good tread but moderate perishing

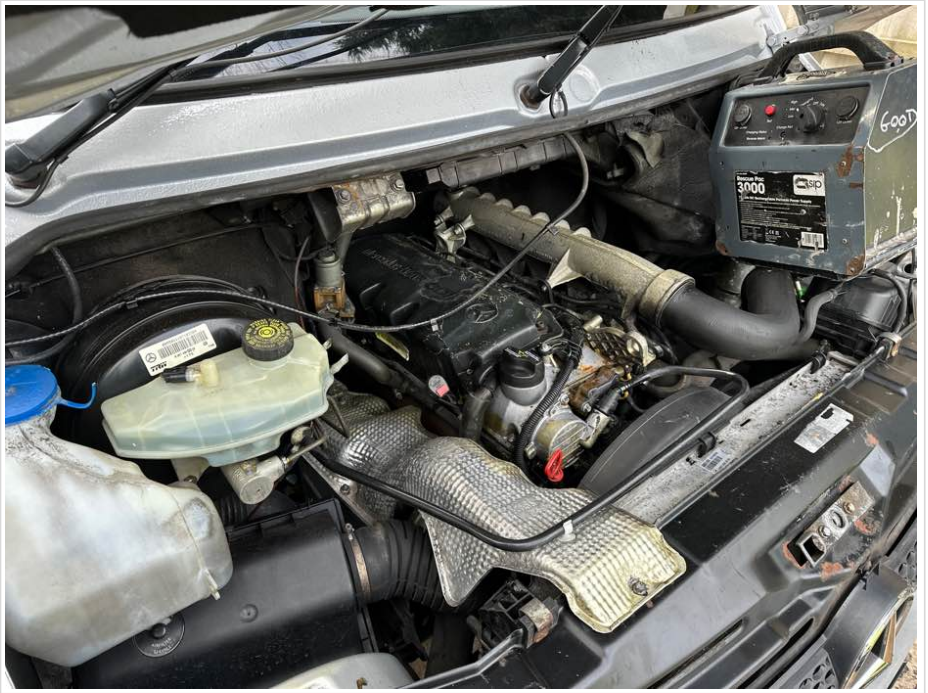
Engine bay photo

Comment	2.7L auto, pure filth!
