Basevan.com General Inspection

Vehicle registration	R713GMW
Vehicle chassis no.	WDB6683532N065724
Miles (if in km, multiply by 0.62)	66,377
Make	Mercedes
Model	Vario
Transmission	Manual, 5 speed
Factory immobiliser installed	Yes
Speed limiter installed	Yes
Drive configuration	RWD
Gross Vehicle Weight (kg)	5990
Towing capacity	3000
Tow bar installed	No

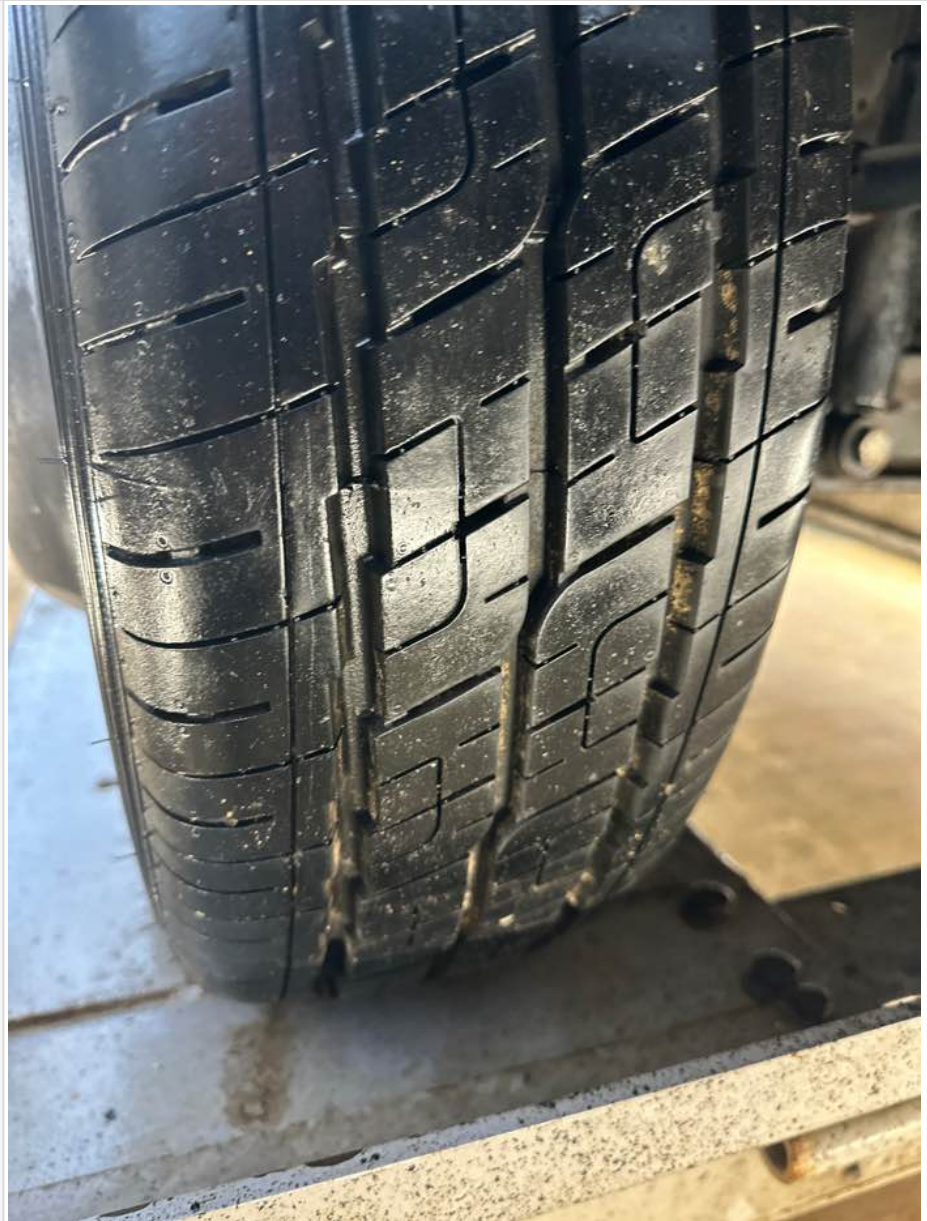
Images of tyre

Off side front

Age (month/year) Manufactured	36/21
Make, brand.	Other (comment)
Tyre size	215/75/R16
Pressure 1	50
Pressure 2	
Wearing / Perishing (inner)	none
Wearing / Perishing (outer)	None
tread depth (mm)	10
General comments	Avon

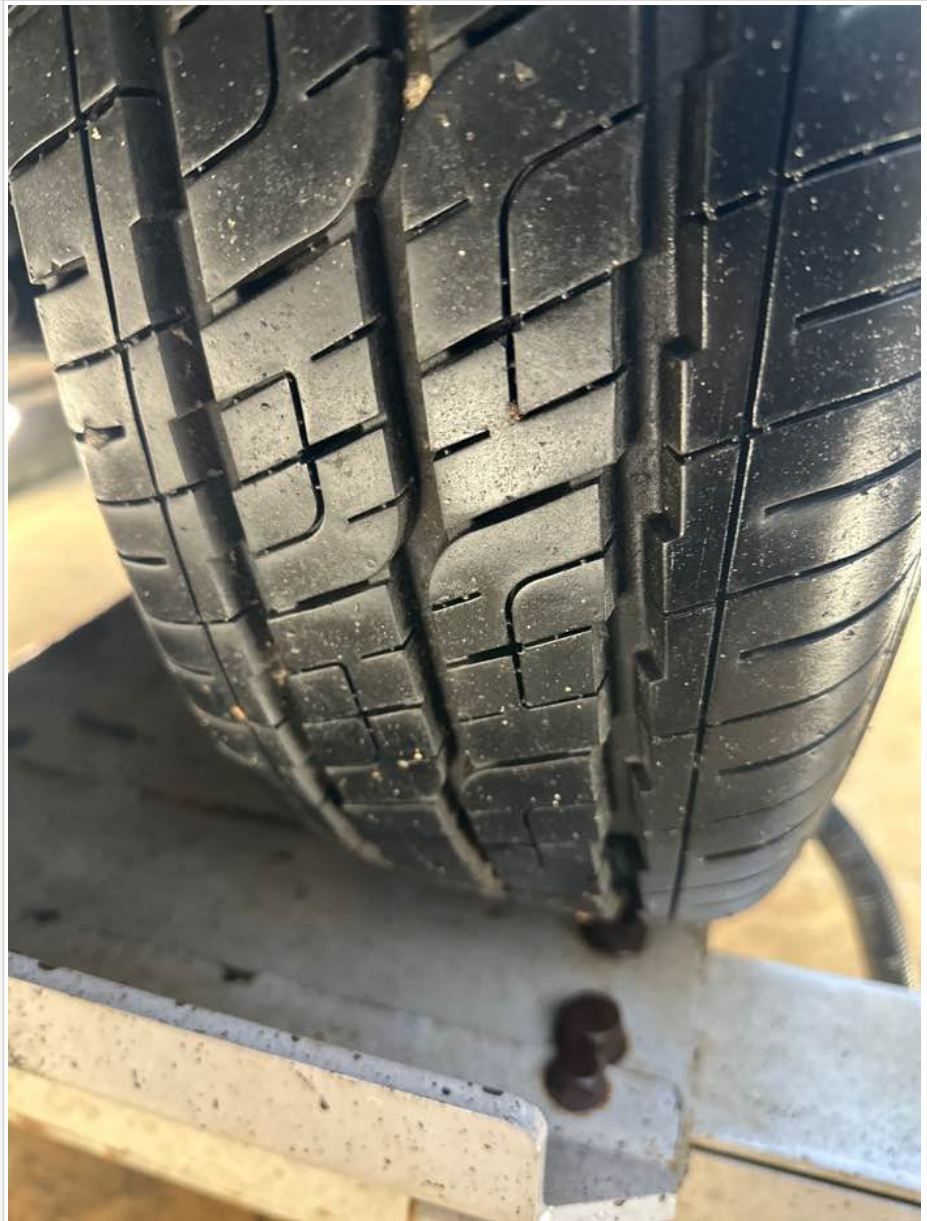
Images of tyre

Near side front

Age (month/year) Manufactured	50/21
Make, brand.	Other (comment)
Tyre size	215/75/R16
Pressure 1	50
Pressure 2	
Wearing / Perishing (inner)	none
Wearing / Perishing (outer)	None
tread depth (mm)	10
General comments	Avon

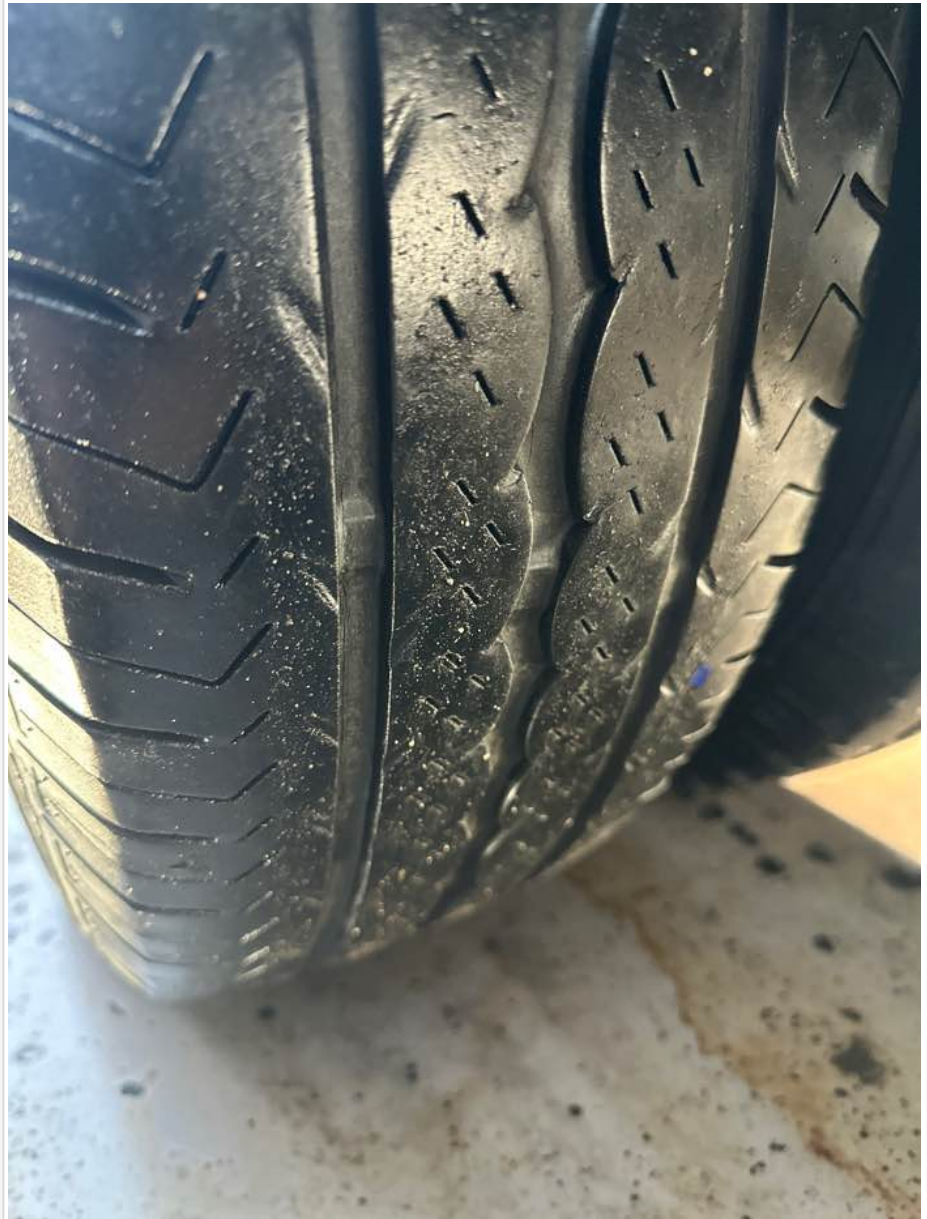
Images of tyre

Off side rear

Age (month/year) Manufactured	24/12
Make, brand.	GT Radial
Tyre size	215/75/R16
Pressure 1	49
Pressure 2	
Wearing / Perishing (inner)	Medium
Wearing / Perishing (outer)	Medium
tread depth (mm)	5
General comments

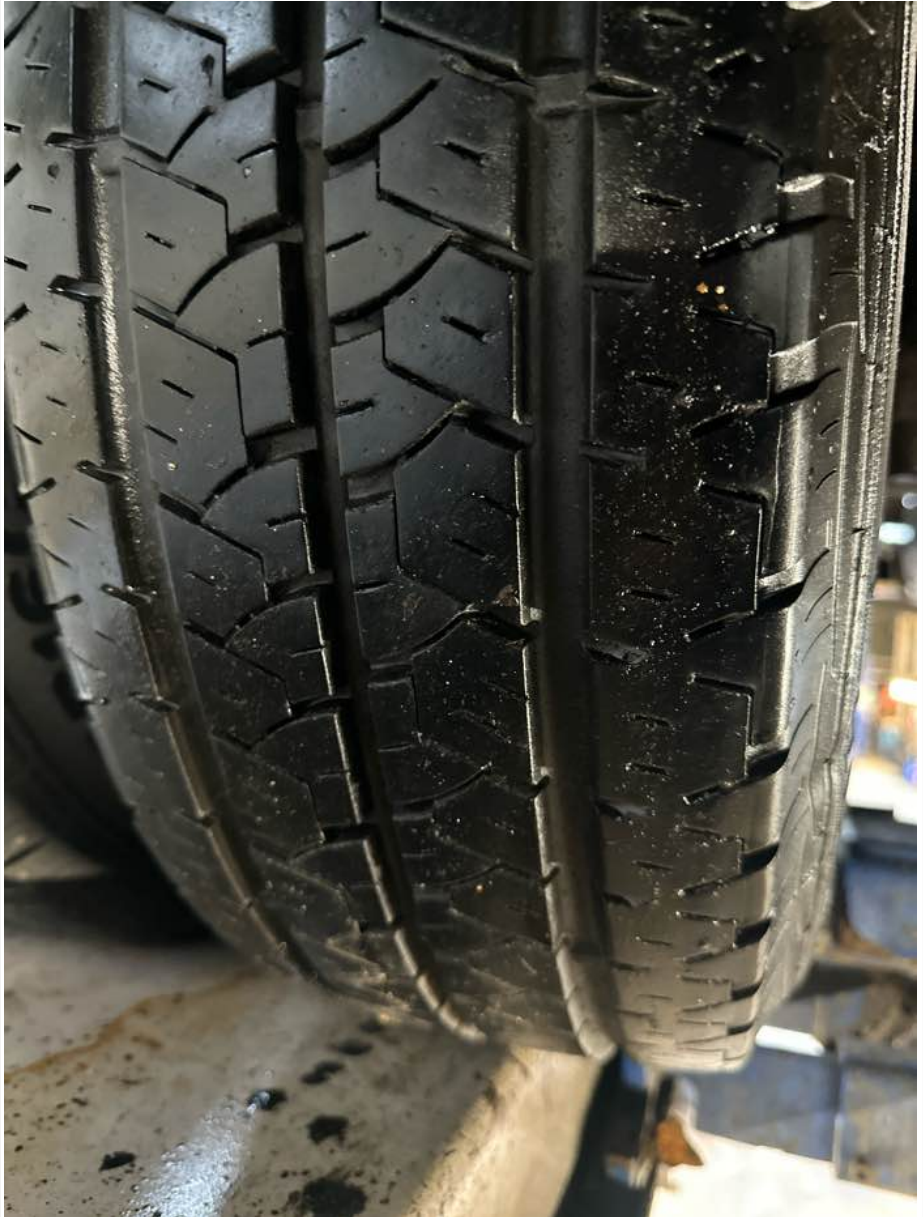
off side Inner (for twin wheel vans)

Is the vehicle a twin wheel axle? (if no don't fill out)	Yes
Age (month/year) Manufactured	42/12
Make, brand.	Budget
Tyre size	215/75/R16
Pressure 1	50
Pressure 2	
Wearing / Perishing (inner)	Slight
Wearing / Perishing (outer)	Slight

tread depth (mm)	8
General comments	
Images of tyre

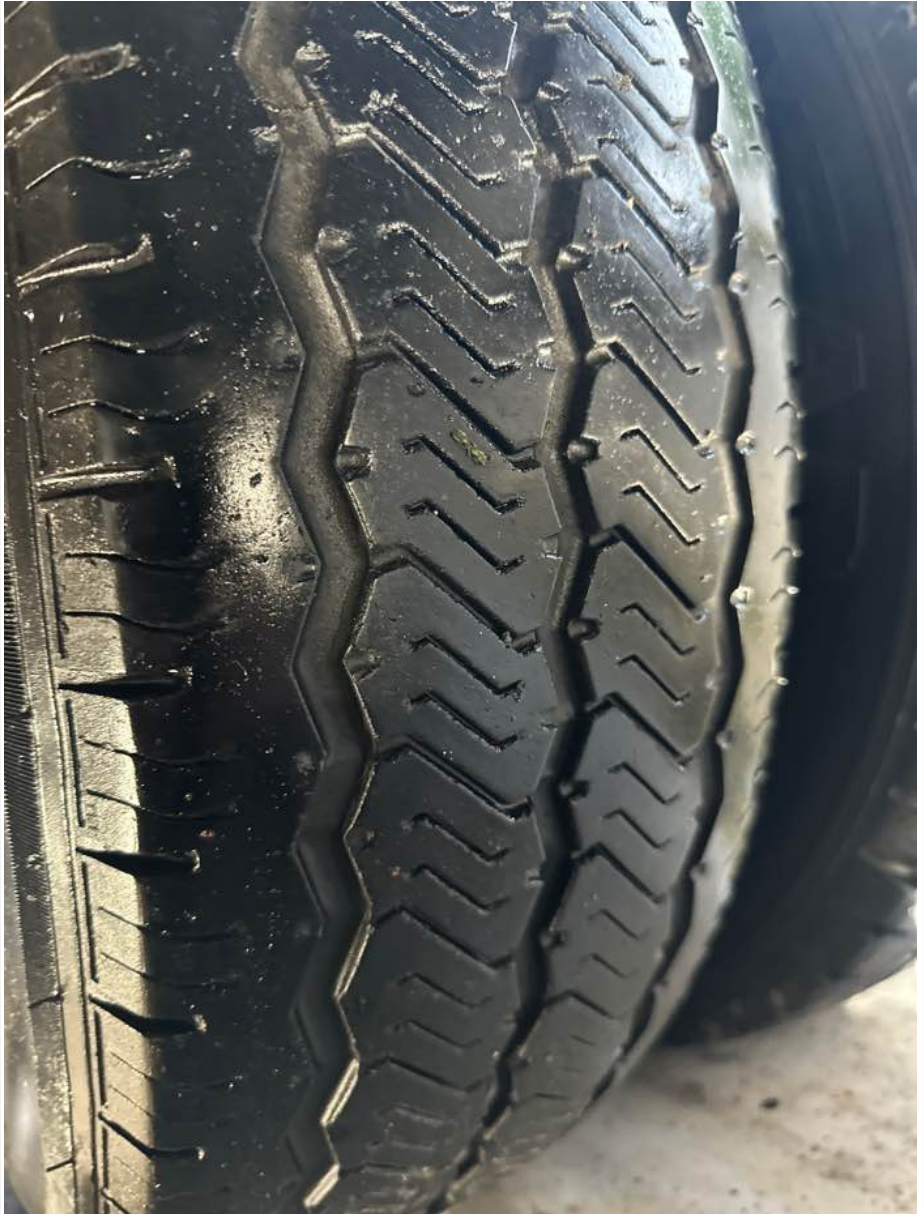
near side Inner (for twin wheel vans)

Is the vehicle a twin wheel axle? (if no don't fill out)	Yes
Age (month/year) Manufactured	16/10
Make, brand.	Budget
Tyre size	215/75/R16
Pressure 1	45
Pressure 2

Wearing / Perishing (inner)	Medium
Wearing / Perishing (outer)	Medium
tread depth (mm)	6
General comments	
Images of tyre

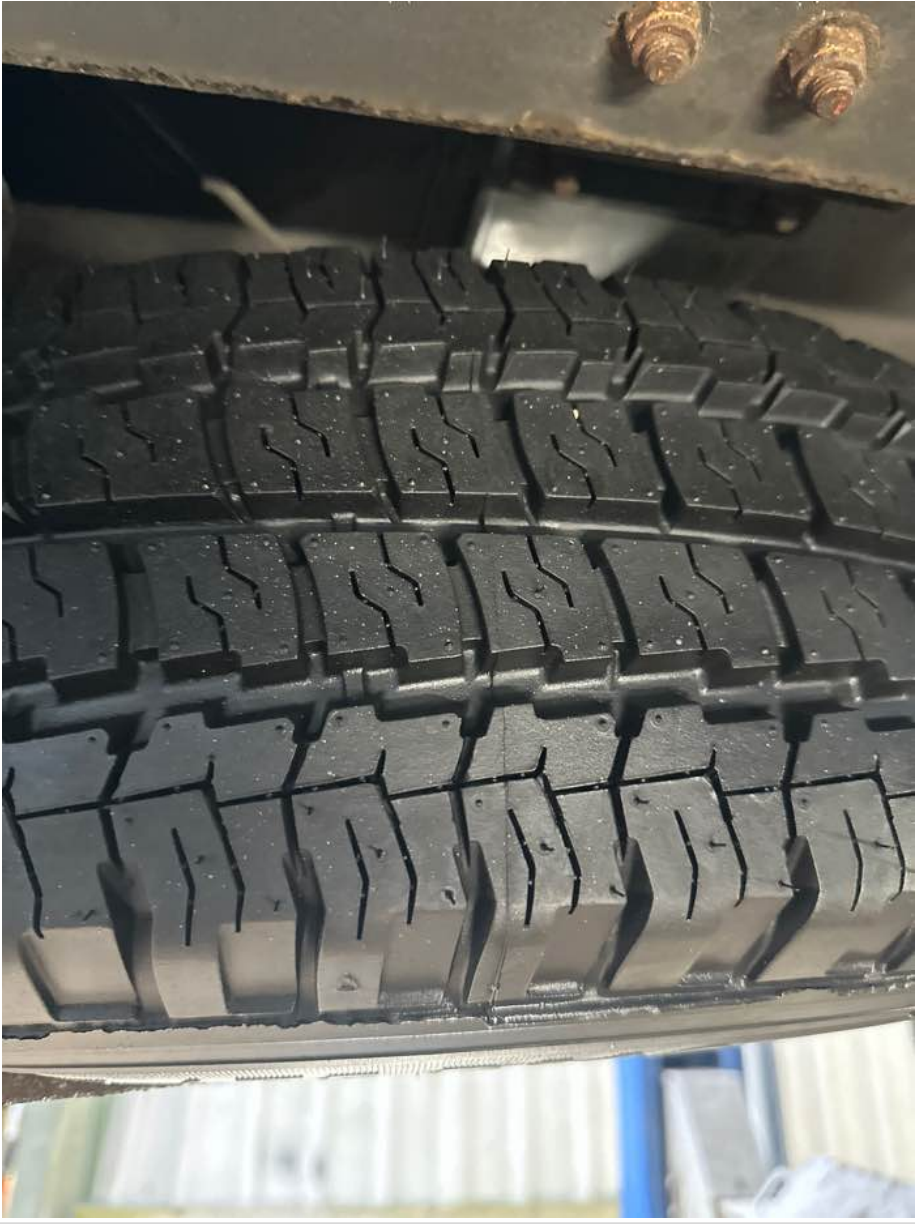
Spare wheel

Spare installed? (If no, don't fill out)	Yes
Age (month/year) Manufactured	
Make, brand.	Budget
Tyre size	215/75/R16

Pressure 1	30
Pressure 2	
Wearing / Perishing (inner)	none
Wearing / Perishing (outer)	None
tread depth (mm)	10
General comments	
Images of tyre

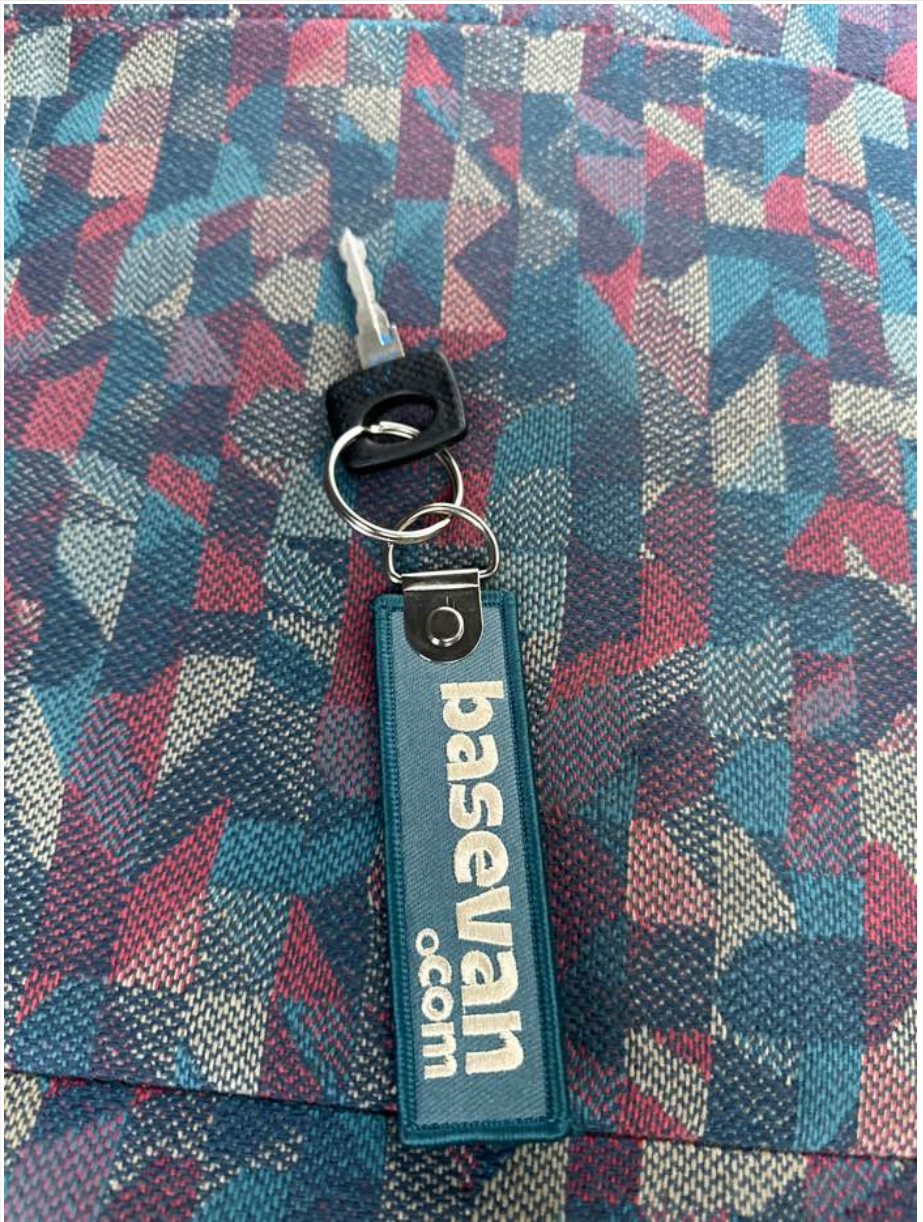
Response from in-cab locking button?	N/A
Do all the doors lock from central locking function?	None
Select the following doors that lock.	N/S Front, O/S Front, N/S Rear, O/S Rear
Method of locking	Key
In conclusion can all the doors be locked in some way and thus the vehicle can be left unattended at night safely?	No
How many keys present at time of inspection?

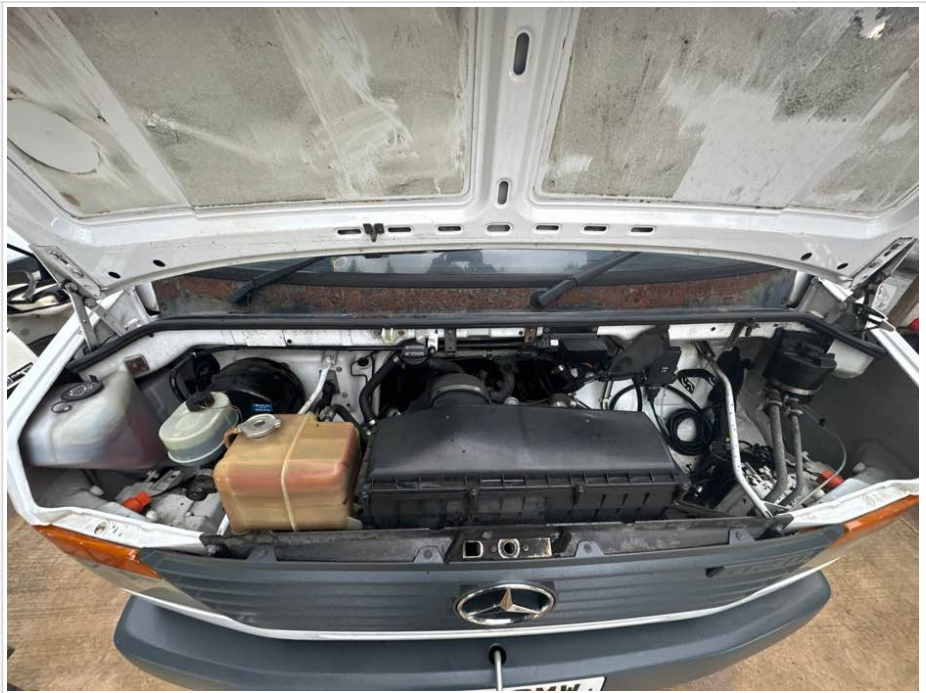
<p>Engine bay photo</p>

Fuel level	1/2 Full
Oil level	Low
Oil conditon	Service due soon
Start up, chassis battery check	Started without jump pack
Start-up from cold	2 seconds
Exhaust smoke from cold	Normal
Output Voltage of Alternator test	14.1
Chain or Belt driven engine?	Chain
If belt any proof of change?	N/A
Coolant condition	Clean
Coolant level	Full
Anti-freeze temperature check	
Washer fluid	Full
Brake fluid	Medium
Power steering fluid	Maximum
Dashboard warning light	No warning lights
OBD Scan results
