## BaseVan Initial Inspection

Vehicle registration	KR16CFP
Vehicle chassis no.	WOLVV34UEEB064783
Miles (if in km, multiply by 0.62)	tacho
Make	Renault
Model	Master
Transmission	Manual, 6 speed
Factory immobiliser installed	Yes
Speed limiter installed	N/A
Drive configuration	FWD
Gross vehicle weight	
Towing capacity	3890 gross. 6000 train
Tow bar installed	No

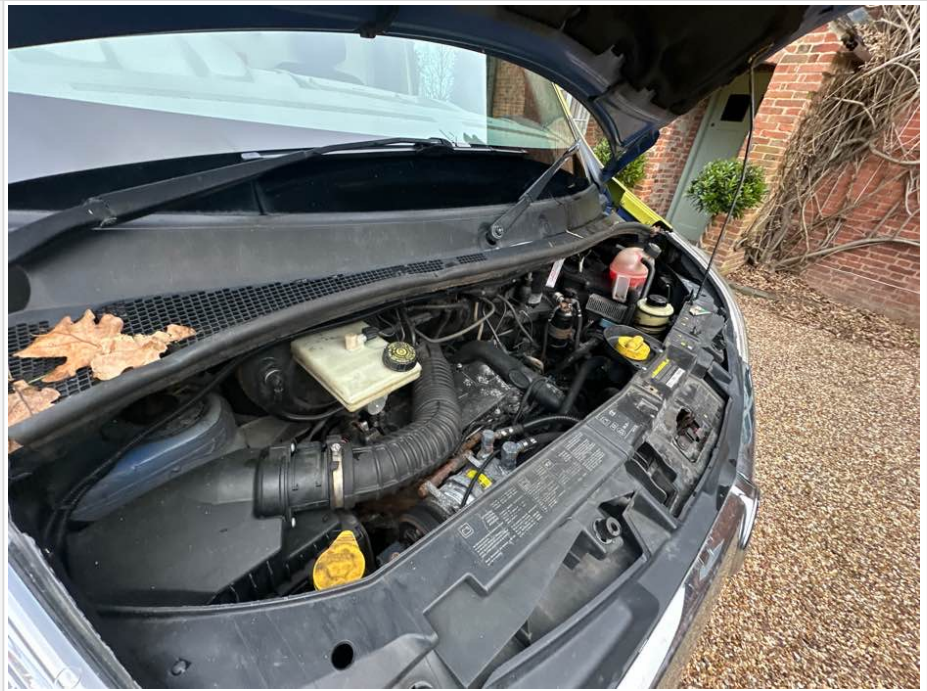
Engine bay photo

Fuel level	1/2 Full
Oil level	Full
Oil conditon	Clean
Start up, chassis battery check	Started without jump pack
Start-up from cold	Instant
Exhaust smoke from cold	Normal
Output Voltage of Alternator test	15.0v
Chain or Belt driven engine?	Chain
If belt any proof of change?	-
Coolant condition	Clean
Coolant level	Full
Anti-freeze temperature check	-15
Washer fluid	Full
Brake fluid	Full
Power steering fluid	Maximum
Dashboard warning light	No warning lights
OBD Scan results
