BaseVan Initial Inspection

Vehicle registration	LJ18EXU
Vehicle chassis no.	WV1ZZZ2KZJX049110
Miles (if in km, multiply by 0.62)	92926
Make	Volkswagen
Model	Caddy Maxi
Transmission	Manual, 6 speed
Factory immobiliser installed	Yes
Speed limiter installed	No
Drive configuration	FWD
Gross vehicle weight	<3500kg
Towing capacity	
Tow bar installed

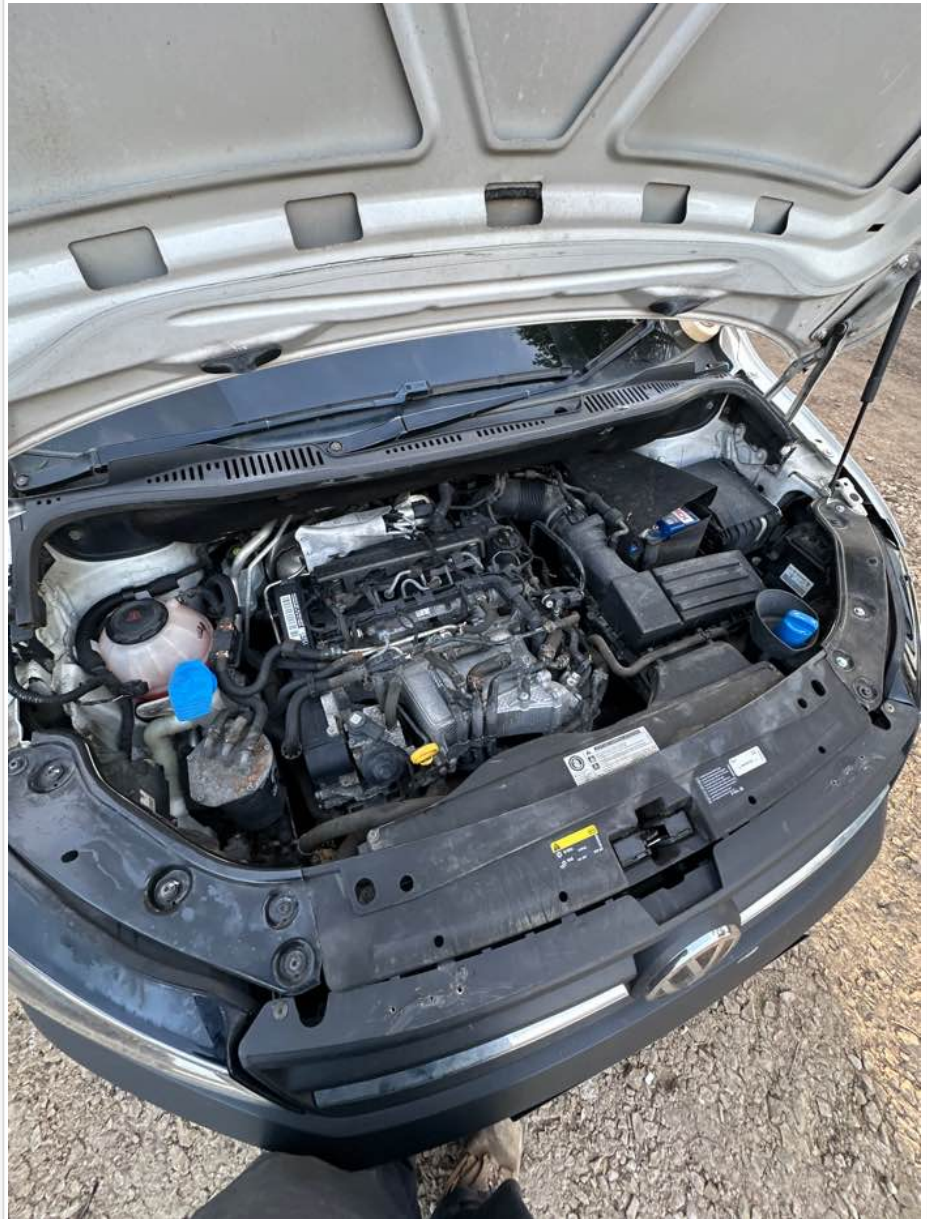
Engine bay photo

Fuel level	1/2 Full
Oil level	Full
Oil conditon	Clean
Start up, chassis battery check	Started without jump pack
Start-up from cold	Instant
Exhaust smoke from cold	Normal
Output Voltage of Alternator test	14..2
Chain or Belt driven engine?	Belt
If belt any proof of change?	
Coolant condition	Clean
Coolant level	Full
Anti-freeze temperature check	-16
Washer fluid	Full
Brake fluid	Full
Power steering fluid	N/A
Dashboard warning light	No warning lights
OBD Scan results
