## BaseVan Initial Inspection

Vehicle registration	DX08ATN
Vehicle chassis no.	VF1EDC1K638340727
Miles (if in km, multiply by 0.62)	10,382
Make	Renault
Model	Master
Transmission	Manual, 6 speed
Factory immobiliser installed	Yes
Speed limiter installed	No
Drive configuration	FWD
Gross vehicle weight	3500kg
Towing capacity	2000kg
Tow bar installed	No

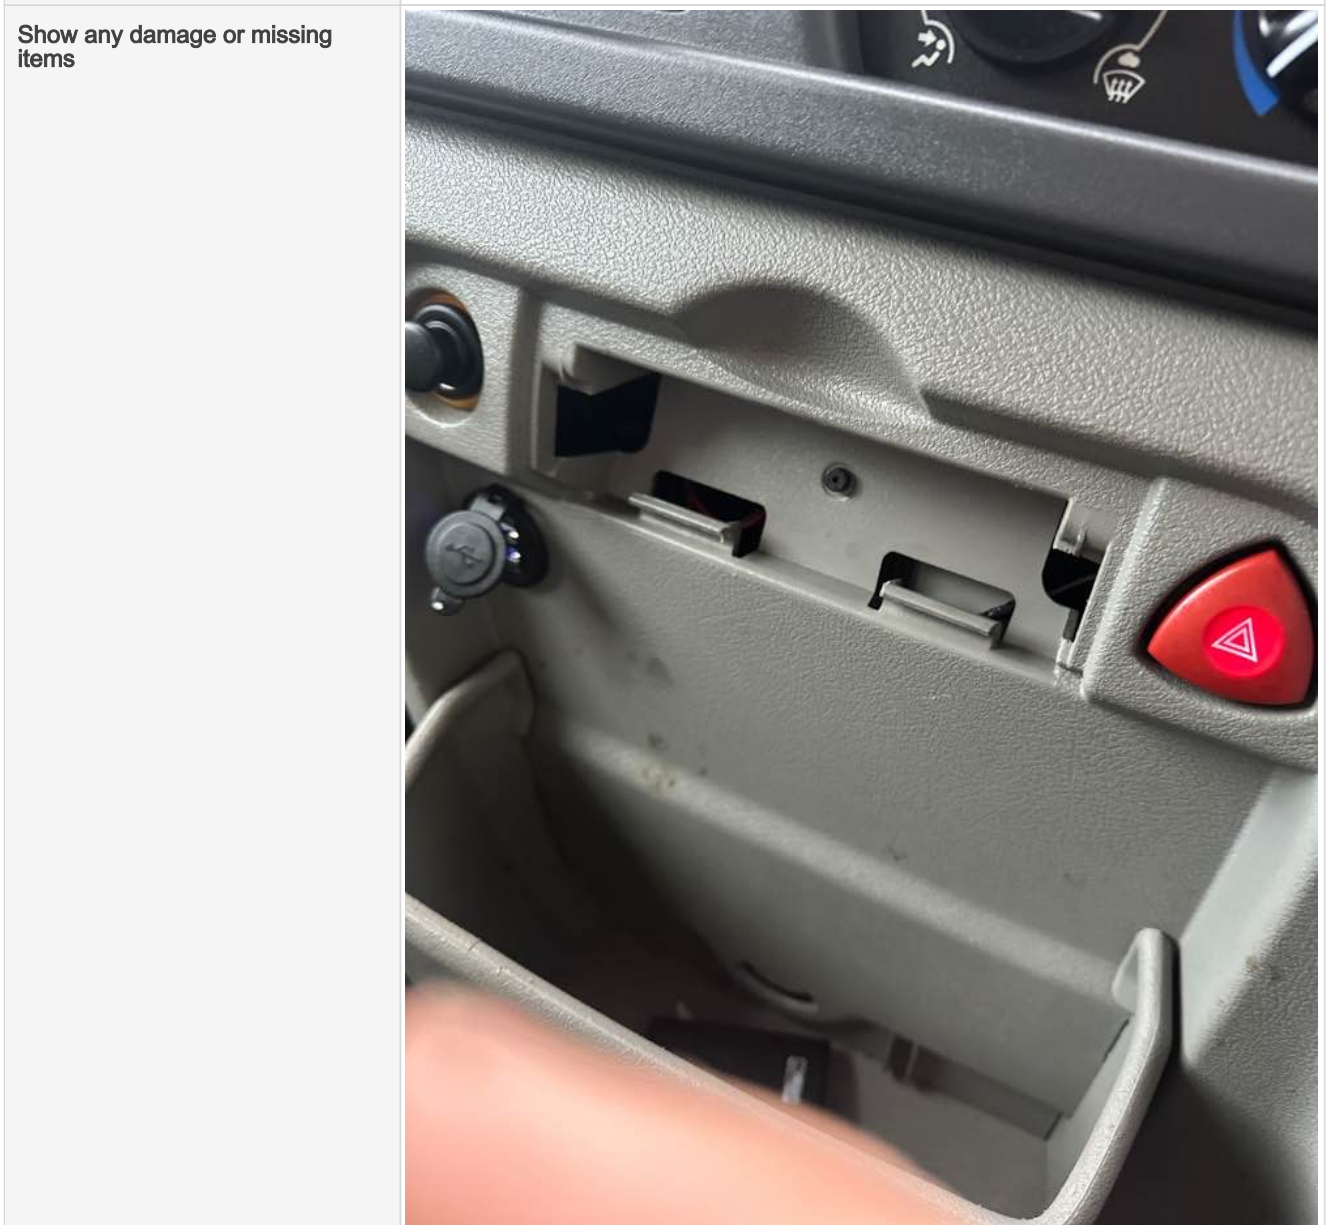
Electric windows present	Yes
Cab windows function check	Driver side function, Passenger side function
Air conditioning present	No
Charging socket present (cigarette lighter)	Yes
Function working?	Yes
Radio / Media system fitted?	Yes
Radio / media system check	Requires code
Reverse camera present?	No
Reverse camera functioning?	N/A
