BaseVan Initial Inspection

Vehicle registration	KE12BBN
Vehicle chassis no.	VF3YCTMFC12200950
Miles (if in km, multiply by 0.62)	127566
Make	Peugeot
Model	BOXER
Transmission	Manual, 6 speed
Factory immobiliser installed	Yes
Speed limiter installed	No
Drive configuration	FWD
Gross vehicle weight	3500kg
Towing capacity	2500kg
Tow bar installed	No

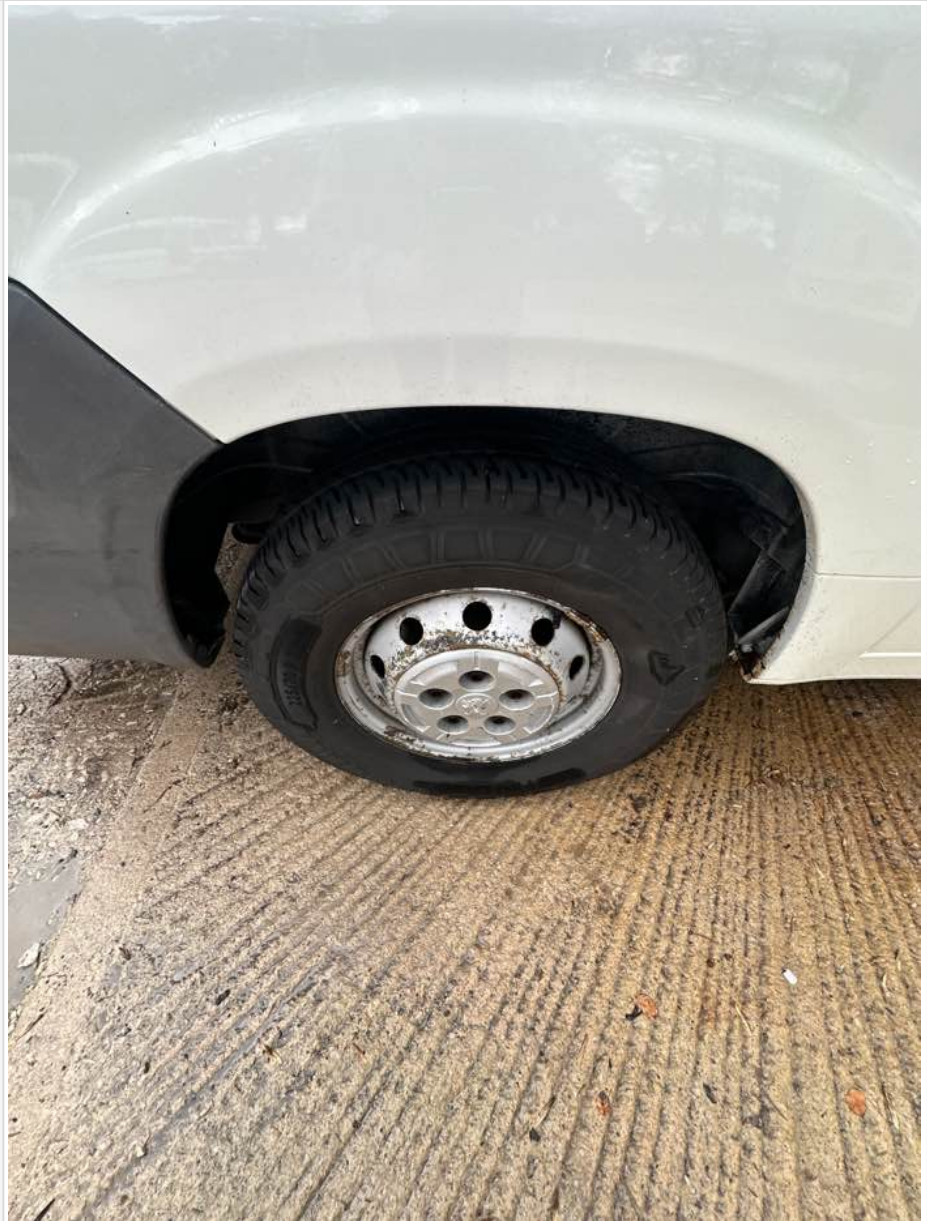
Off side rear

Age (month/year) Manufactured	43/21
Make, brand.	Michelin
Tyre size	Not here (see comment)
Pressure 1	
Pressure 2	
Wearing / Perishing (inner)	none
Wearing / Perishing (outer)	None
tread depth (mm)	8
General comments	basically brand new, 225/70/15
