Basevan.com Inspection Report 2025

Vehicle registration	HF05FZC
Vehicle chassis no.	SEYZMUSZGDN109824
Miles (if in km, multiply by 0.62)	31208
Make	LDV
Model	CONVOY
Transmission	5 speed
Factory immobiliser installed	Yes
Speed limiter installed	No
Drive configuration	RWD
Gross Vehicle Weight (kg)	3050
Towing capacity	1650
Tow bar installed	No

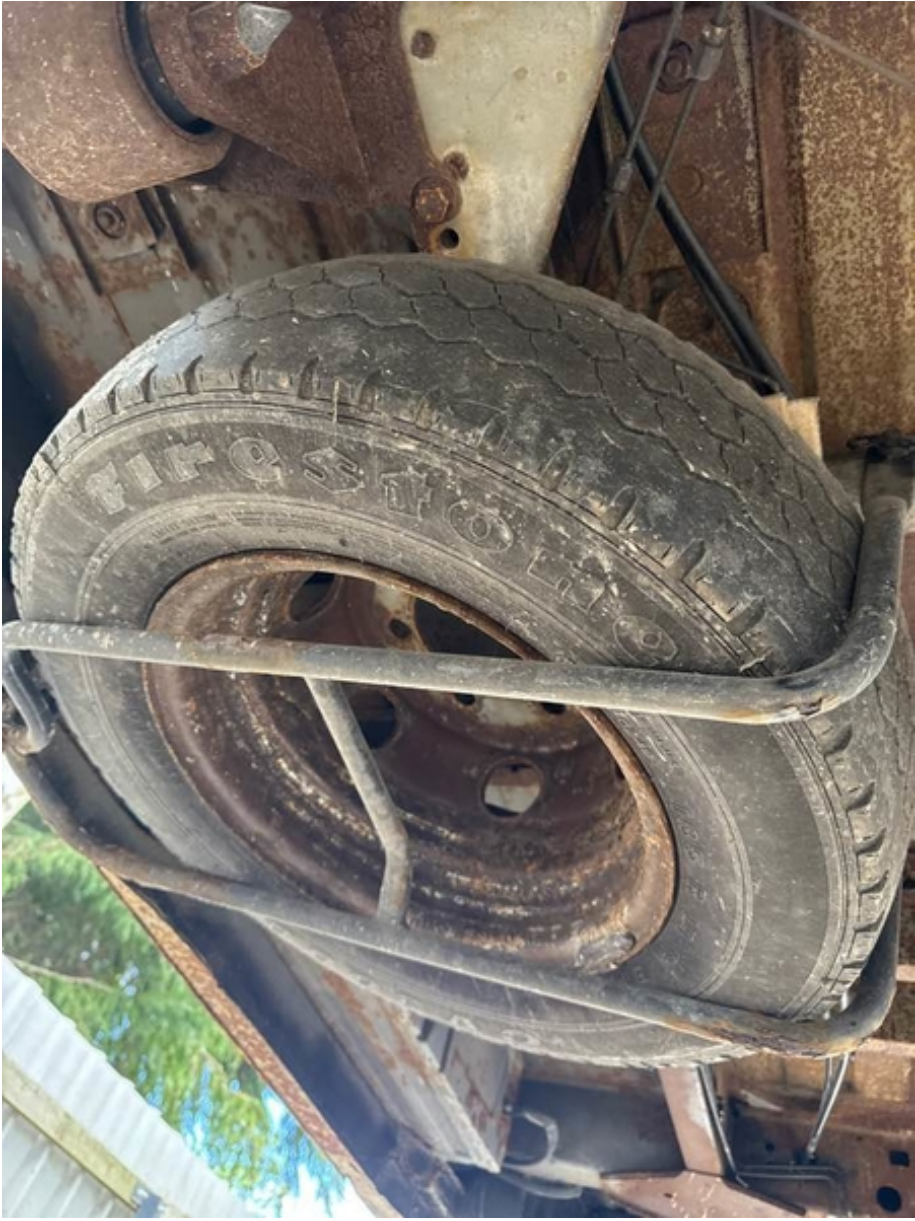
Spare wheel

Pressure 1	
Pressure 2	
Wearing / Perishing (inner)	none
Wearing / Perishing (outer)	None
tread depth (mm)	2
General comments	Good spare
Images of tyre

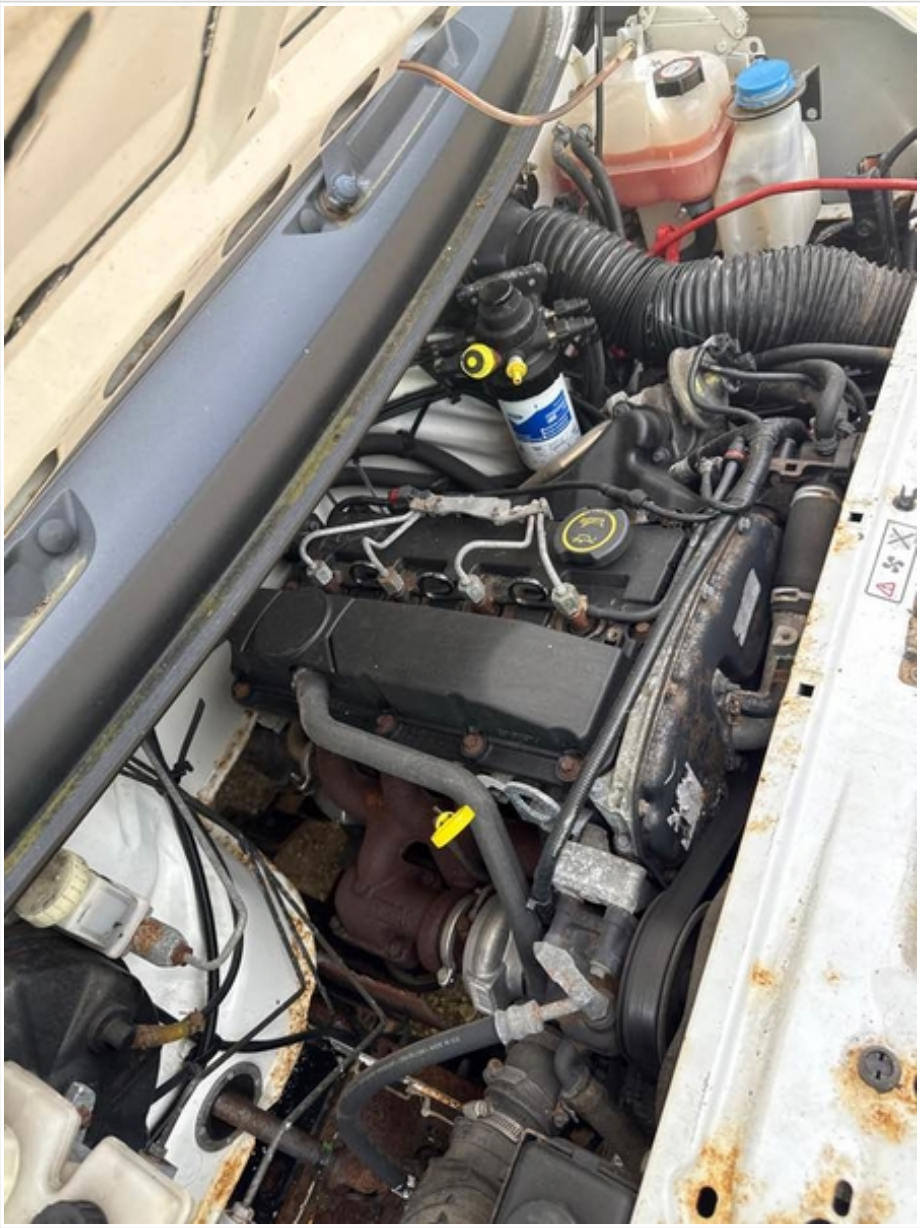
Coolant condition	Clean
Coolant level	Full
Anti-freeze temperature check	-17
Washer fluid	Full
Brake fluid	Full
Power steering fluid	Maximum
Dashboard warning light	No warning lights
OBD Scan results	
Engine bay photo
