Basevan.com General Inspection

Vehicle registration	YJ14HMU
Vehicle chassis no.	VF3YDTMFC12548726
Miles (if in km, multiply by 0.62)	145097
Make	Peugeot
Model	Boxer
Transmission	Manual, 6 speed
Factory immobiliser installed	Yes
Speed limiter installed	N/A
Drive configuration	FWD
Gross Vehicle Weight (kg)	3500
Towing capacity	3000
Tow bar installed	No

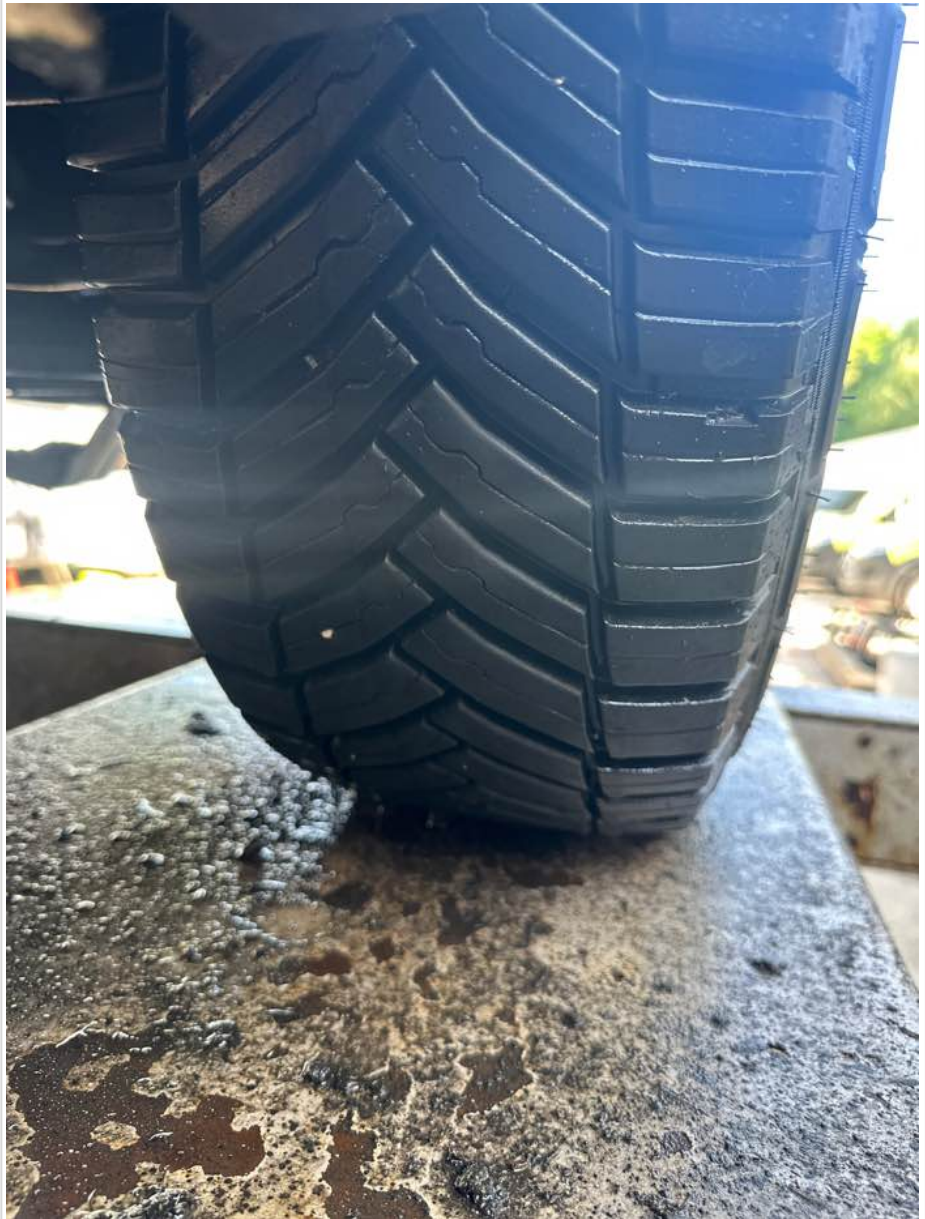
Images of tyre

Off side front

Age (month/year) Manufactured	08/23
Make, brand.	Michelin
Tyre size	225/75/R16
Pressure 1	64
Pressure 2	
Wearing / Perishing (inner)	none
Wearing / Perishing (outer)	None
tread depth (mm)	10
General comments

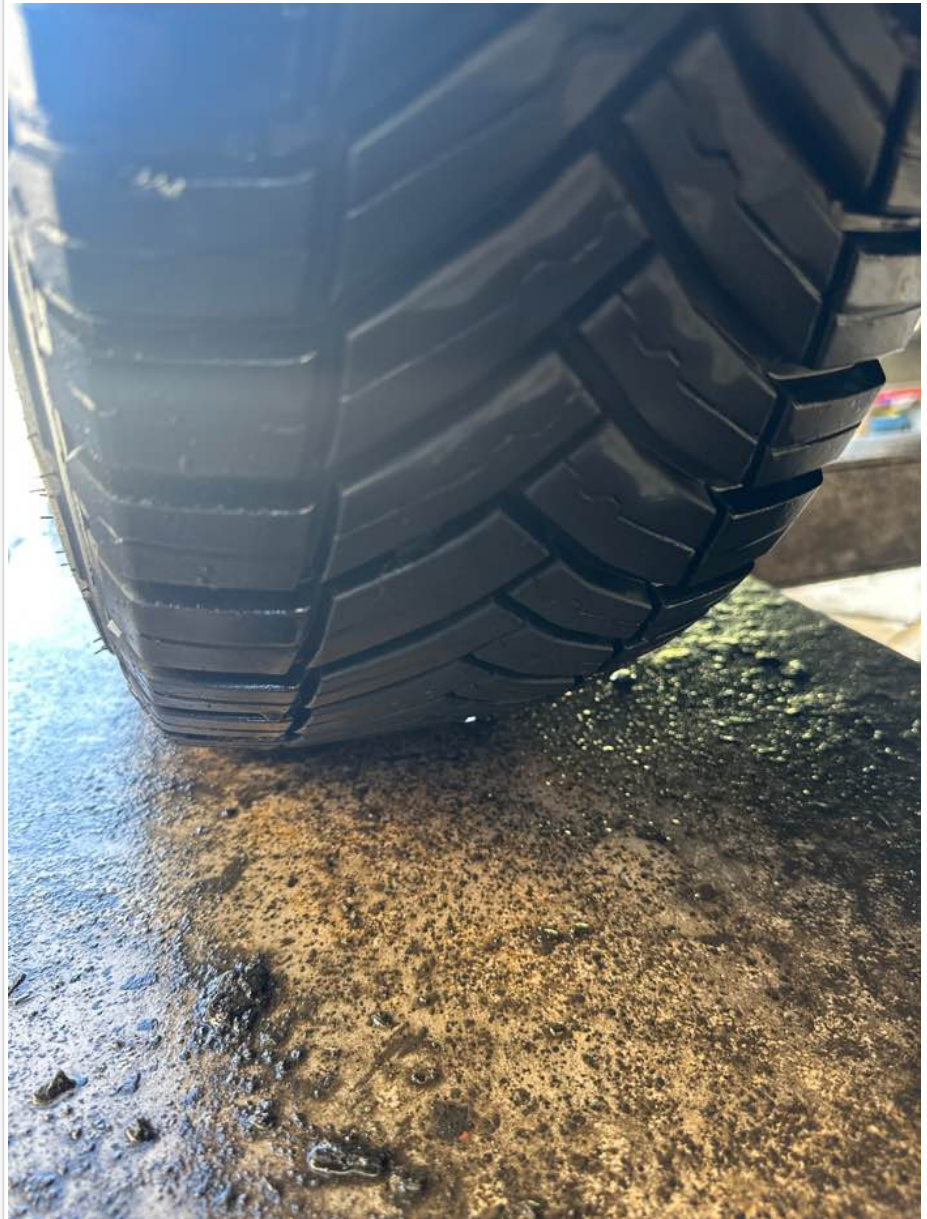
Images of tyre

Near side front

Age (month/year) Manufactured	08/23
Make, brand.	Michelin
Tyre size	205/75/R16
Pressure 1	64
Pressure 2	
Wearing / Perishing (inner)	none
Wearing / Perishing (outer)	None
tread depth (mm)	9
General comments

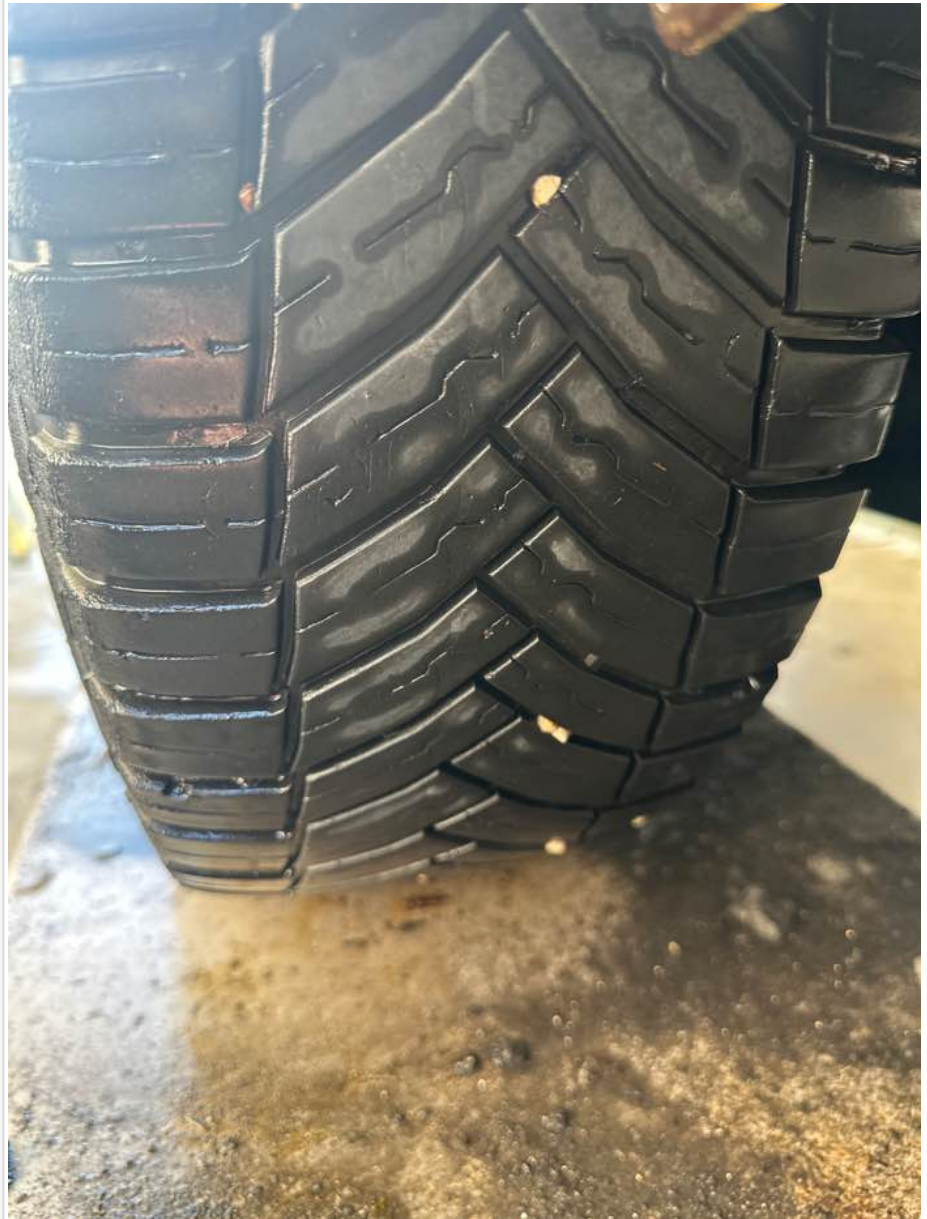
Images of tyre

near side rear

Age (month/year) Manufactured	08/21
Make, brand.	Michelin
Tyre size	215/75/R16
Pressure 1	72
Pressure 2	
Wearing / Perishing (inner)	Medium
Wearing / Perishing (outer)	Medium
tread depth (mm)	5
General comments

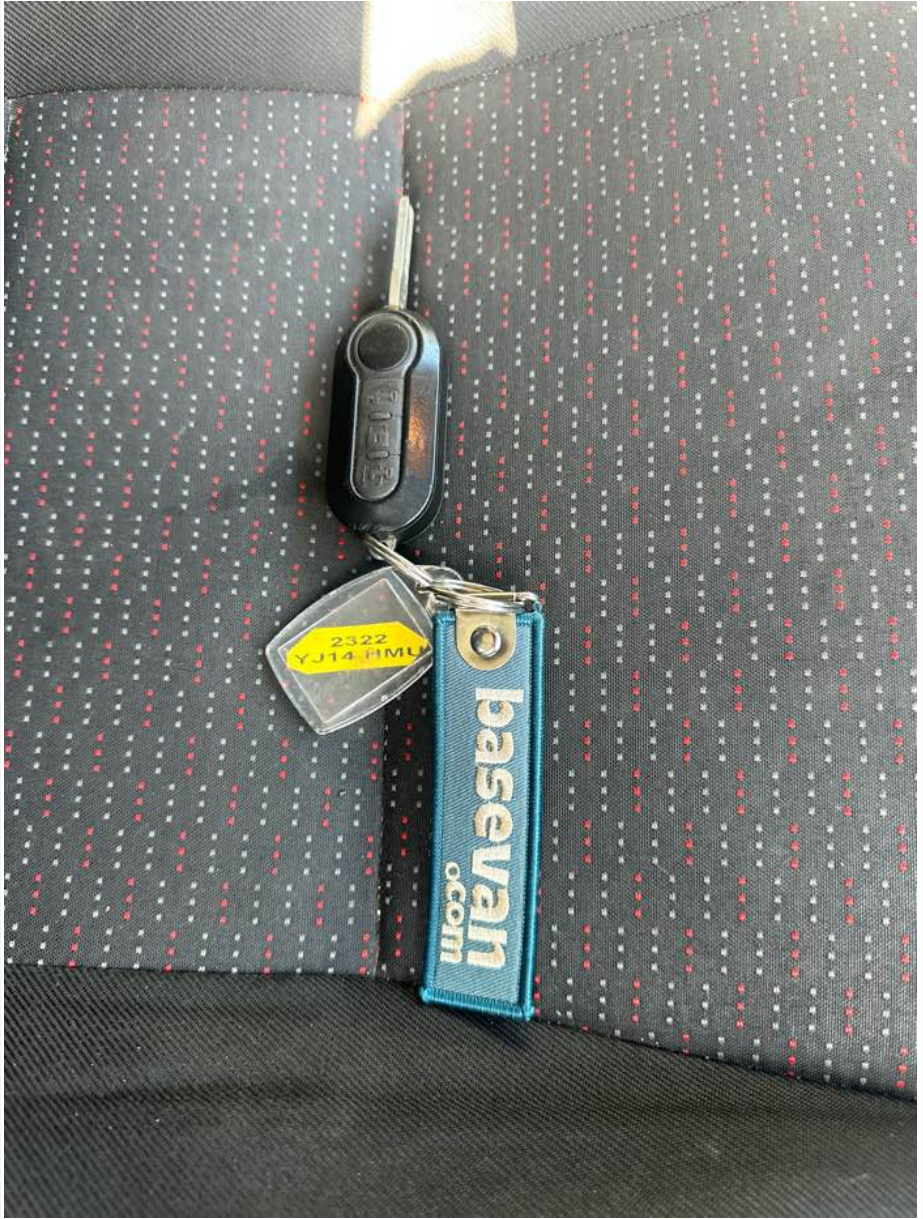
Select the following doors that lock.	N/S Front, O/S Front, N/S SL, N/S Rear, O/S Rear
Method of locking	Fob
In conclusion can all the doors be locked in some way and thus the vehicle can be left unattended at night safely?	Yes
How many keys present at time of inspection?

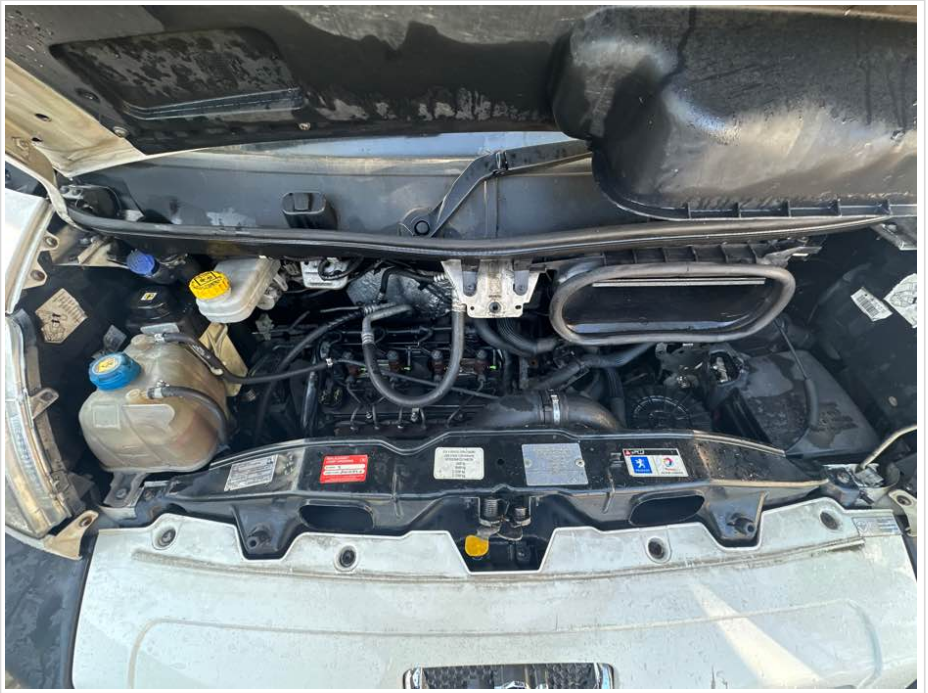
<p>Engine bay photo</p>

Fuel level	1/2 Full
Oil level	Full
Oil conditon	Clean
Start up, chassis battery check	Started without jump pack
Start-up from cold	2 seconds
Exhaust smoke from cold	Normal
Output Voltage of Alternator test	14.1
Chain or Belt driven engine?	Chain
If belt any proof of change?	N/A
Coolant condition	Clean
Coolant level	Full
Anti-freeze temperature check	-23
Washer fluid	Medium
Brake fluid	Full
Power steering fluid	Miniumum
Dashboard warning light	No warning lights
OBD Scan results
